***Testing  
Hybrids with Pitch Adapter  
and  
TOB Module #11  
using ARC system***

CERN hybrid &  
module test station

Module Test Meeting  
05.03.2002

Michael Pöttgens, Giacomo Sguazzoni

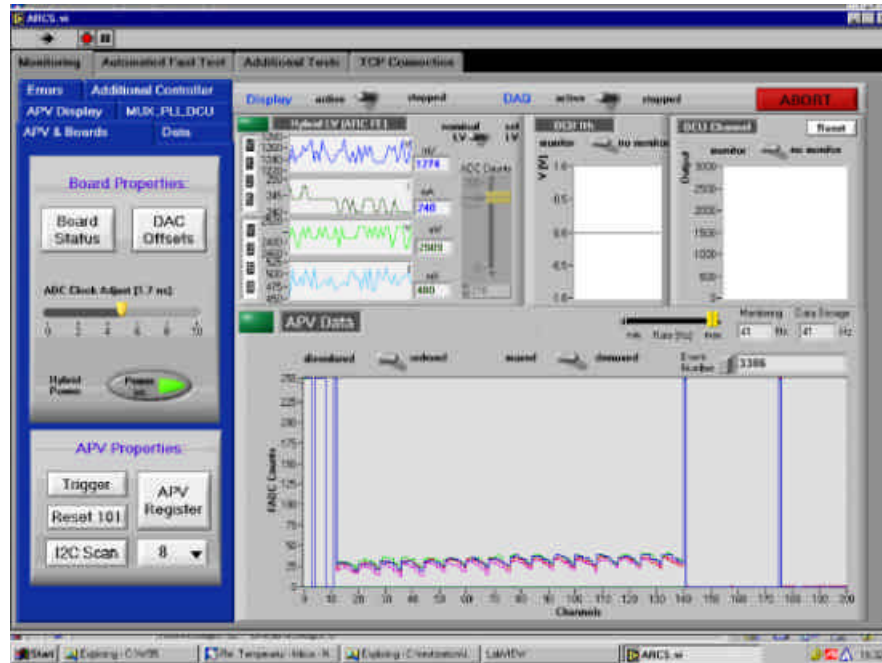
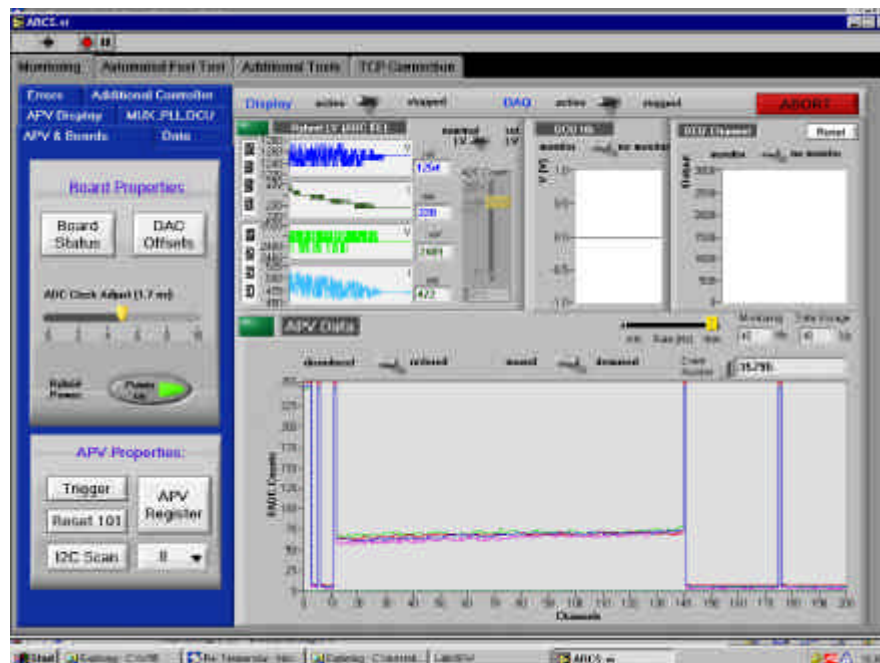
# Screenshots

observation:

- at about  $-10^{\circ}\text{C}$  baseline starts to jump up and down
- data shows a regular structure
- V125 and V250 move up and down
- noise increases

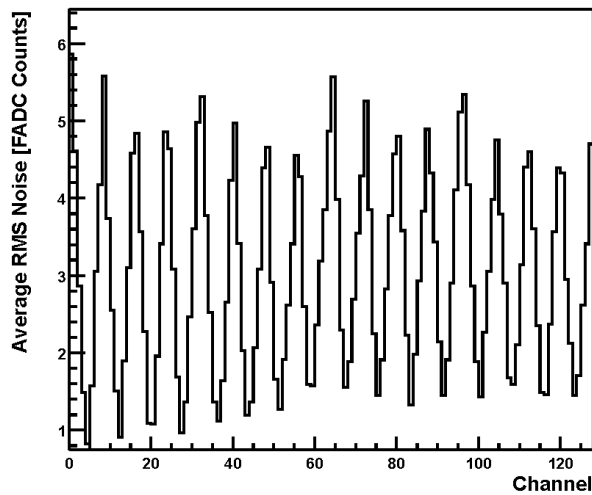
- capacitance of capacitors is reduced with decreasing temperature  
=> voltage is not constant

=> current version of FE adapter  
can **not** be used in cold  
environment!

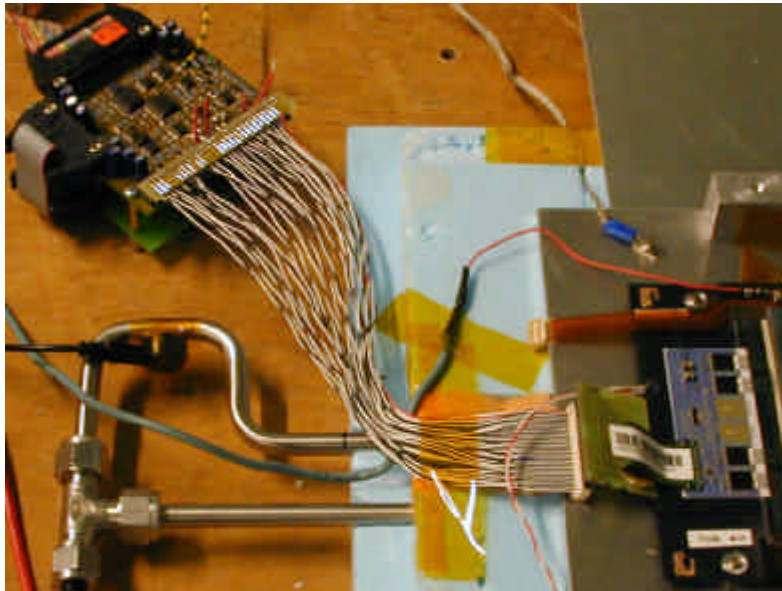
connection FE adapter - test object via  
SAMTEC/ERNIE adaptercable + small  
adaptercard ERNIE/NAIS

⇒ adapter stays outside test box

⇒ bad influence on signal performance

⇒ shielding of cable necessary?
