I²C Problems in LT: The Solution

Marco Meschini
INFN Firenze

Introduction: The Problem

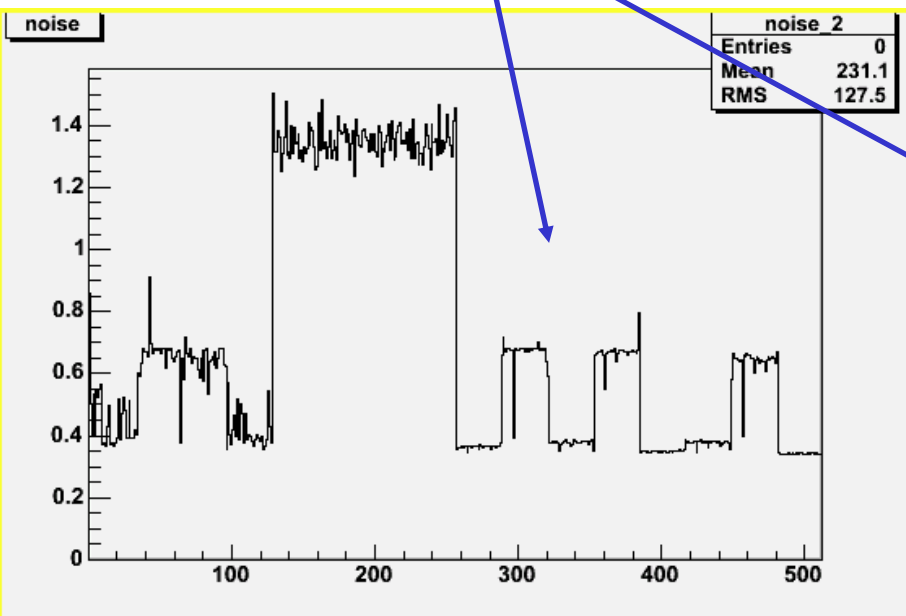
- As reported at last ModTest meeting modules were "lost" during LT in cold cycles
- Everything started observing a strange behaviour in APV noise, associated with error messages from FecServer - Modules excluded from DAQ

```
fec Exception: Mon Feb 16 17:42:20
2004
FecDevice::writei2cDevice(single
byte write extended (RAL) mode):
Register acces
FEC Functions error code: 205
Position: FEC 0x0 Ring 0x0 CCU 0x4
Channel 0x6 I2C address 0x3F
```

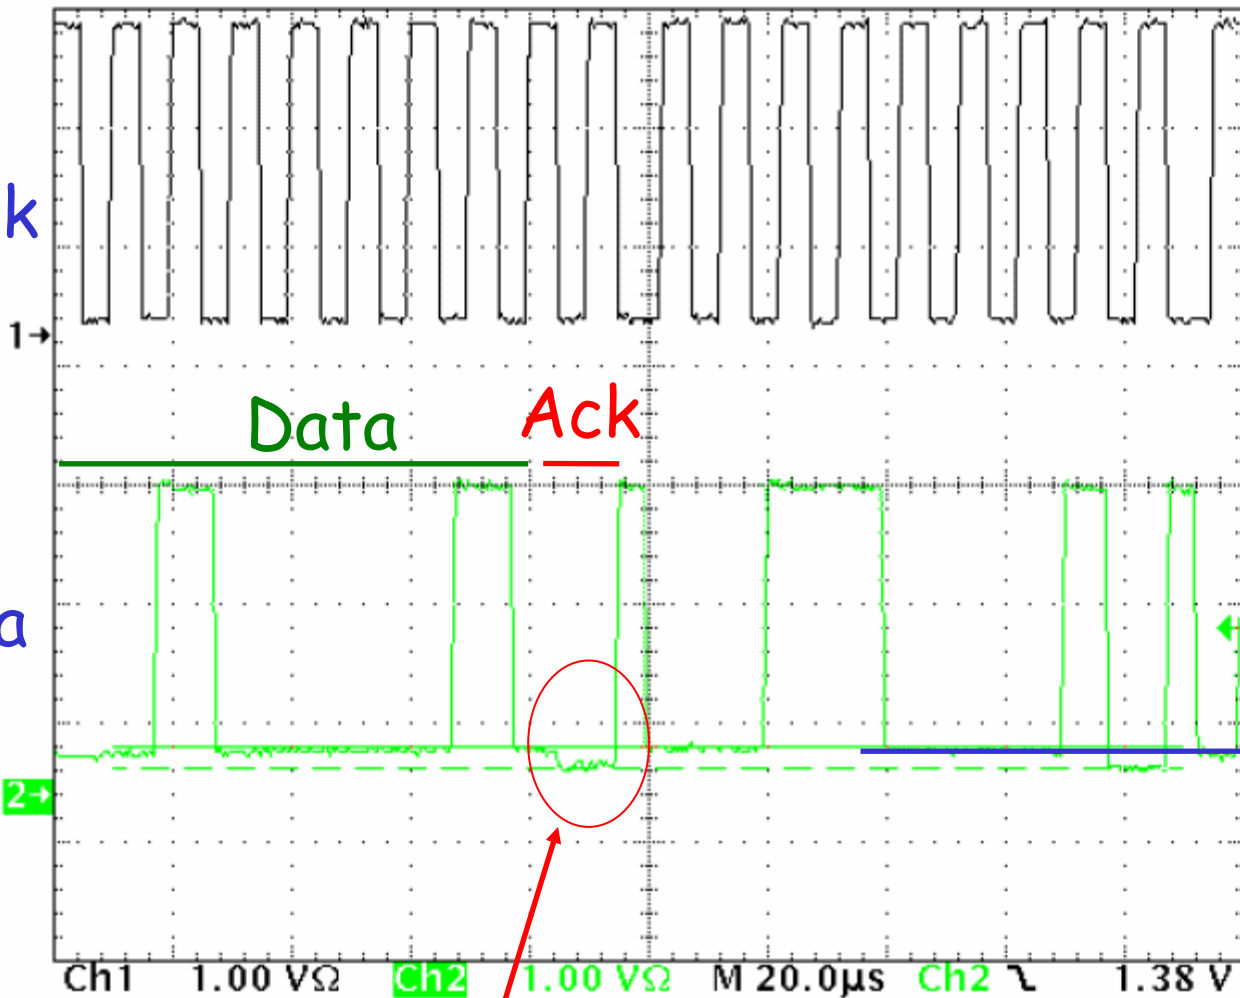
The Standard Situation

Δ: 180mV
@: 380mV

Acknowledge bit = 0 means that the APV is understanding the I²C communication

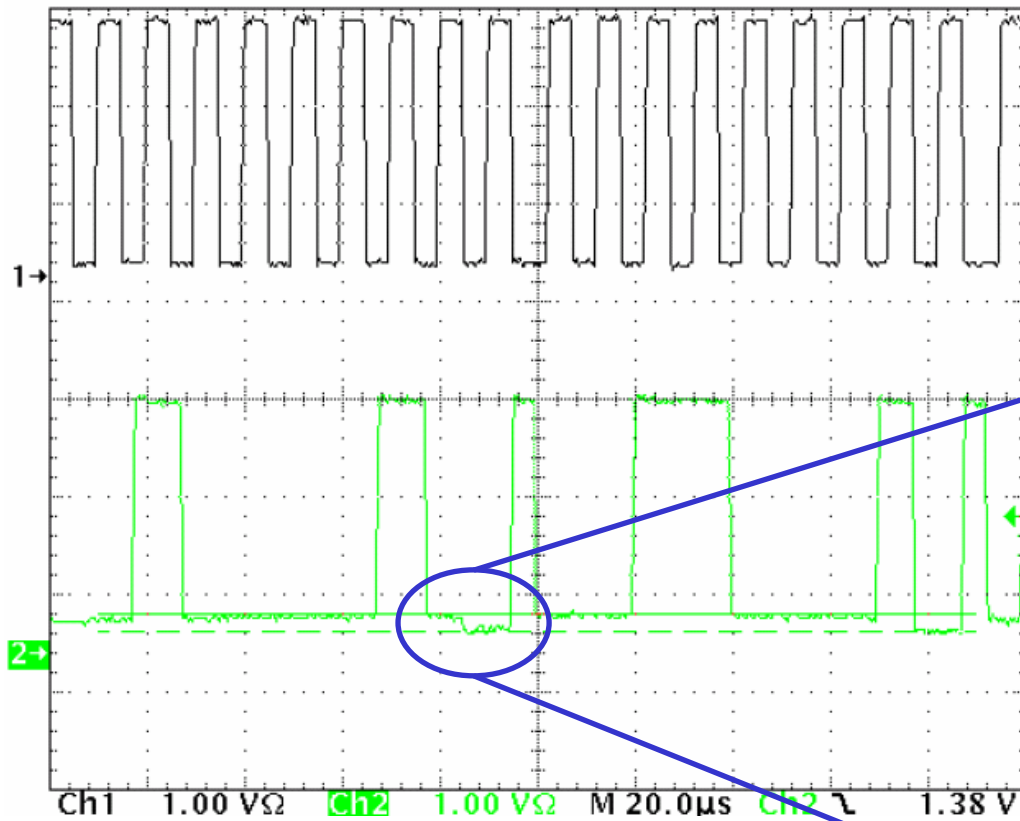
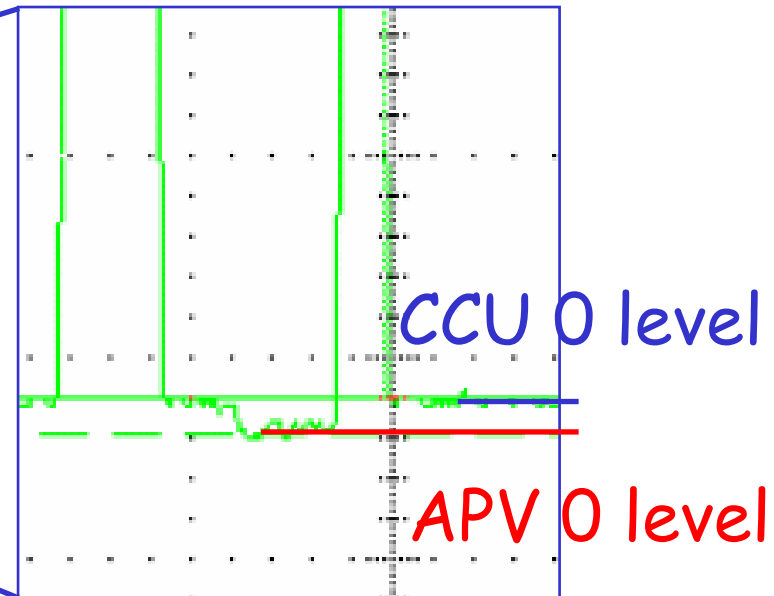
APV Answer

The LOW level of the I²C data line is lower when the APVs are asserting on the bus

Depending on the pull-up R_p it can happen that the CCU6 does not pull down enough the I²C line

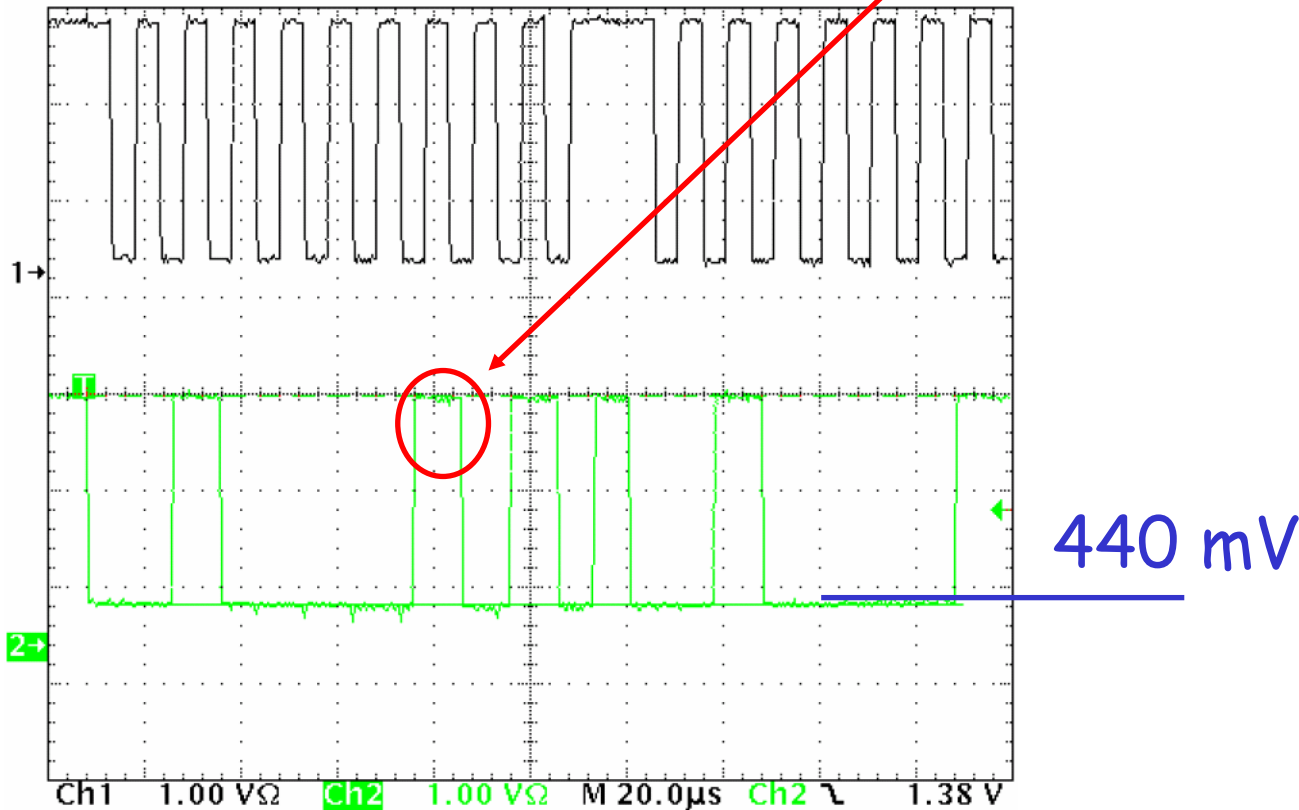
A Bad Situation

- In this case the acknowledge bit is HIGH
- The APV is not understanding the I²C signals and then it goes into an unpredictable state

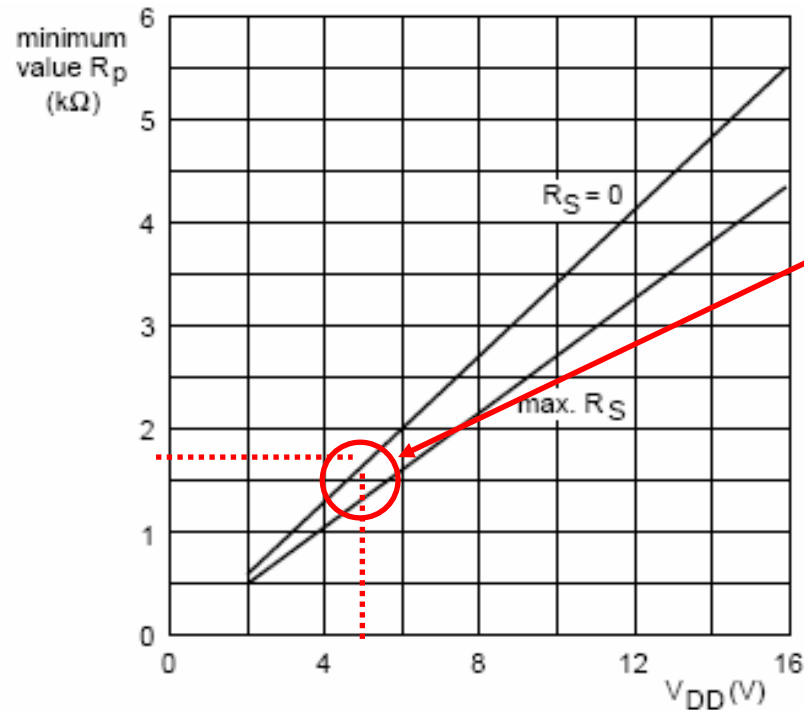
Fig.37 Minimum value of R_p as a function of supply voltage with the value of R_S as a parameter.

- In our case $R_S = 0$ so the minimum R_p value is higher than 1500Ω (original pull-up resistor on CCU6)

So we decided to try changing the pull-up resistors (using trimmers) to understand the LOW level behaviour

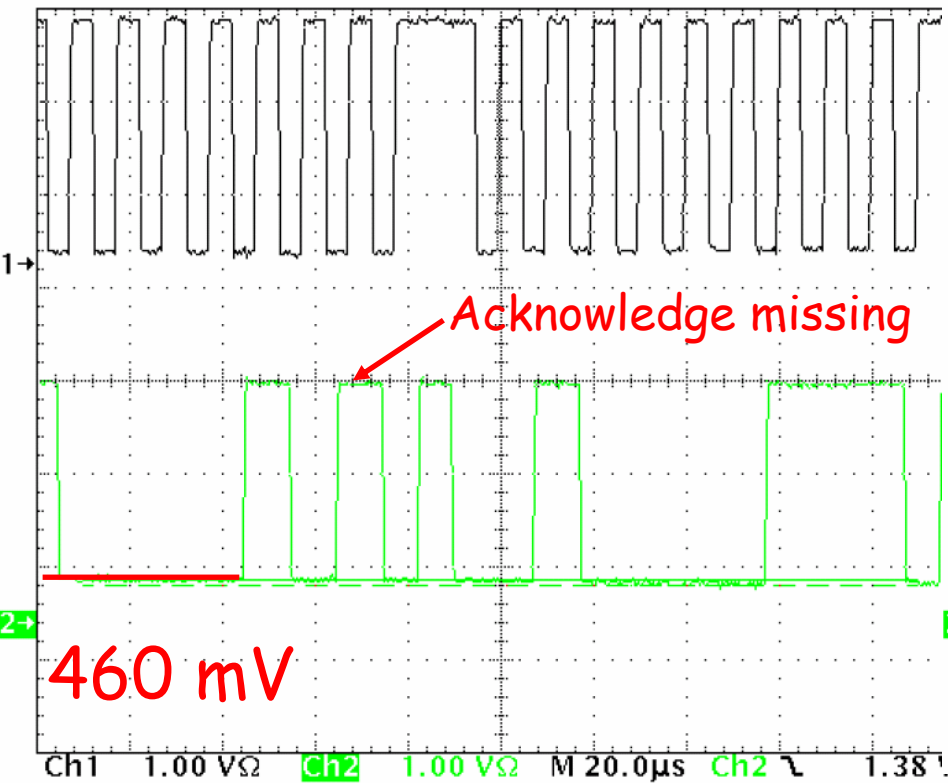
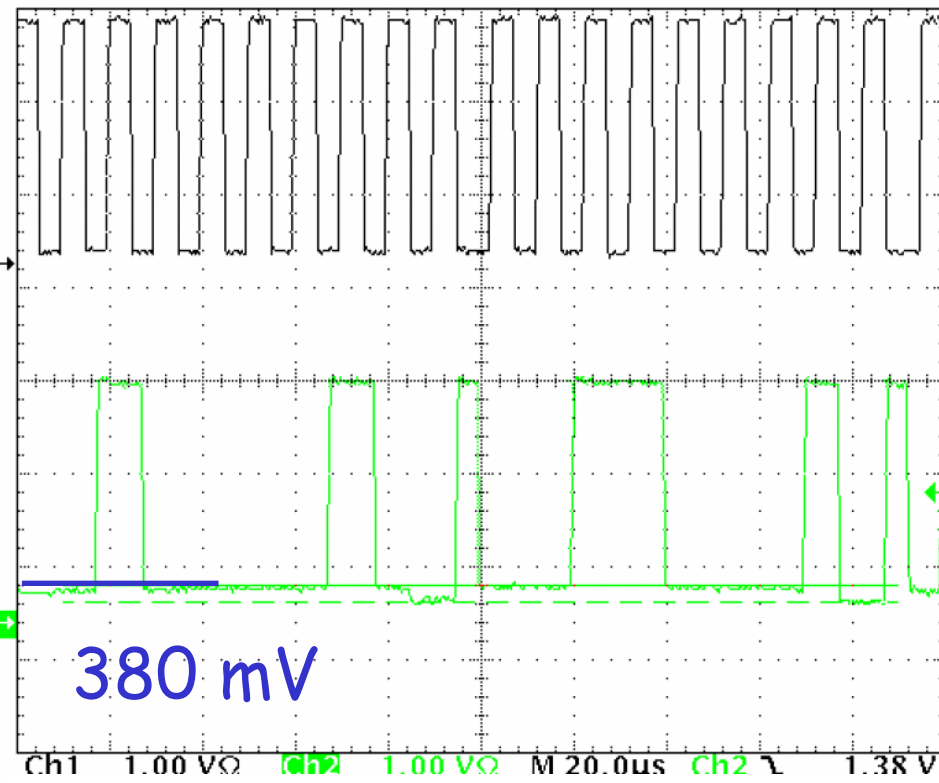
APV Behaviour

- Warm temperature, same APV at different I²C LOW levels
- Even if below 500 mV, there are problems in communication

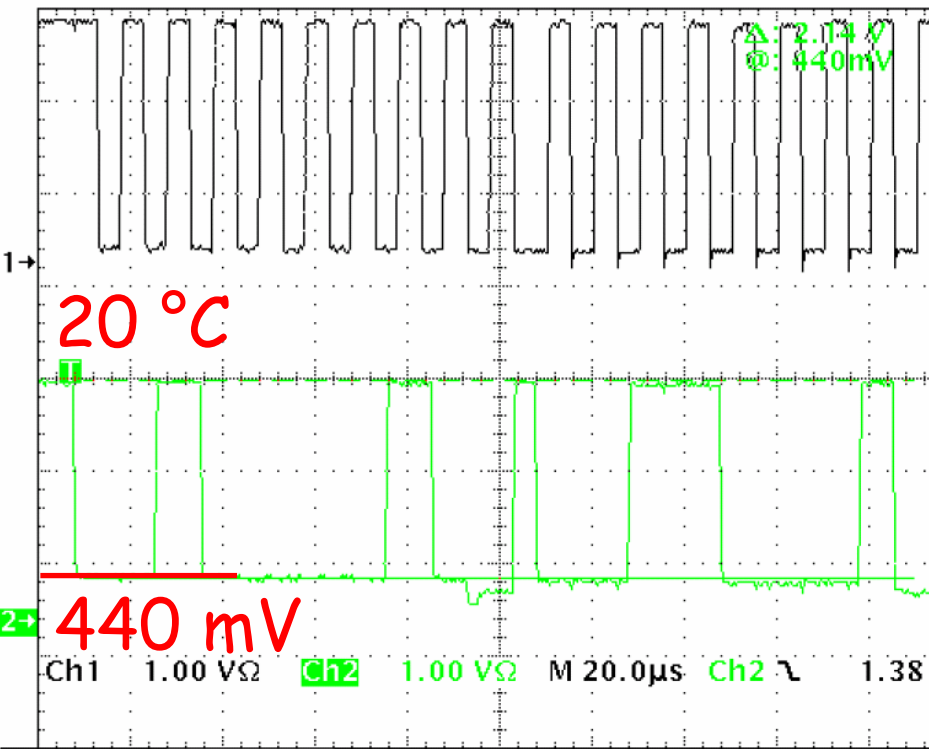
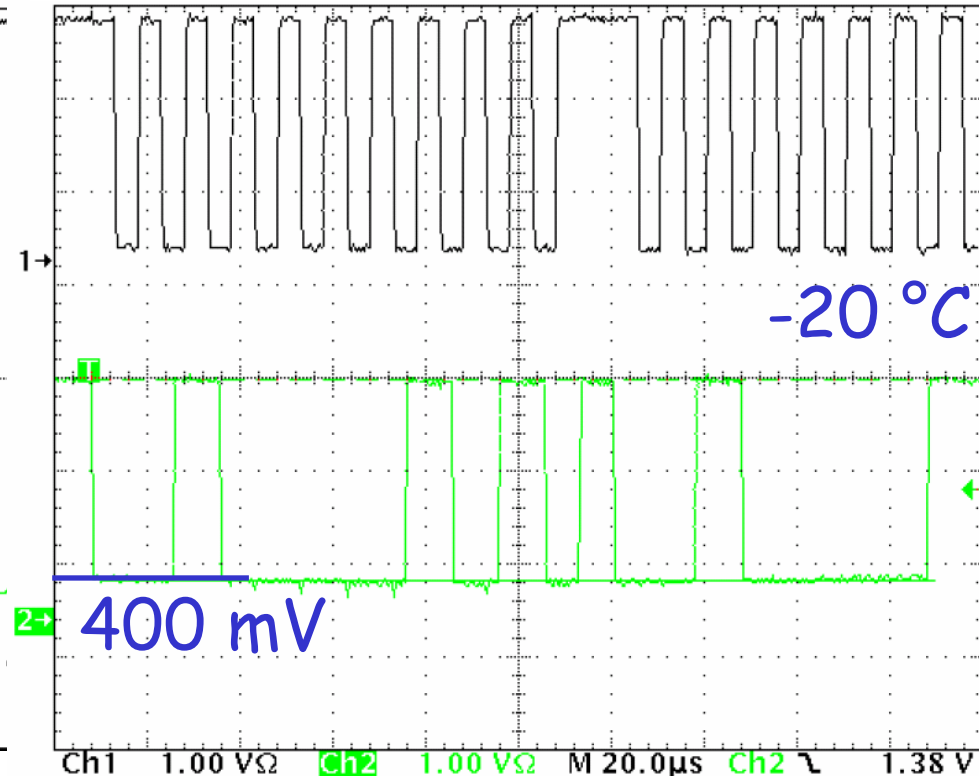
Warm and Cold

- Varying the working temperature, the APV doesn't recognize the same LOW level

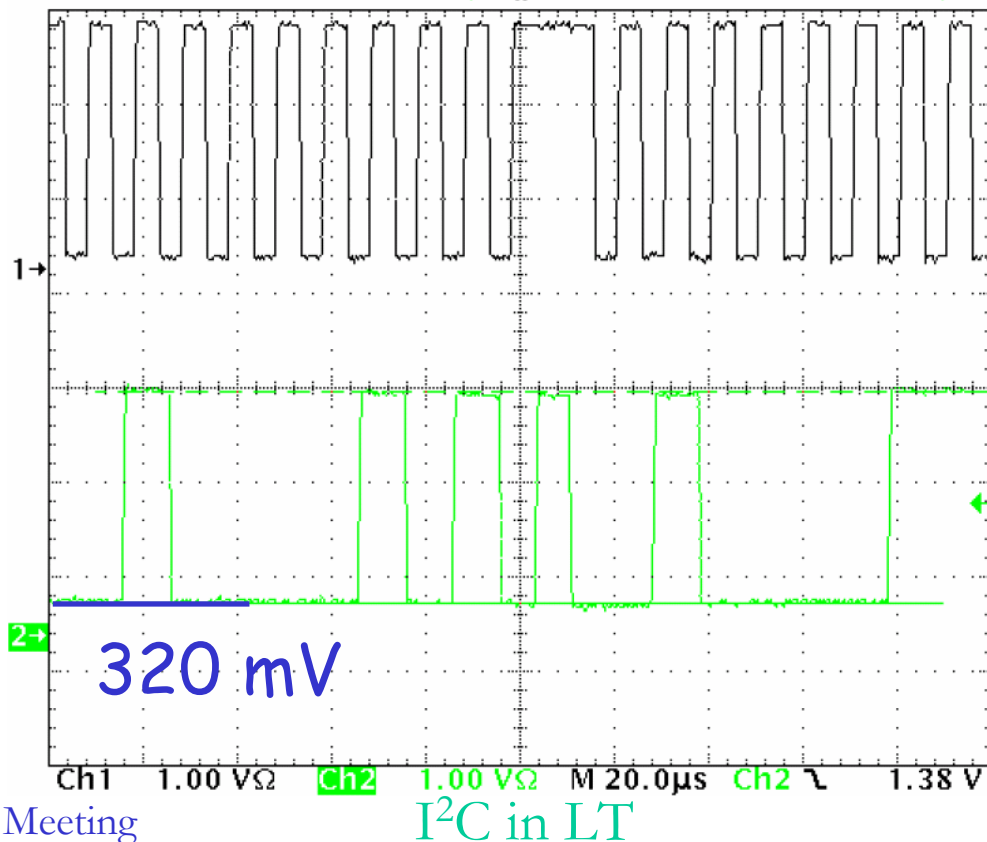
Problems in Cold

- One chip at low temperature doesn't work even pulling the LOW level down to 320 mV
- With 2200 Ω pull-up resistors even this chip is completely recovered

- Not all APVs behave in the same way: different sensitivity to LOW thresholds leads to loss of communication → **WE WERE RIGHT!**
- To avoid this problem we chose to increase the pull-up resistors on the data line of the CCU6 from 1500 Ω to 2200 Ω . **All R1 through R12 on the CCU6 boards have to be replaced**
- **With this modification no I²C errors appear, both on new tested modules and on previously failing modules which are then recovered**
- The line speed of the I²C bus in our case is 100 kHz. Is it safe going to higher speed?
