TOB Testing Status and CMN Issues

Claudio Campagnari - UCSB

On behalf of the US module testing groups

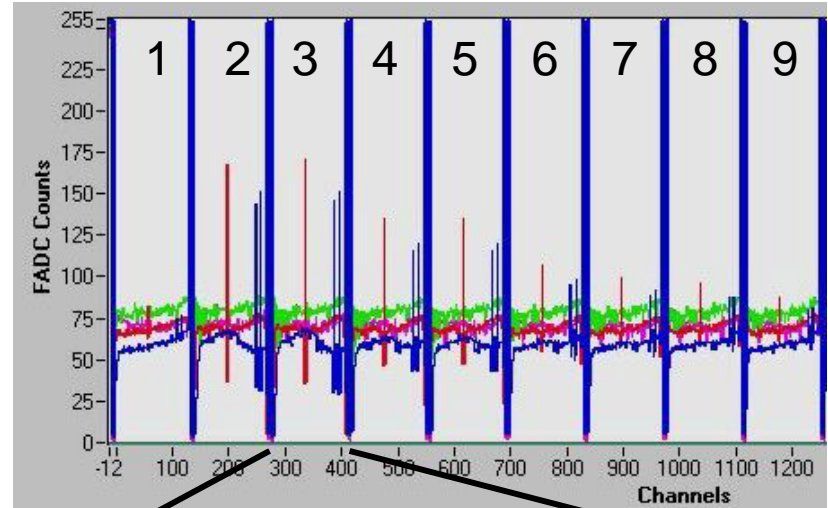
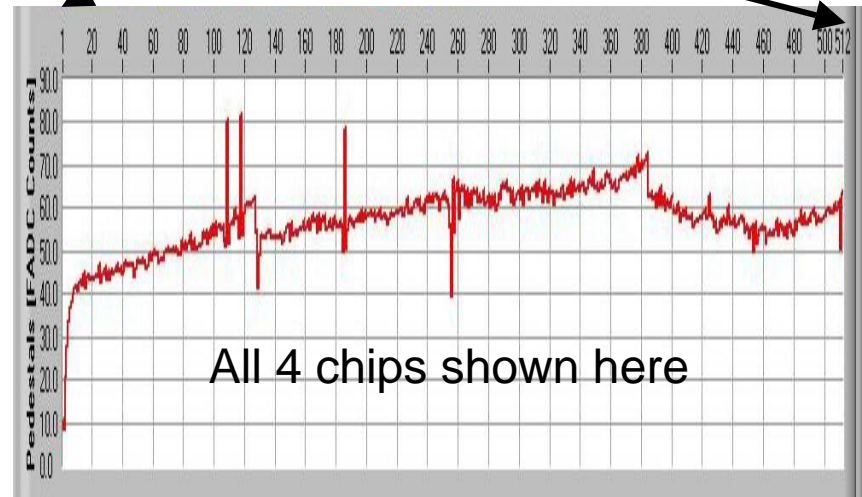
Hybrid Thermal Cycler Validation

- Opens added to a test hybrid to validate PA pulser
 - Opens clearly seen in both scope mode (above) and pedestal tests (below)
- Should have no problems detecting problems in hybrid bonding

Scope mode (25 ns between each acquisition)

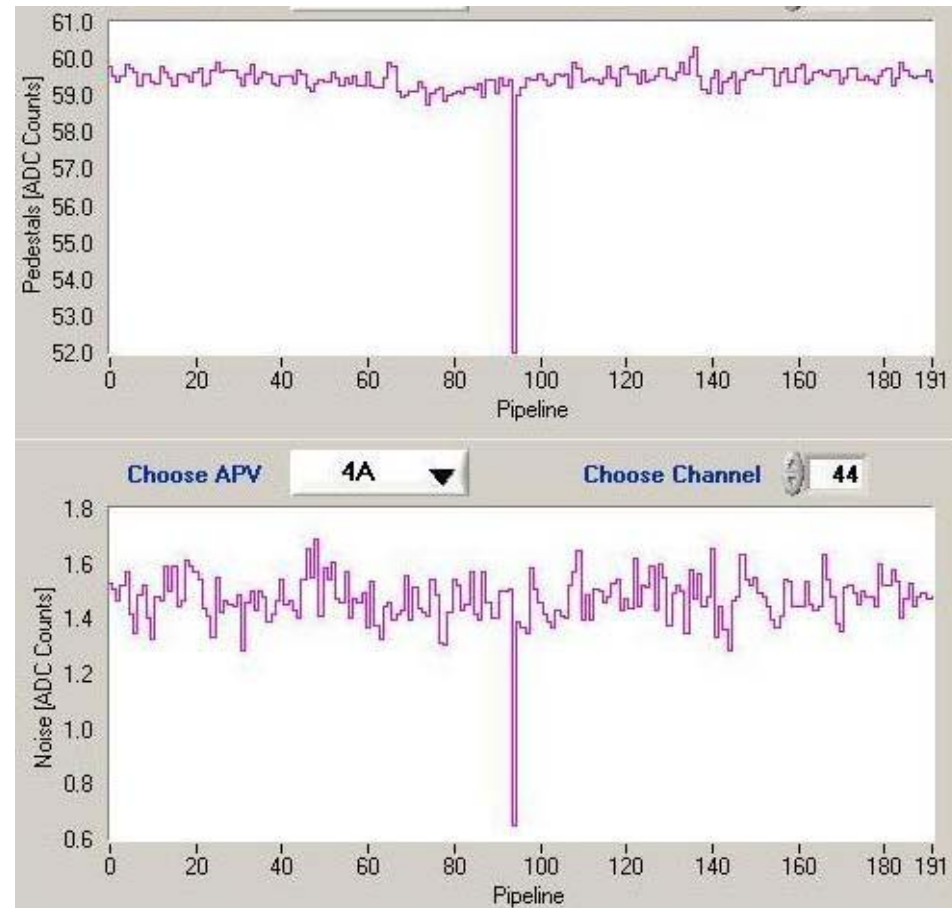
Dead Pipeline Column (1)

- Chip with unusual pulse shape and pinhole tests found (see next slide)
 - After conferring with Aachen and CERN, problem appears to be confined to one pipeline column
- After taking a pipeline test with many events, it became clear that the noise of a pipeline column was too low to be active (Dead pipeline column)
 - Noise is lower than APV in bare hybrid
- First time we've seen this in US
- We recommend to routinely calibrate on each column

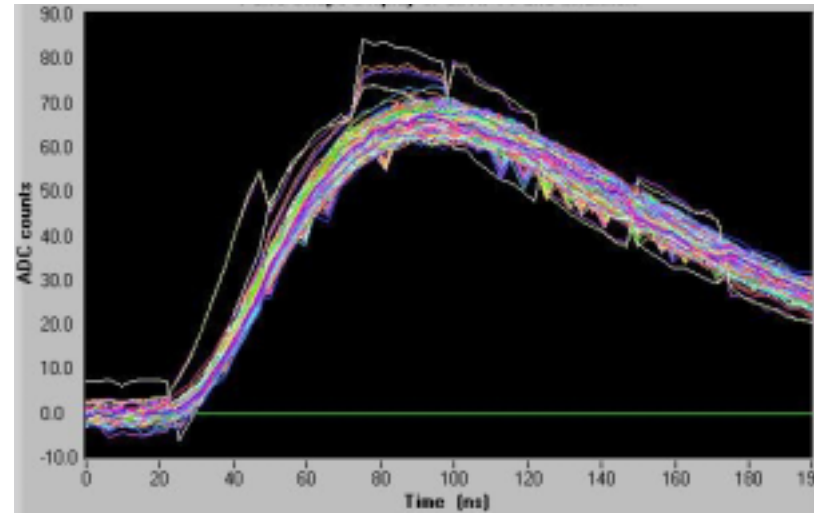
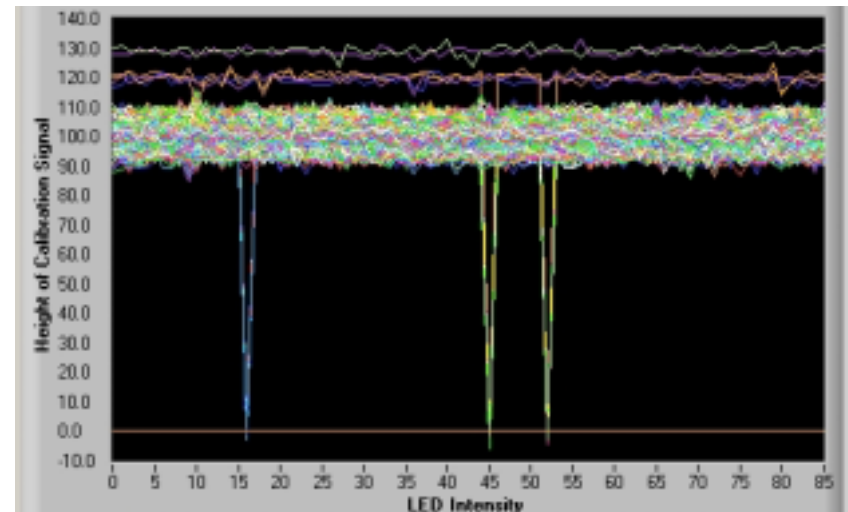
Dead Pipeline Column (2)

- Other symptoms of dead pipeline columns
 - Pulse Shape Test
 - No calibration injection 0.5% of events
 - Causes dips in pulse shapes
 - Pinhole Test
 - 1 in 192 chance of having no calibration injection, causing channels to be marked as pinholes
- Need to modify hybrid testing procedure to find dead column prior to module assembly
 - Measuring pulse height in pipeline-like test with calibration injection would find this problem 100% of time
- Problem is not serious enough to cause rejection of module
 - ~ Equivalent to dead channel

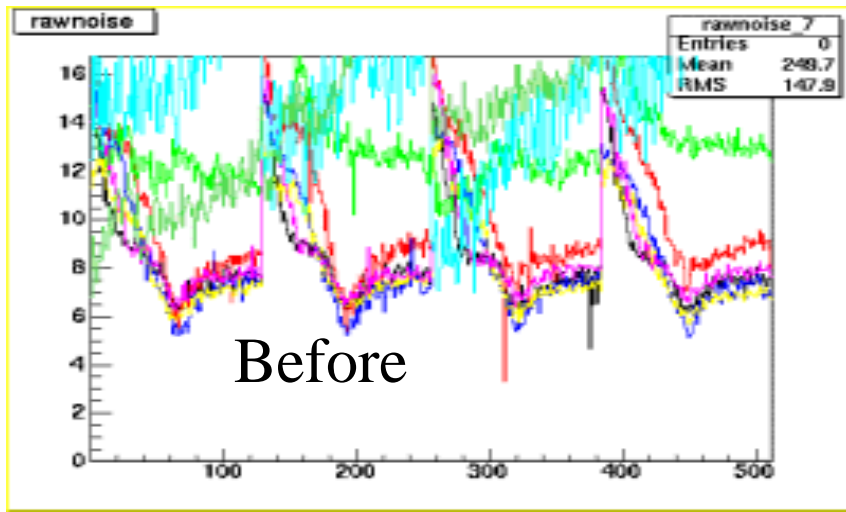
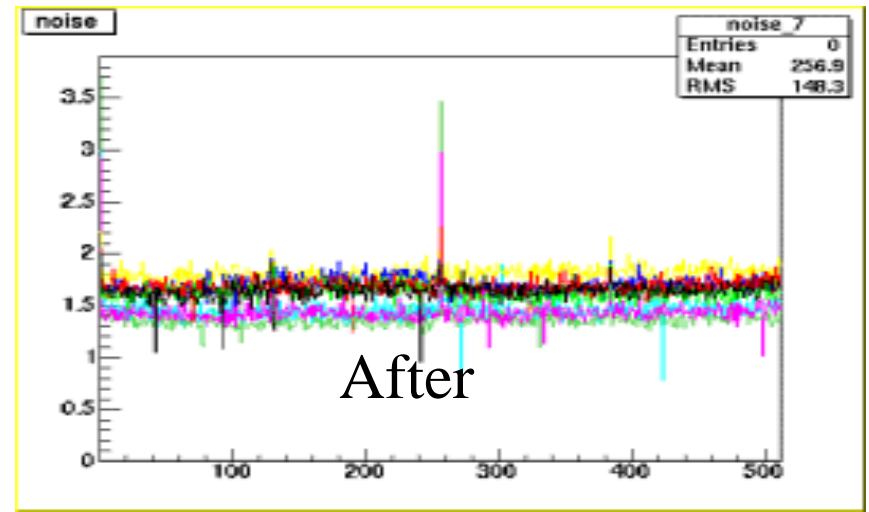
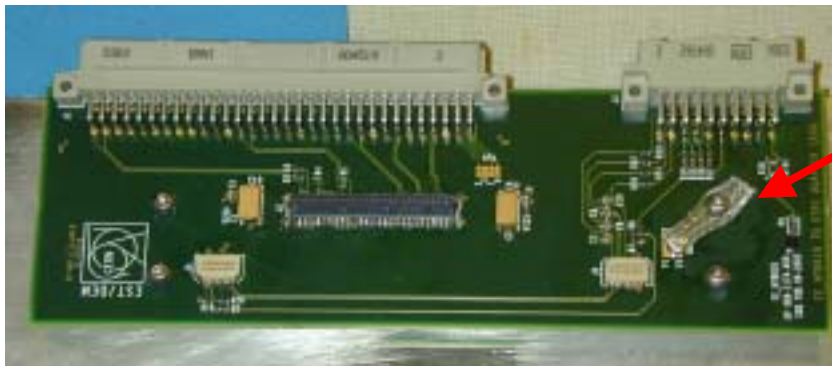
Wien Module Cold Box Noise

- High noise on all 8 slots tested
- Grounded hybrid-to-UTRI adapters to cold box plates.
- Noise reduced on all slots enough for defects to be seen.
 - Both at UCSB and FNAL

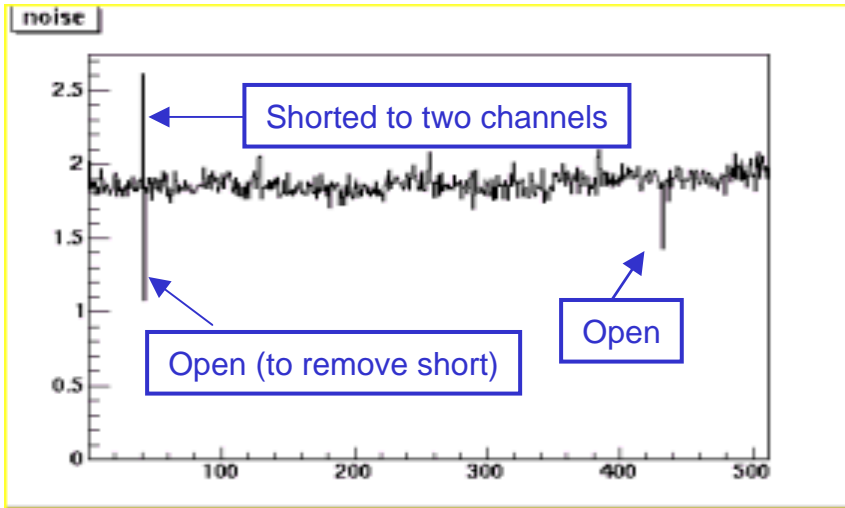
Module 1025 noise with 100V bias

- Channel with marginally low noise shows up clearly in backplane pulse response
- Successfully tested in LT version 1.15 (needed upgrade from 1.10)

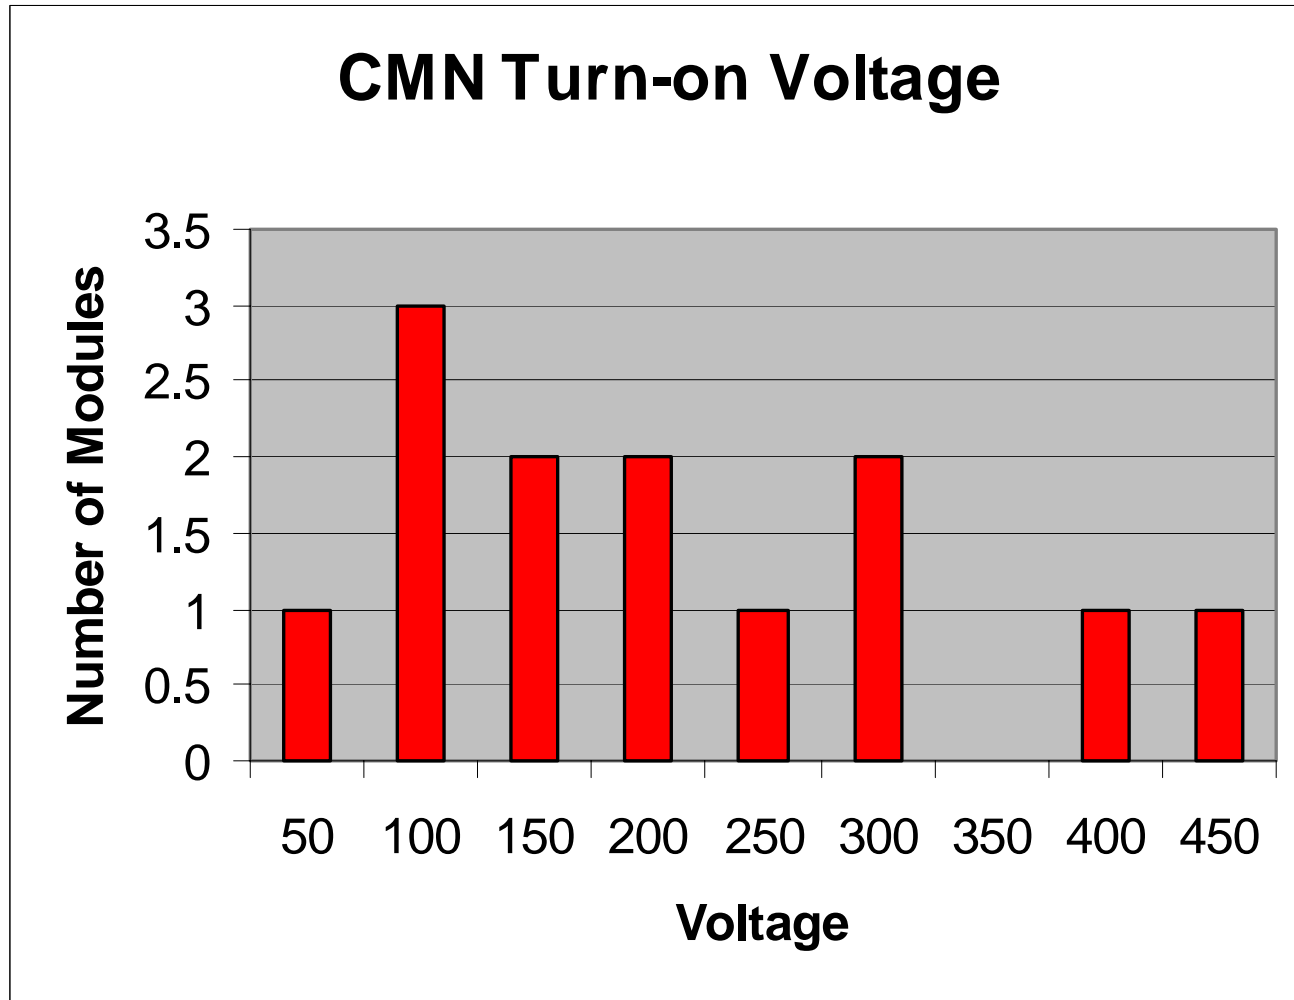
CMN Turn-on Voltage

1. It can have an onset at any bias voltages
2. It can cause serious levels of Common Mode Noise (CMN)
3. CMN subtraction in the FED does not always eliminate it
 - More sophisticated algorithm may work ?
4. Has been seen to develop “spontaneously”
 - One FNAL module started showing during LT test
5. Newer sensors seem better

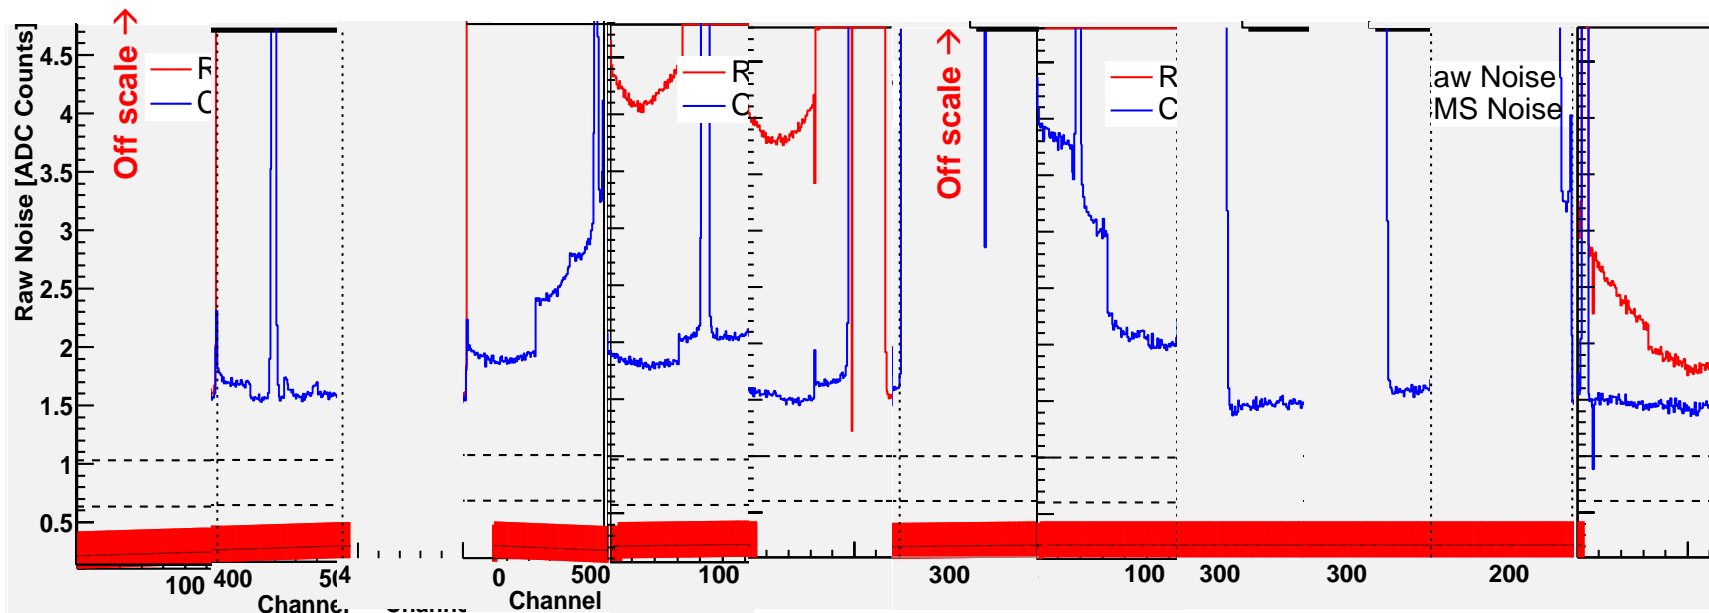
Common Mode Subtracted Noise

Module #: 869 881 1010 1011 1013 1014 1015 1016 1030 1031 1038 1042

Chips with CMN (micro-discharge problem)

Common mode subtracted noise in blue

**For majority of modules with problems, the CM subtraction is imperfect.
7 of 12 have >2.0 ADC noise
3 of 12 have more than twice the usual noise**

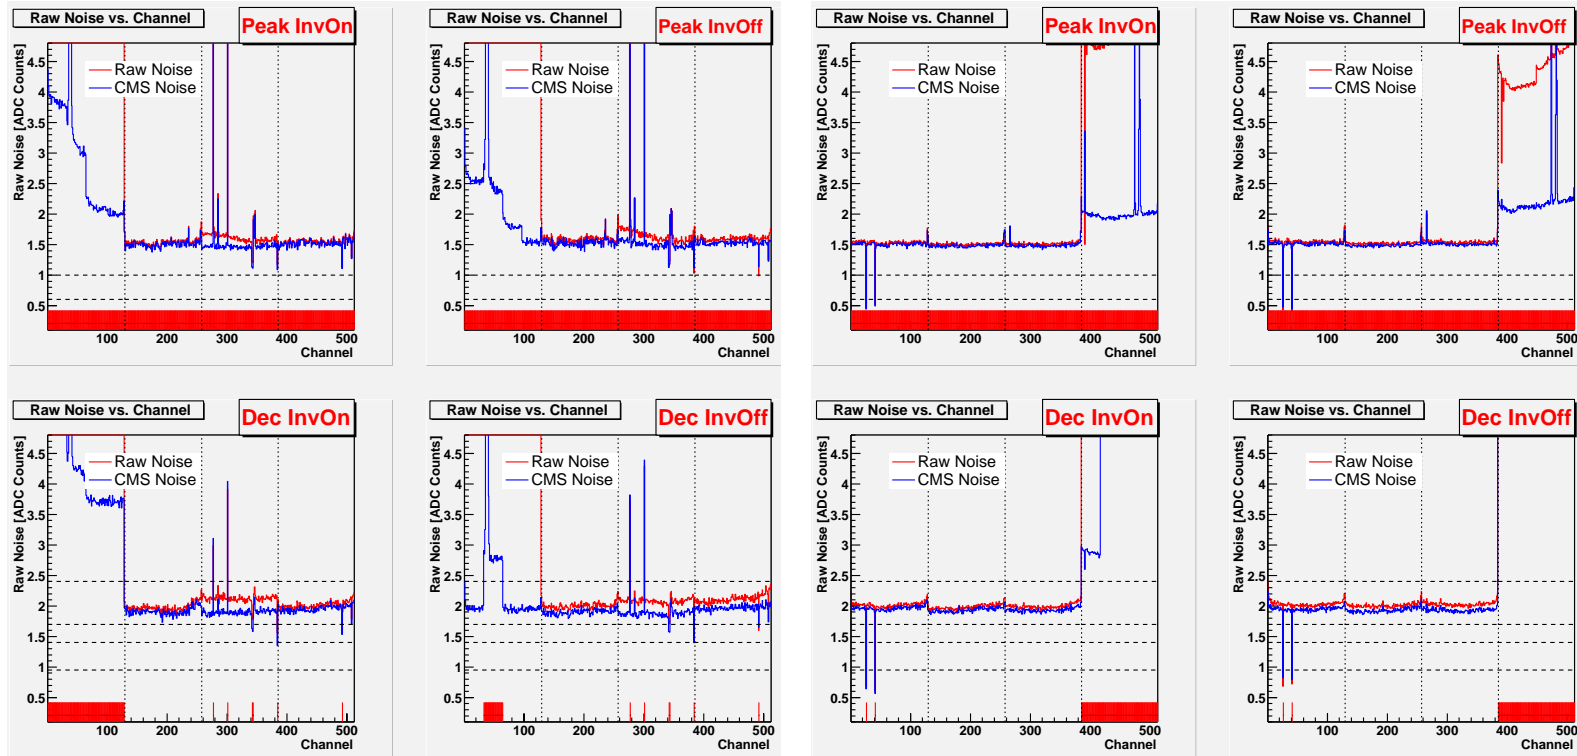
Common Mode Subtraction Variation

- Common mode subtraction results clearly vary
 - Answer differs mode-to-mode or test-to-test
 - **Would yield varying signal efficiency/noise during data taking**
 - **Not clear how this will evolve with time/radiation**

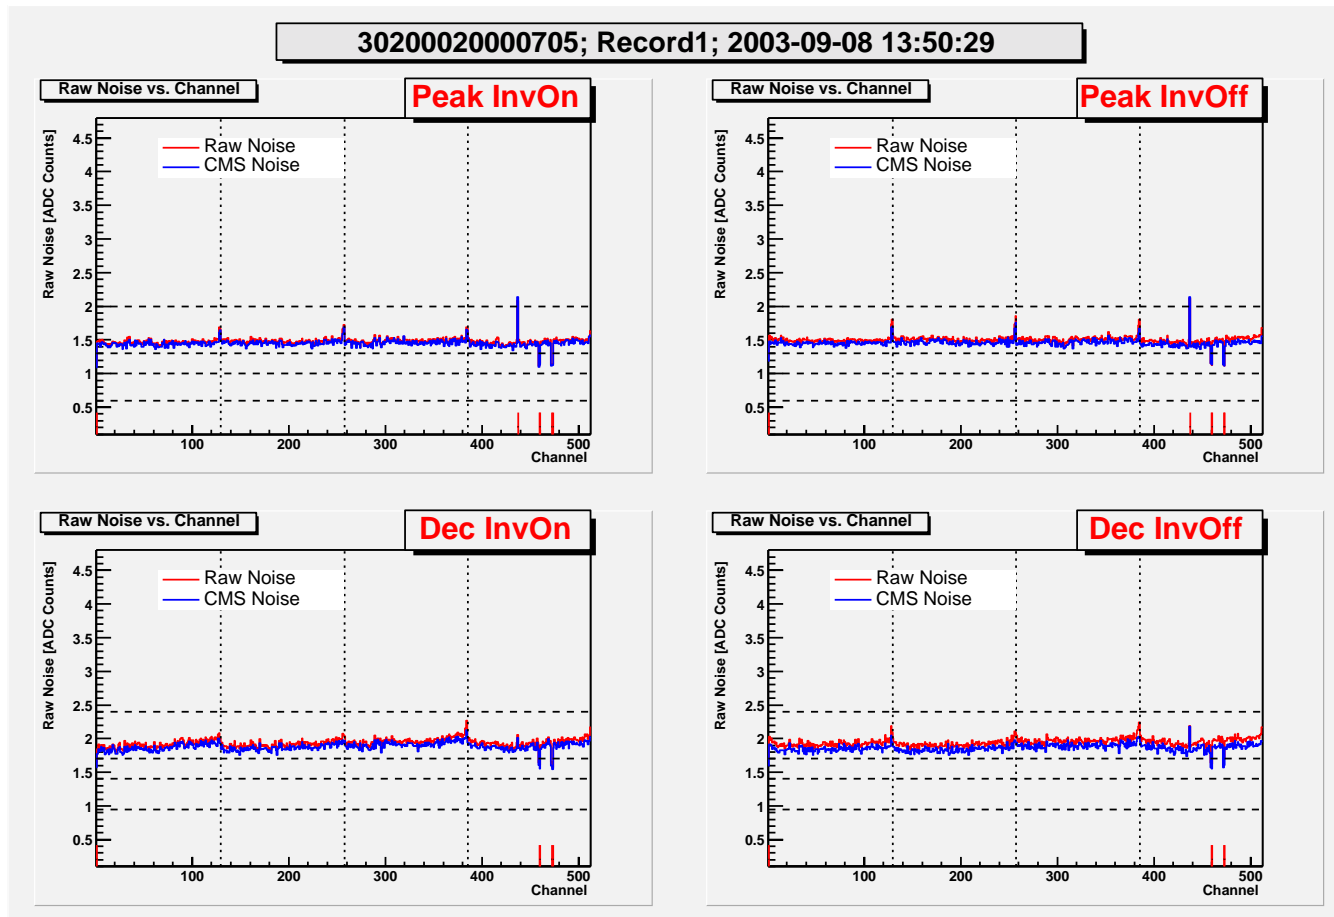
Module 705 before LT (FNAL)

- After assembly module was tested (09/08) on ARCS at 400 V and graded “B” (6 faulty channels). No problems observed.

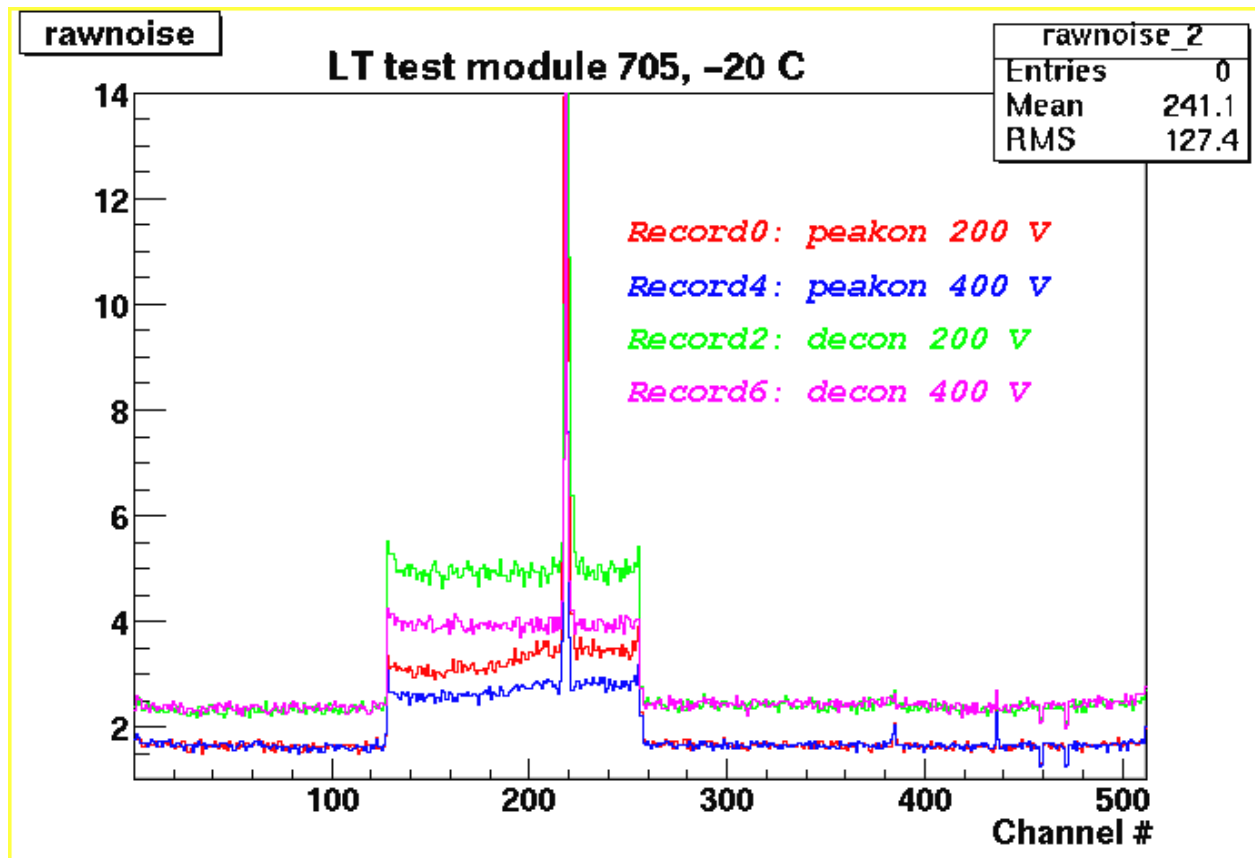
Module 705: LT data (FNAL)

- Data taken at -20°C on Sept.19 (10 days after the first test). A group of high noise channels is seen around channel 219 and increased CMN is seen in chip #2

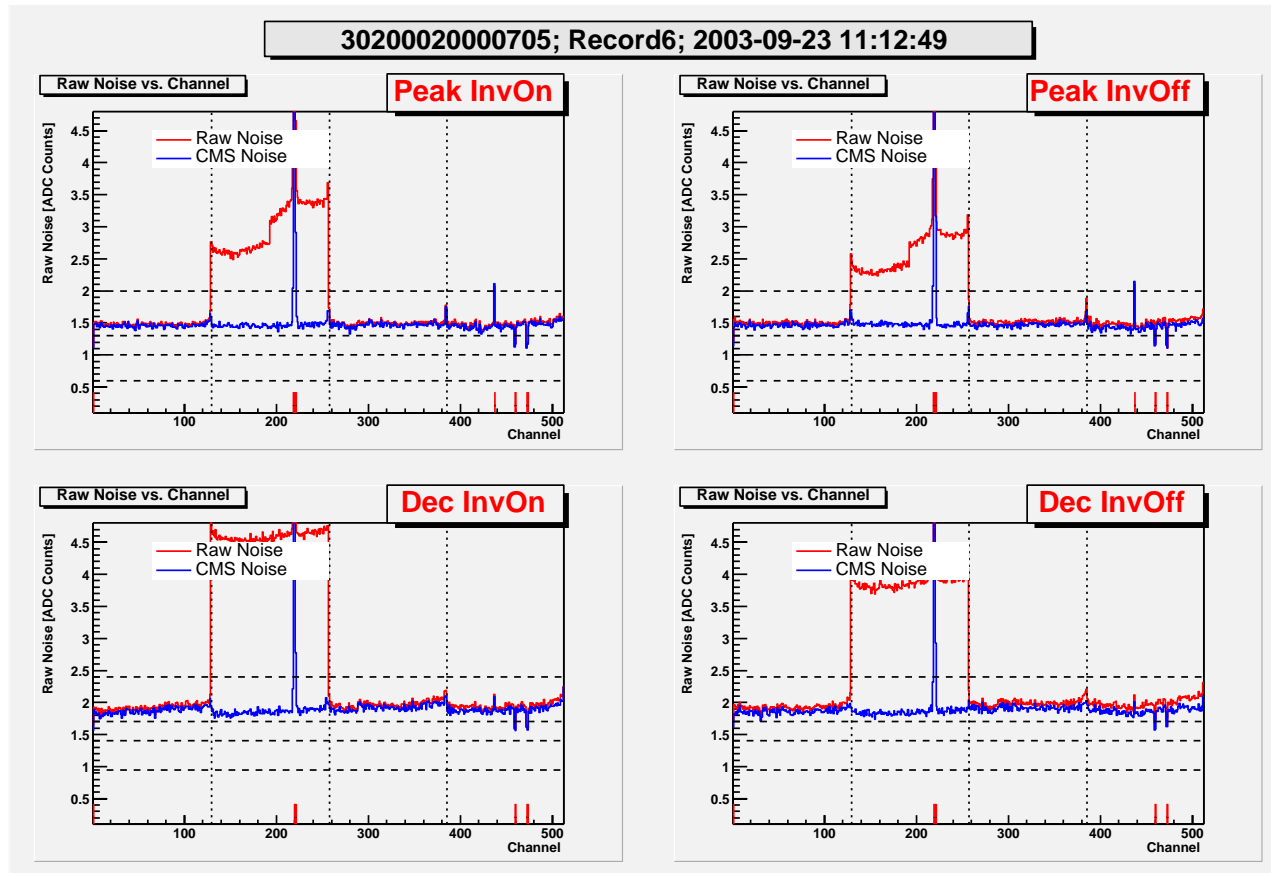
Module 705 after LT – I (FNAL)

- Module was re-tested on ARCS on 09/23. High noise in channel #219 and high CMN is observed at 400 V. At 200 V channel #219 has only slightly higher noise than the rest of the channels

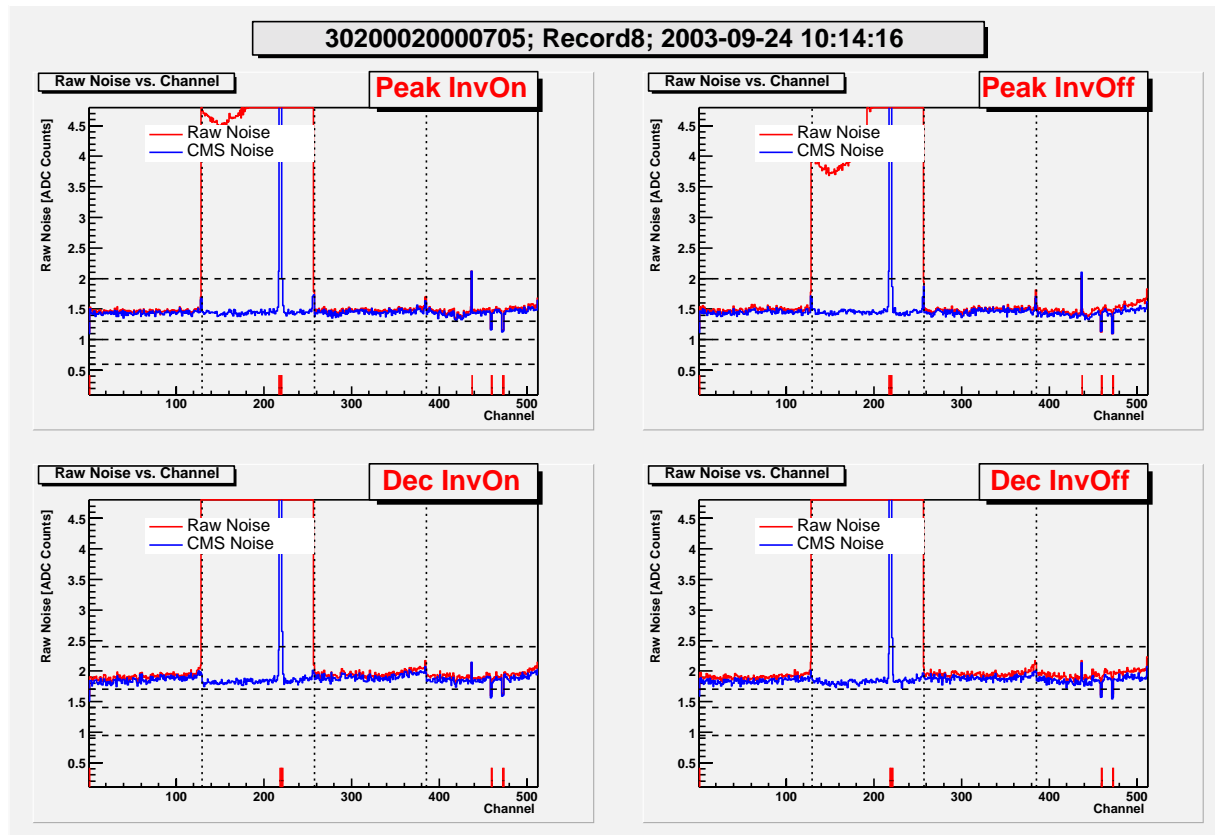
Module 705 after LT – II (FNAL)

- On ARCS kept module at 400 V for 30 minutes before testing (to allow current settle down)
- CMN did not go away, it became even higher

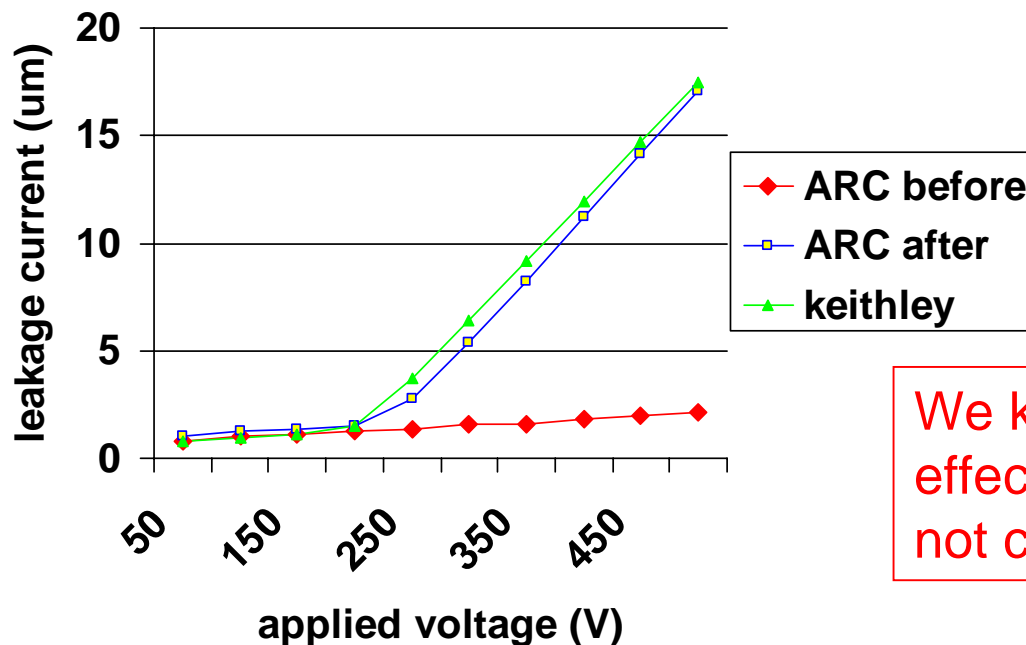
Comparison of IV curves (FNAL)

- “before” measurement is taken on 09/08 on ARCS before LT
- “after” measurement is taken on 09/23 on ARCS after LT
- green curve is a measurement done using Keithley on 09/24 with 1 minute interval between steps

No visual defects are observed on the sensors around noisy channel #219

We know it is not a humidity effect: 3 weeks in dry air did not cure it
