Tracker Week

Currents - Noise - Irrad.

F. Hartmann
Th. Weiler, A. Furgeri

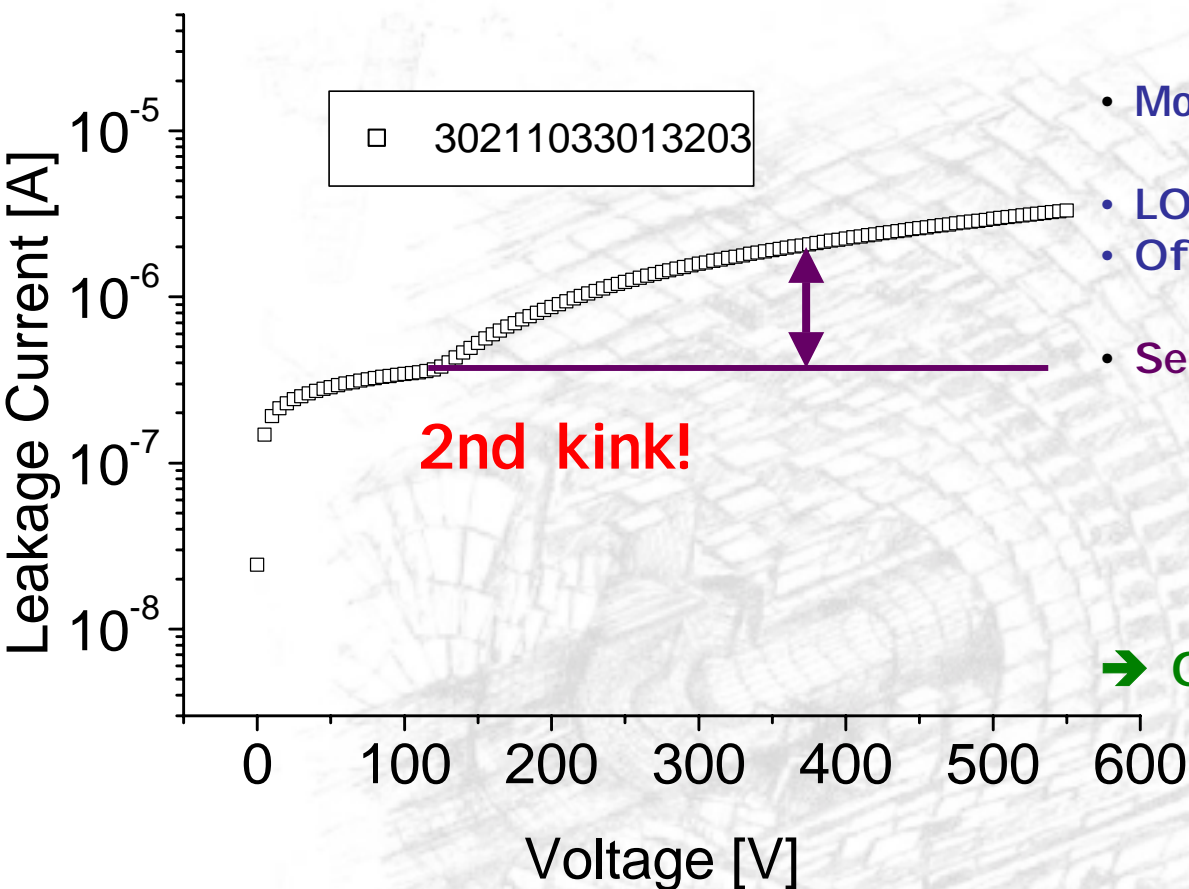
I V with 2nd kink!

- Mostly localized on a small number of strips
 - LOCAL defect (difficult to predict)
 - Often accompanied by scratches or process defects.
 - Sensitive to:
 - RH
 - Vacuum - mechanic deformation!
 - Time under bias
 - ...
 - not to Temp.
- One can "play" with it!

In my personal opinion this is dangerous and difficult to predict wrt Noise/current!

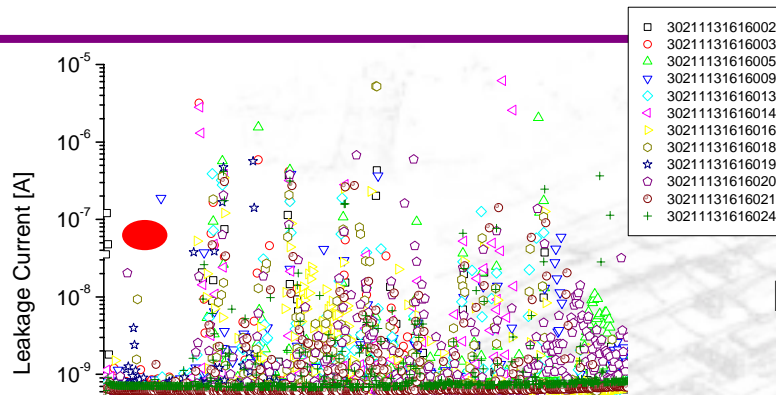
Repeatability of leaky strips (an example)

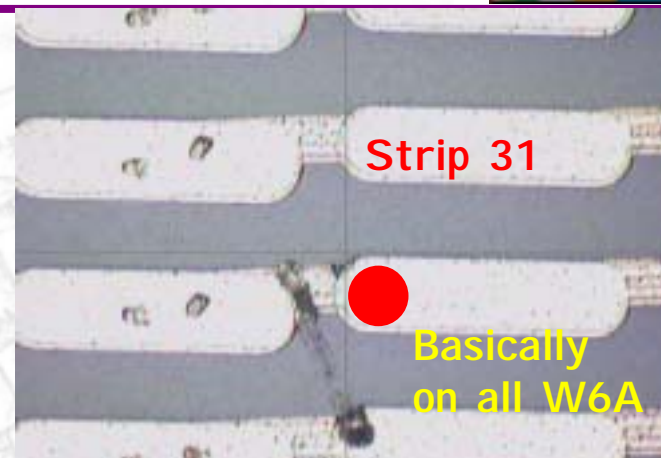
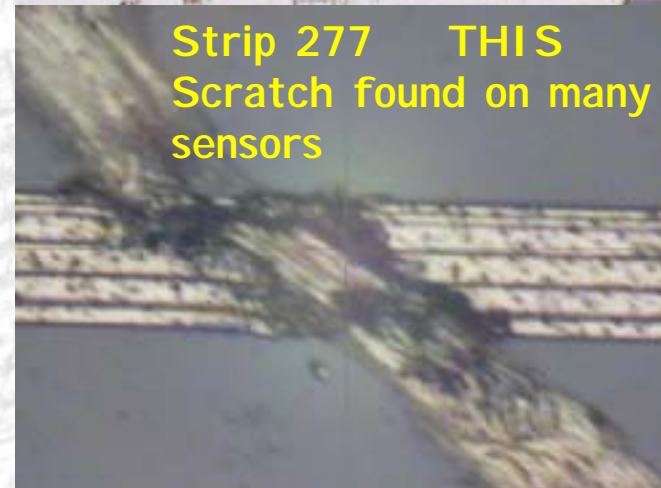
Batch 27324 (S43)

NB. ST finds quite often a short at strip 104/105 (W6A)
ST quotes some leaky strips as bad Rpoly

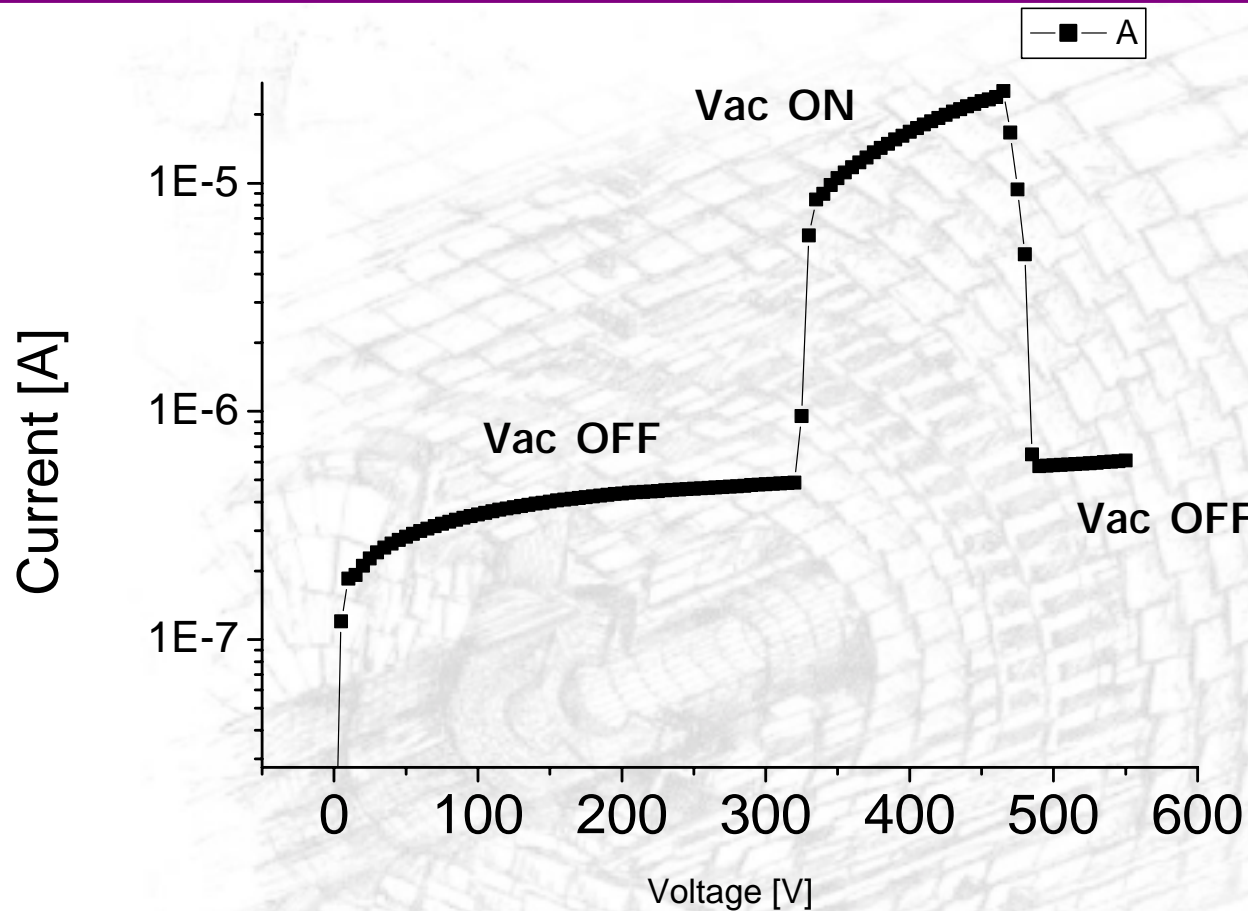
I V with different vacuum levels

Preliminary!
Not observed on all sensors.

Sensor bow $\sim 50\mu\text{m}$ \rightarrow vacuum will impose slight mechanical deformation!
What is the level of mechanical stress in the final experiment?

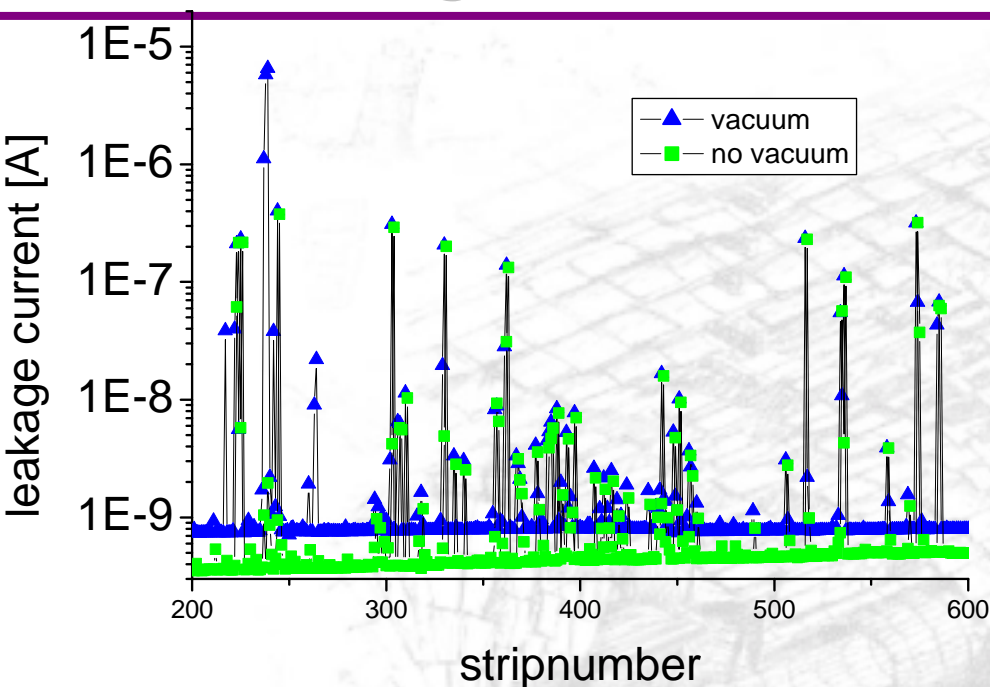
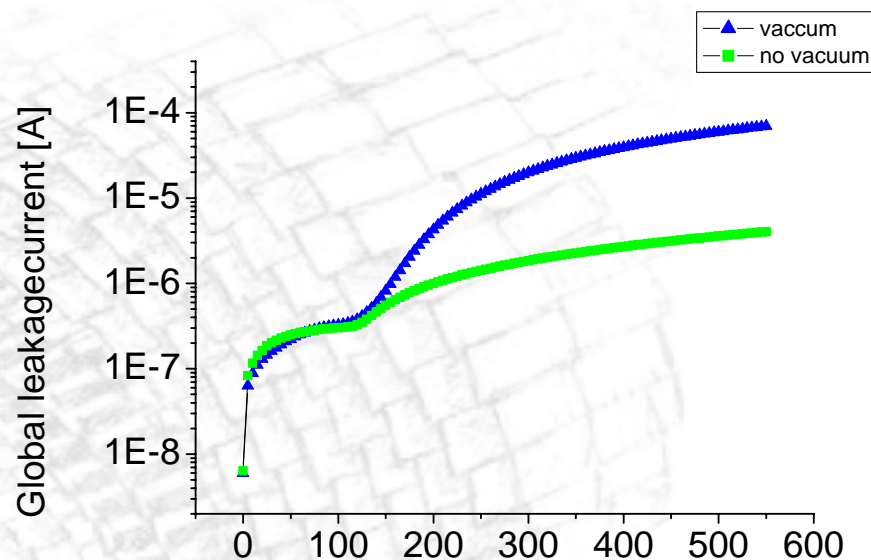
Leakage currents vs. vacuum

ST production week 30 W5B
30211033013222

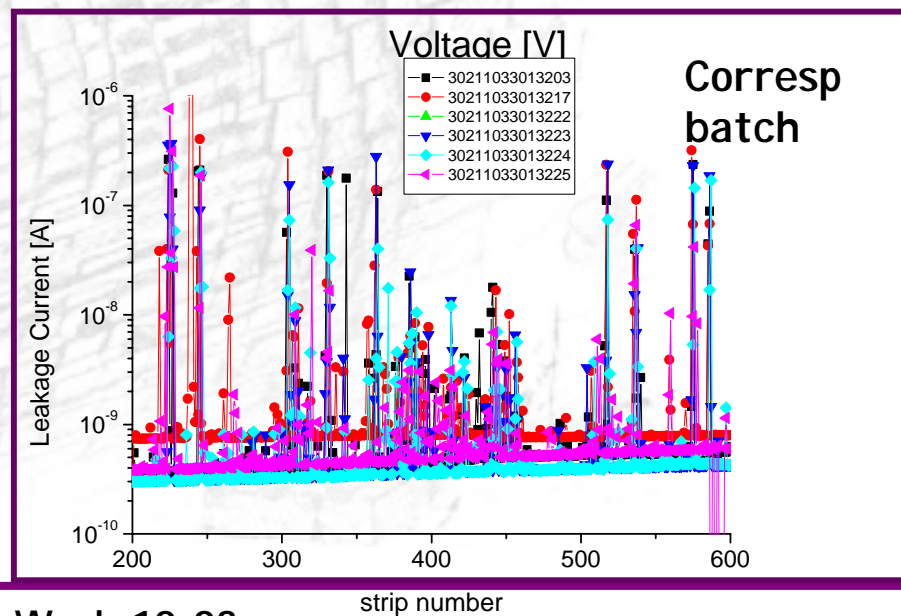
**No visual damage observed
On the critical strips!!!**

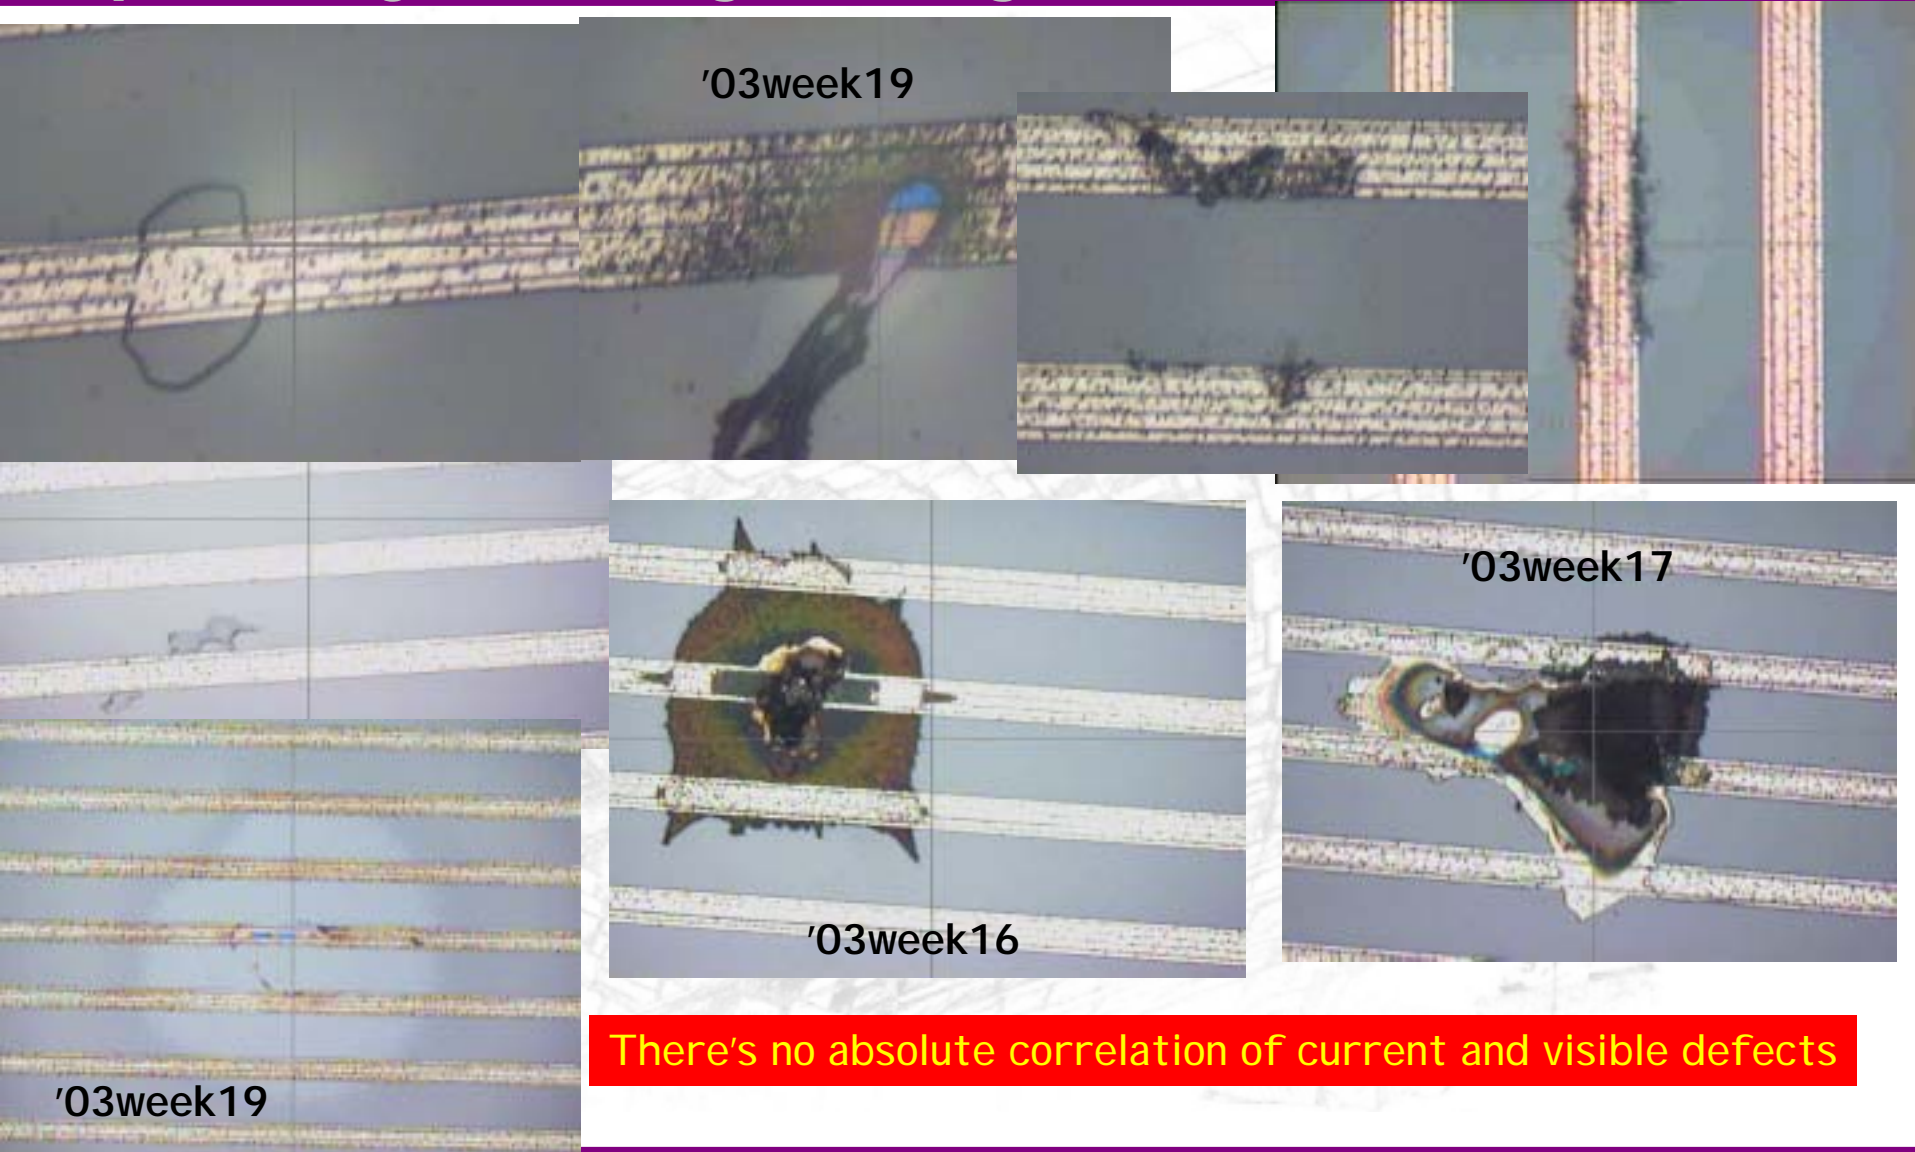
Some defects

possibly leading to high current/noise

There's no absolute correlation of current and visible defects

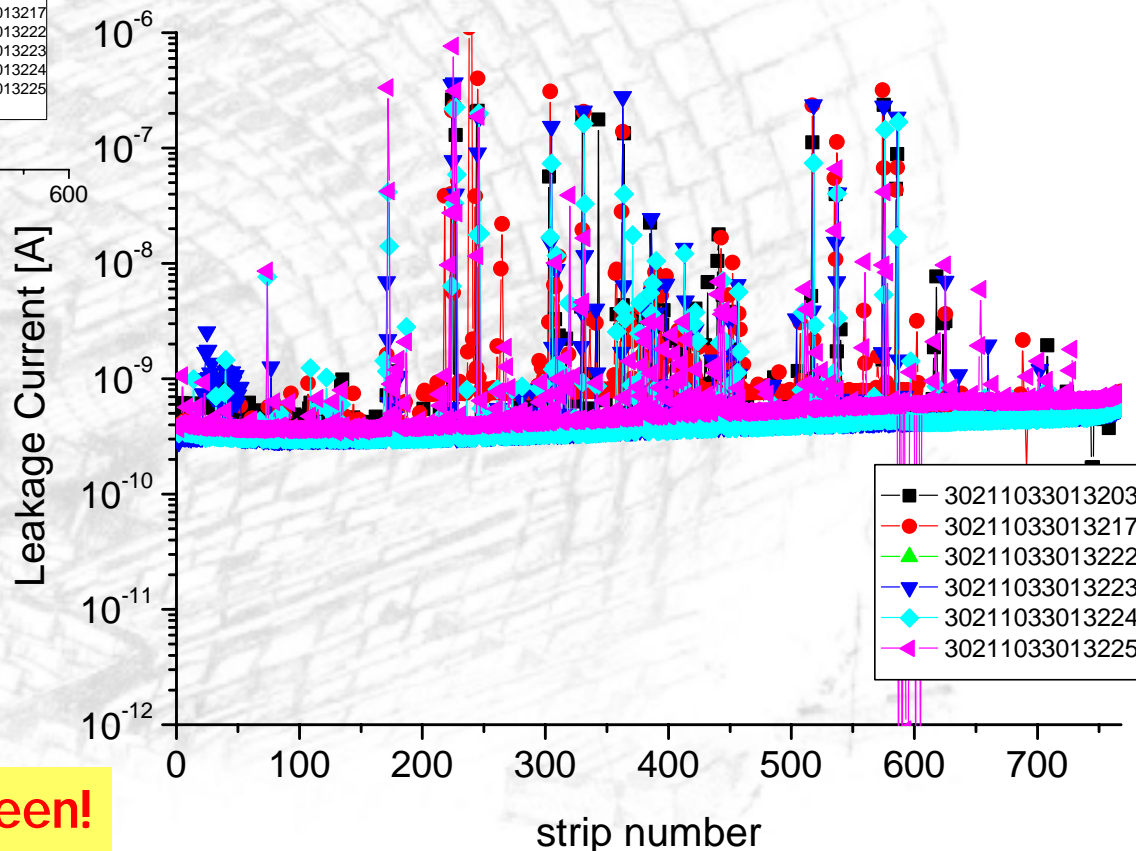
Due to #leaky strips/sensor
9,9,7,9,6,4
At the same positions!
→ Complete batch rejected!

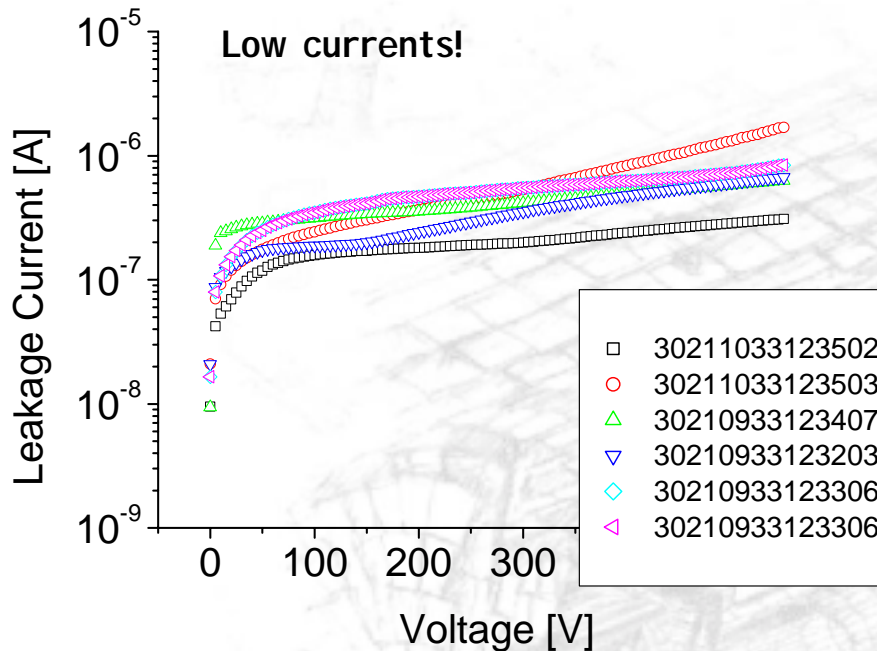
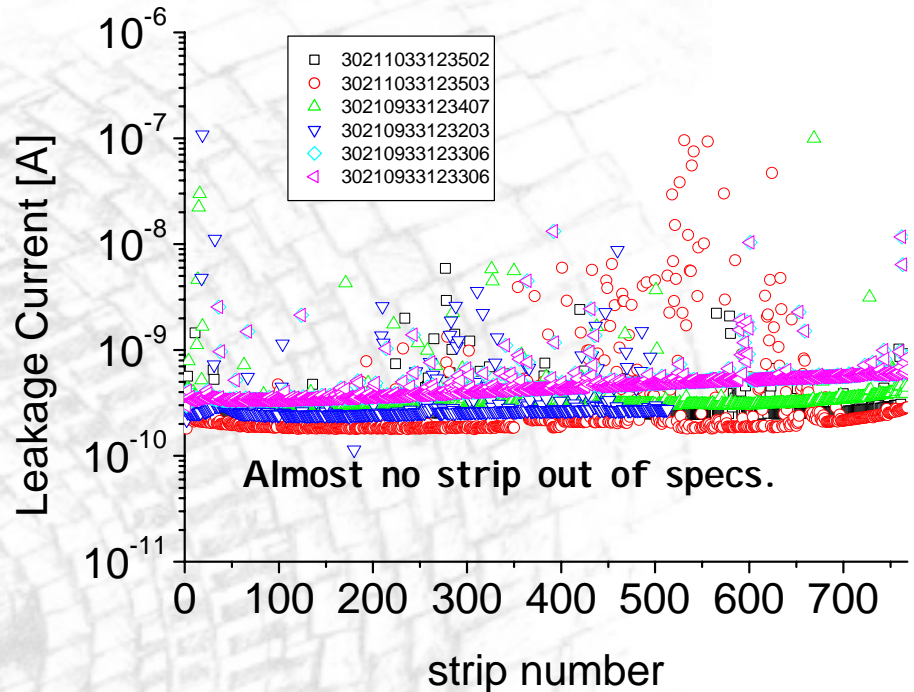
Worry: no visual defect seen!

- Latest available batches in KA!
- **Small statistics! (7)**
- Sensors from Set KA-S53,54,55,60
- No vacuum dependence observed!
- Still some leaky strips!
- **Still 2nd kink**

STM:
All processes frozen WEEK 32!
Add. passivation layer WEEK 39

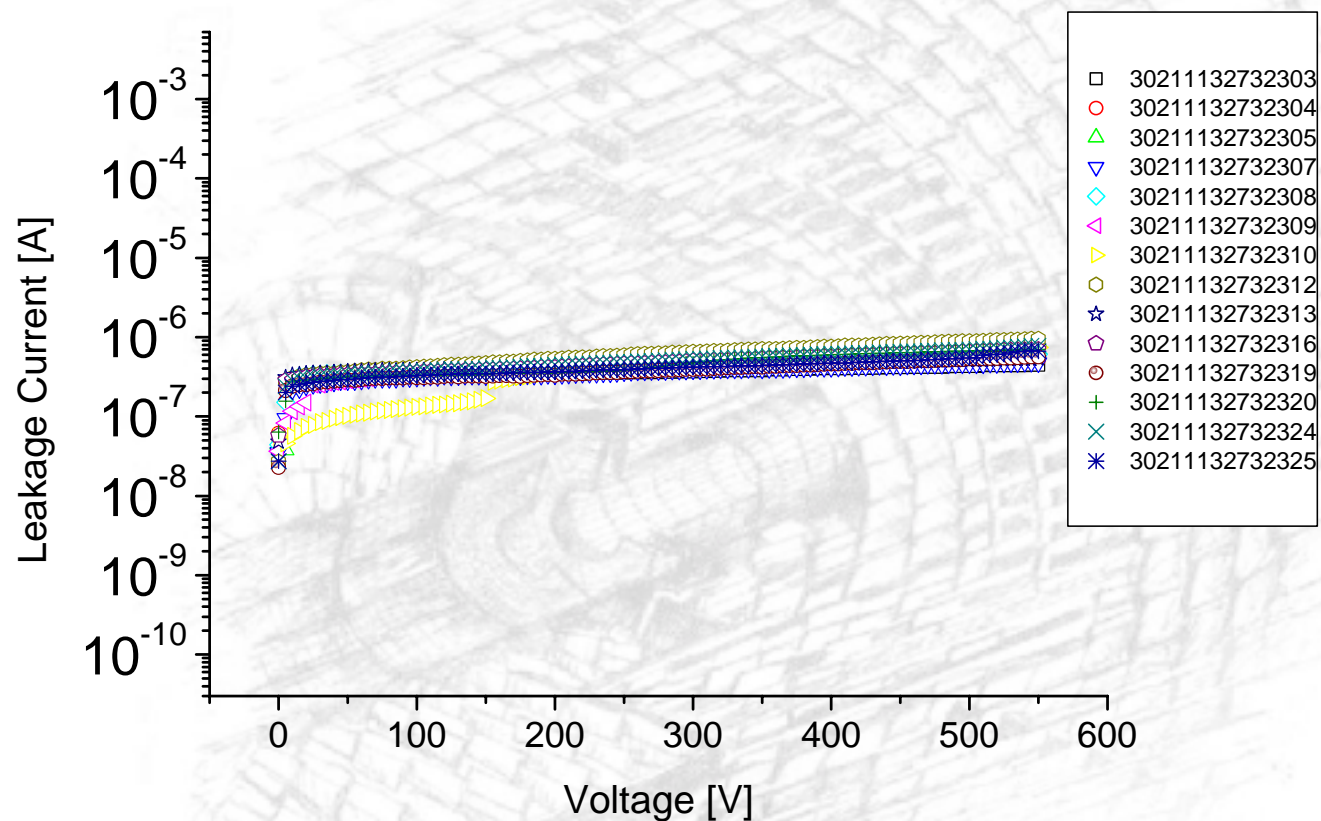
Good batches!

No kink, very low currents!

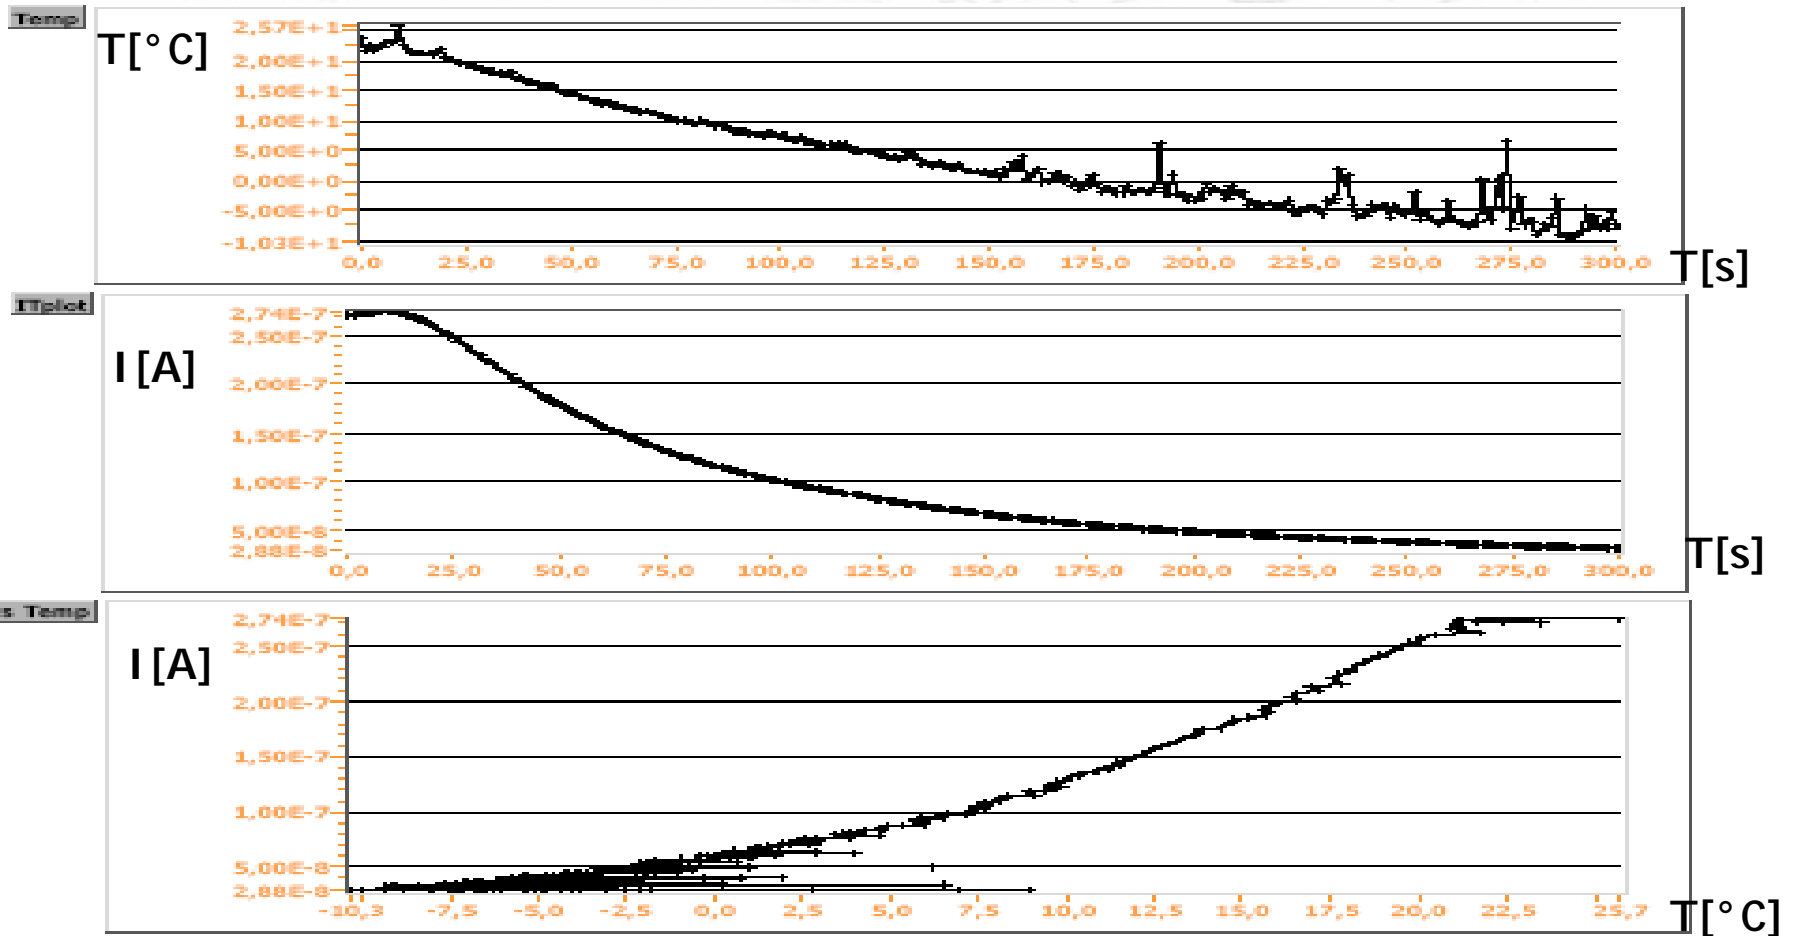
Strip current vs. T of a dubious/failed strips

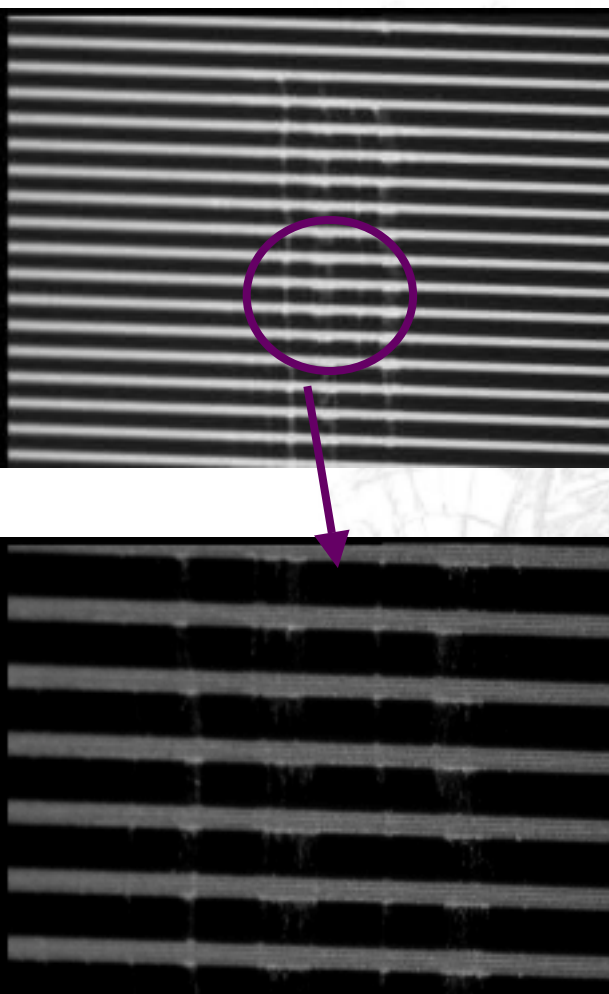
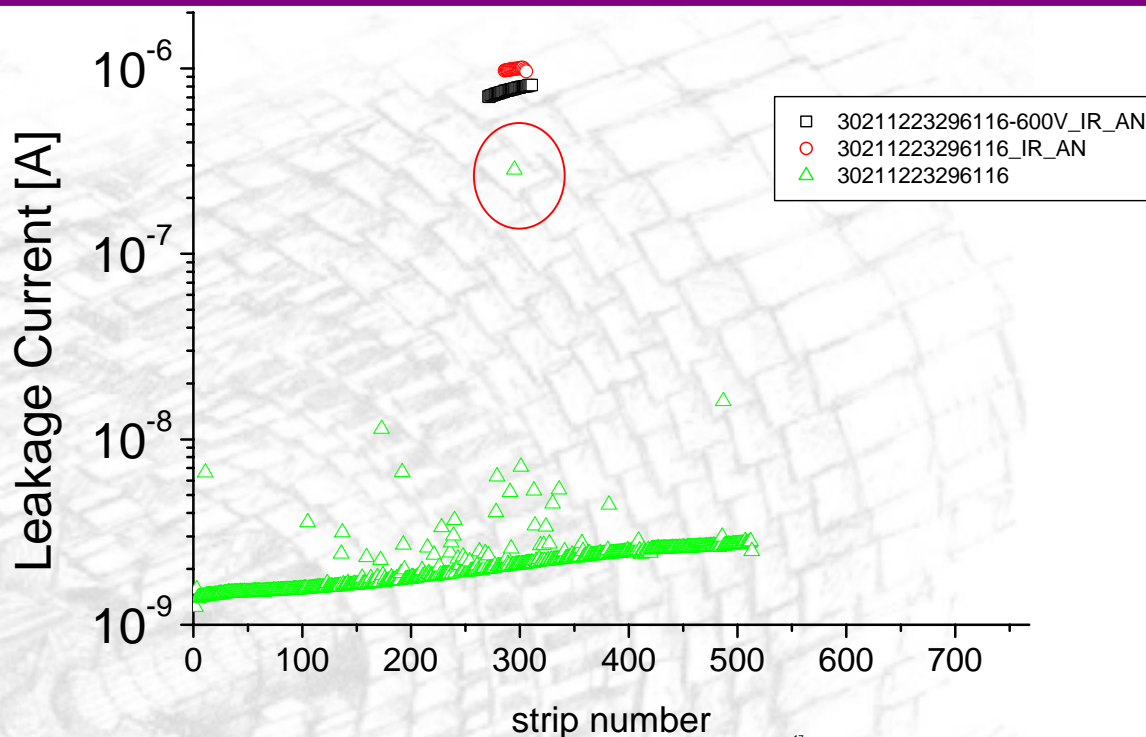
Strip after irradi. (on sensor)

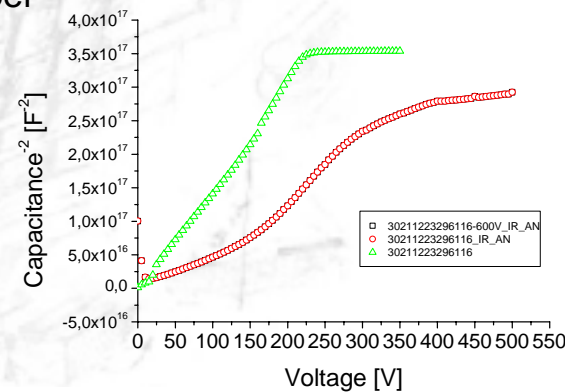
Critical strip before irradi.
Does not show after irradi.

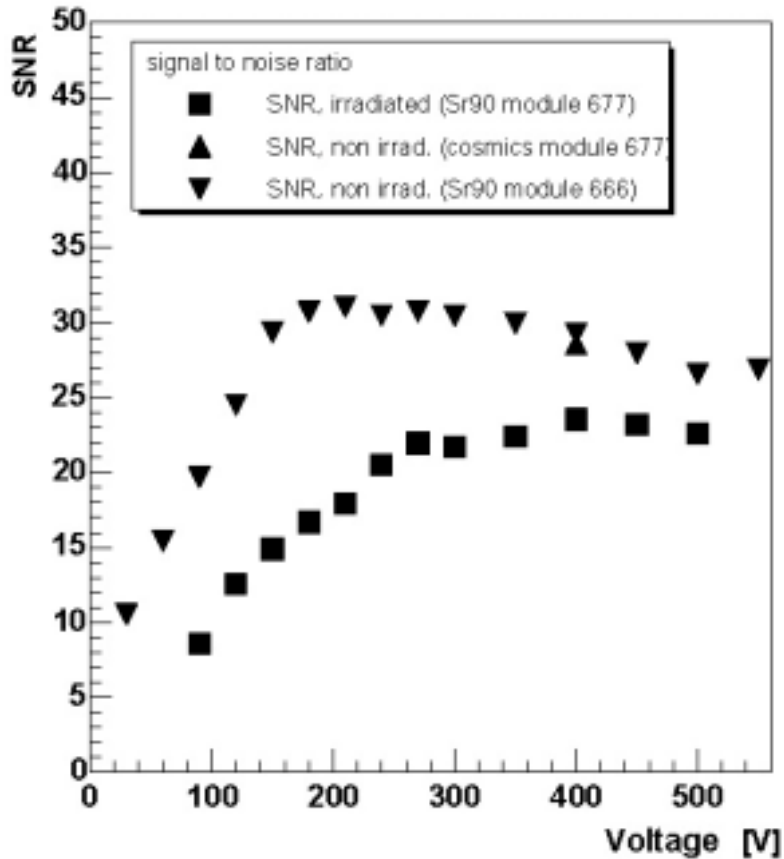
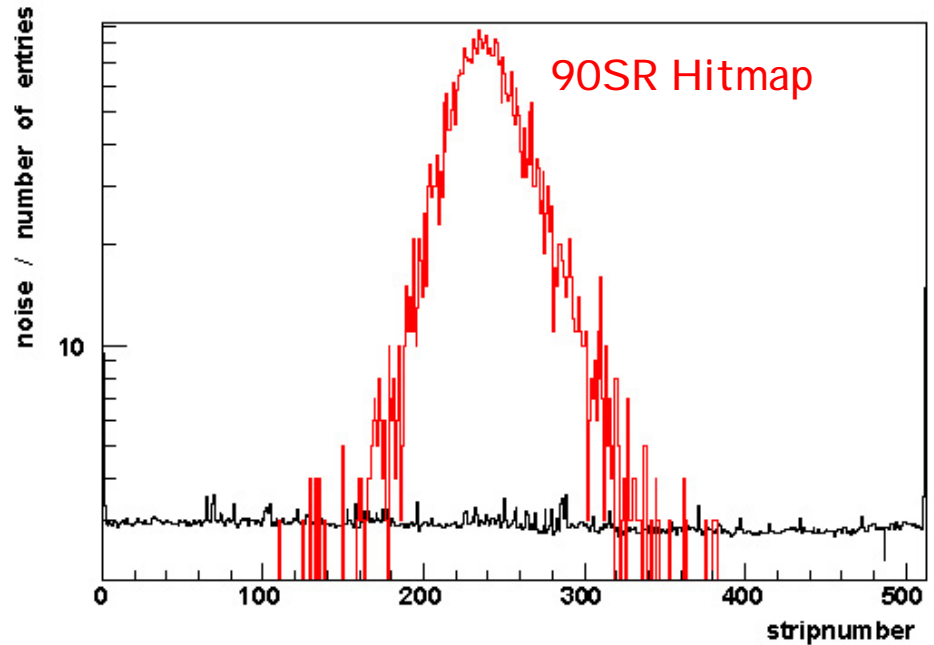
Preliminary result of a defective module irradi. (thanks to FNAL/UCSB)

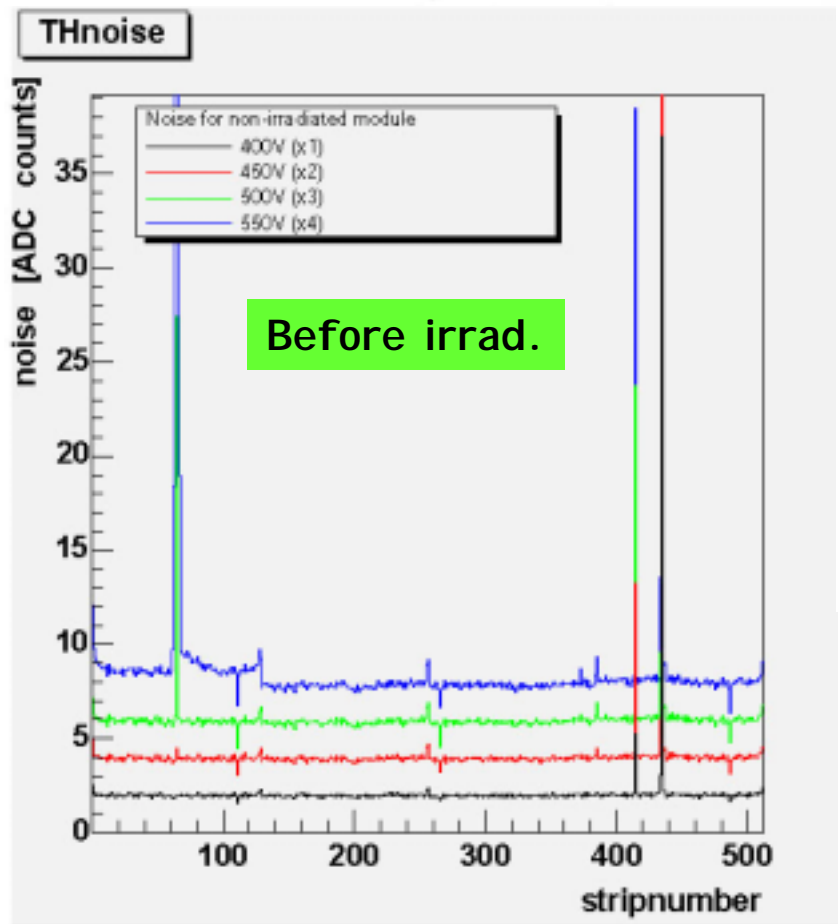
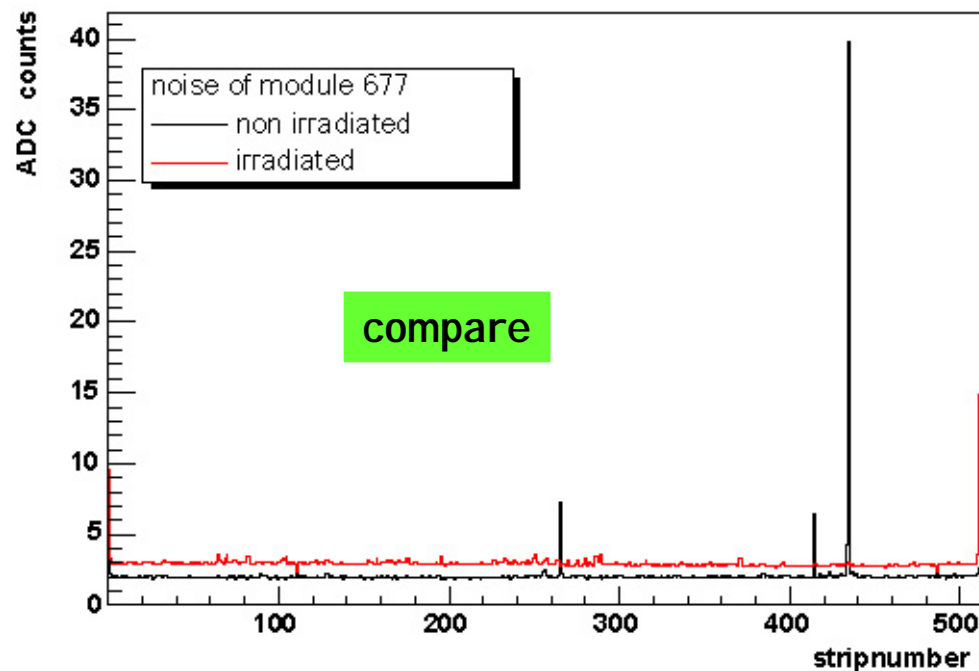
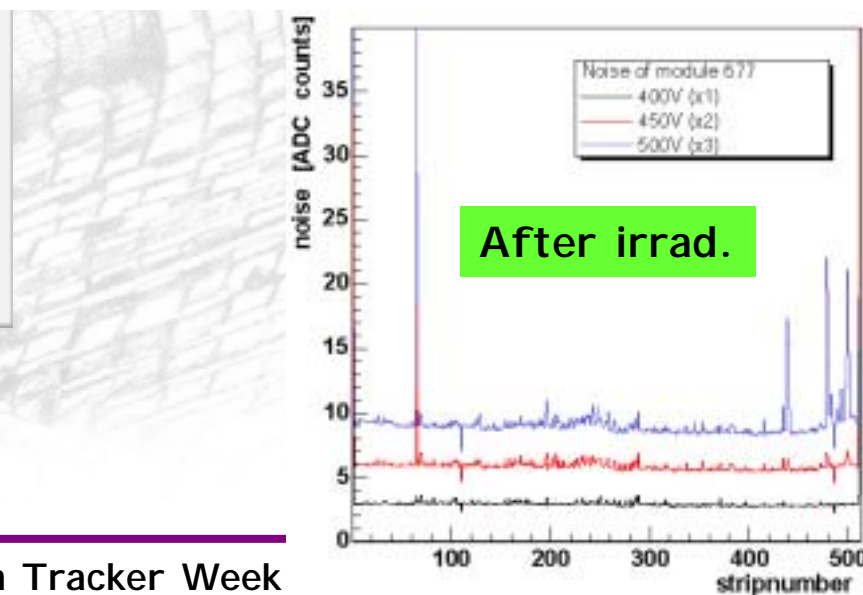
Noise before/after irradiad

preliminary (not fully annealed)

As expected the things are "better"
at least not worse after irrad.
(type inversion → lower field on junction
Effect shifted to higher voltages
→ Implications on the voltage vs. operation
→ Lorentzangle
→ More measurements to come!!
