TOB Testing Summary

E. Chabalina

(University of Illinois Chicago)

for US-CMS Tracker group

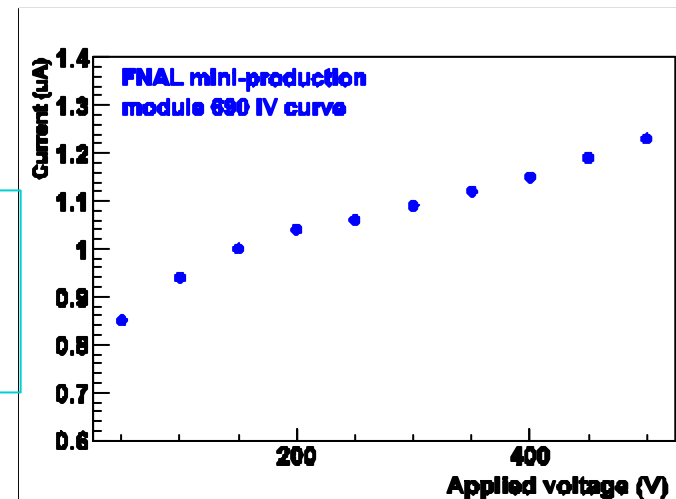
IV curve
module
690

- 9 Grade A
 - 1 has blown the fuse twice when tested with crow bar; shows normal behavior without current limiting
- 2 Grade A/F
 - CMN
- 5 Grade B
- 1 Grade B/F
 - CMN

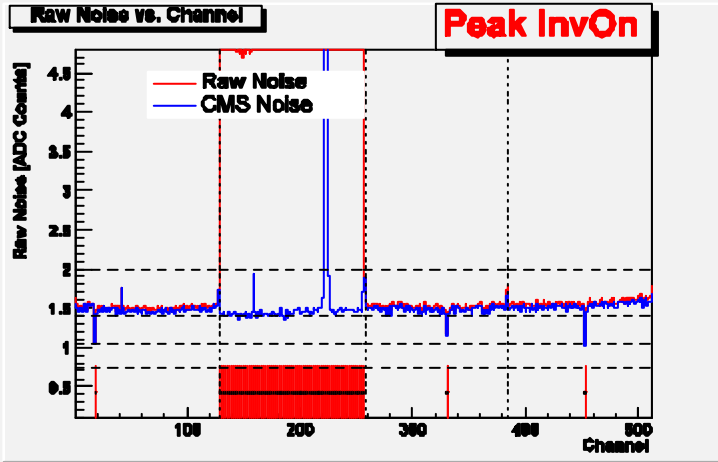
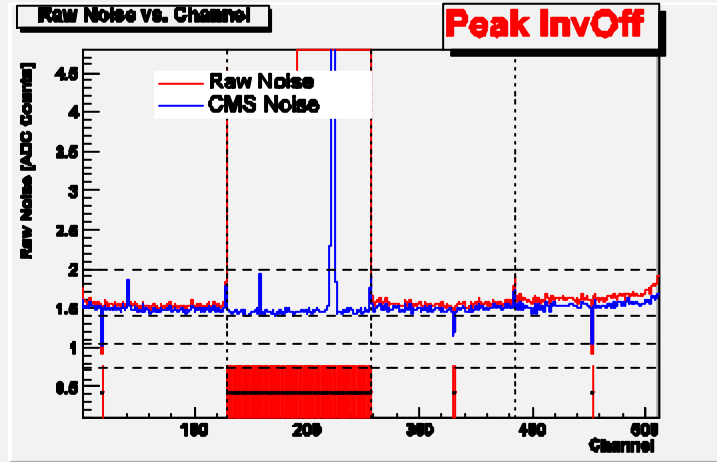
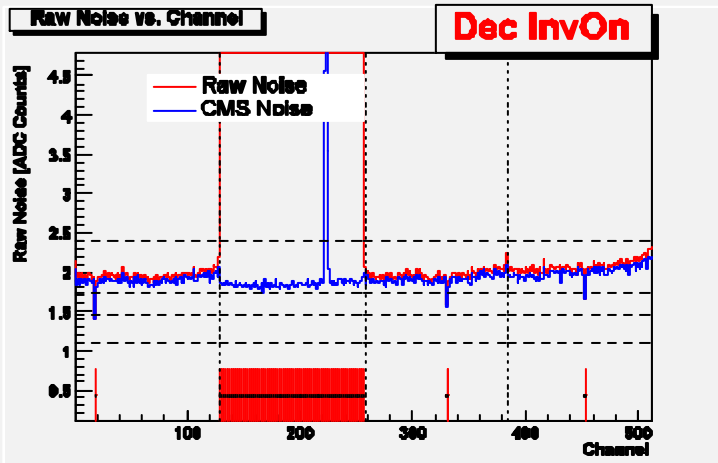
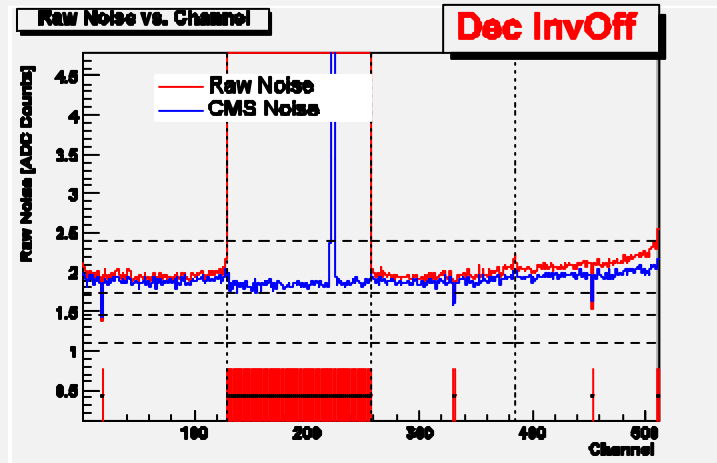
Module 689, 250 V

Grade
A/F

CMN source: sensor issues

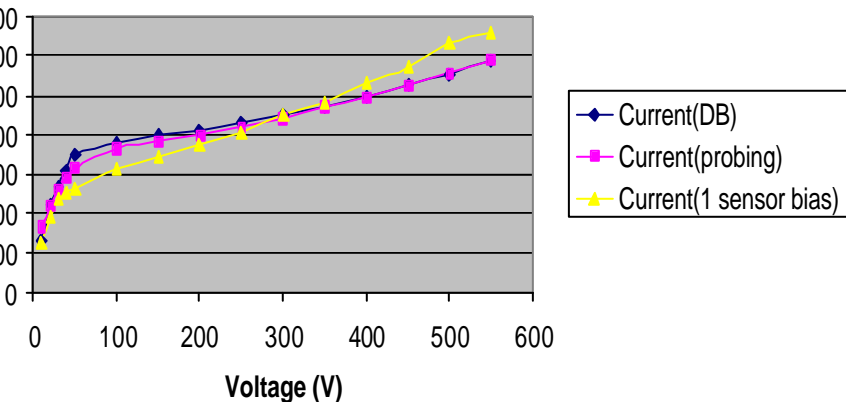
Sensor 1

Mid-sensor open “burn” seen in sensor 30210422067903, channel 285.

The channels referenced above were found to be the noisy channels in module testing

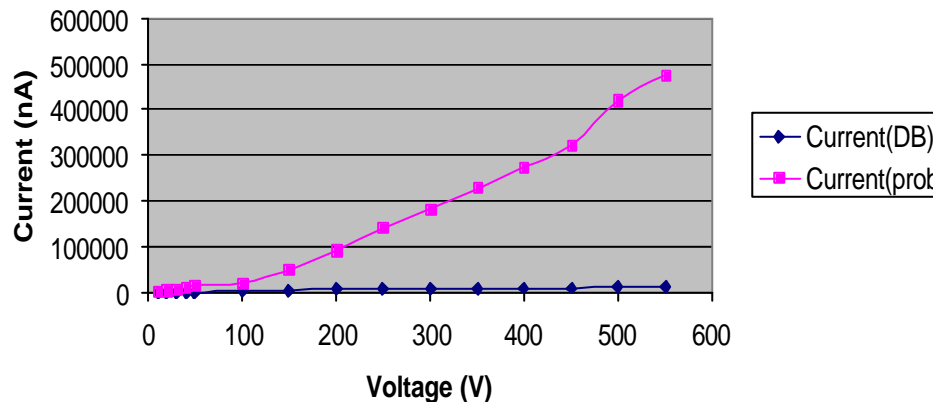
Sensor 2

Strip defect is observed in channel 38 of sensor 30210422066202.

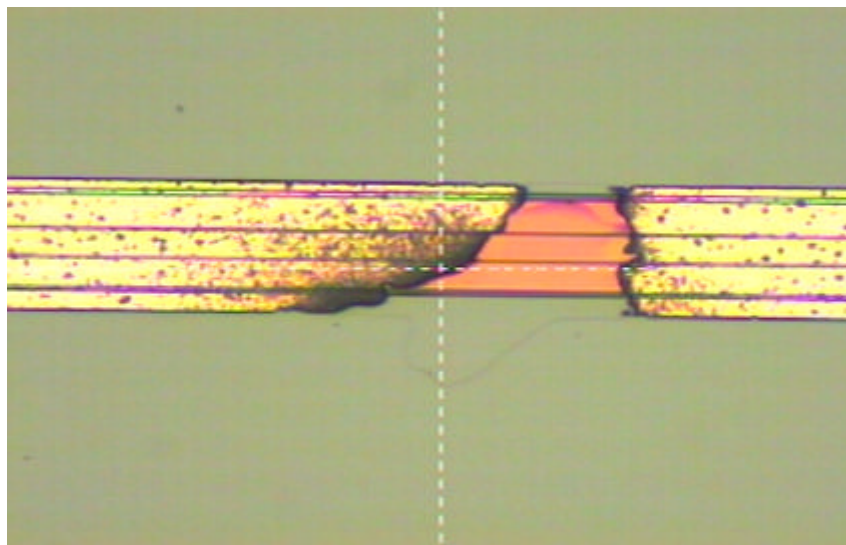
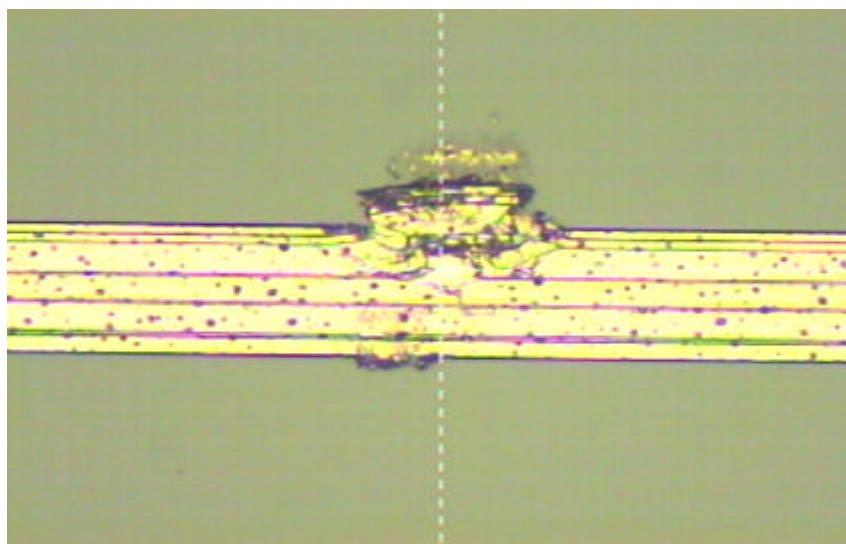
- Picture of mid-sensor open “burn” seen in sensor 30210422067903, channel 285.
- Picture of channel 38, sensor 30210422066202. CMN problem begins at 90 V

High CMN is observed in chip 1 of this module due to noisy strip 38 starting at 90 V

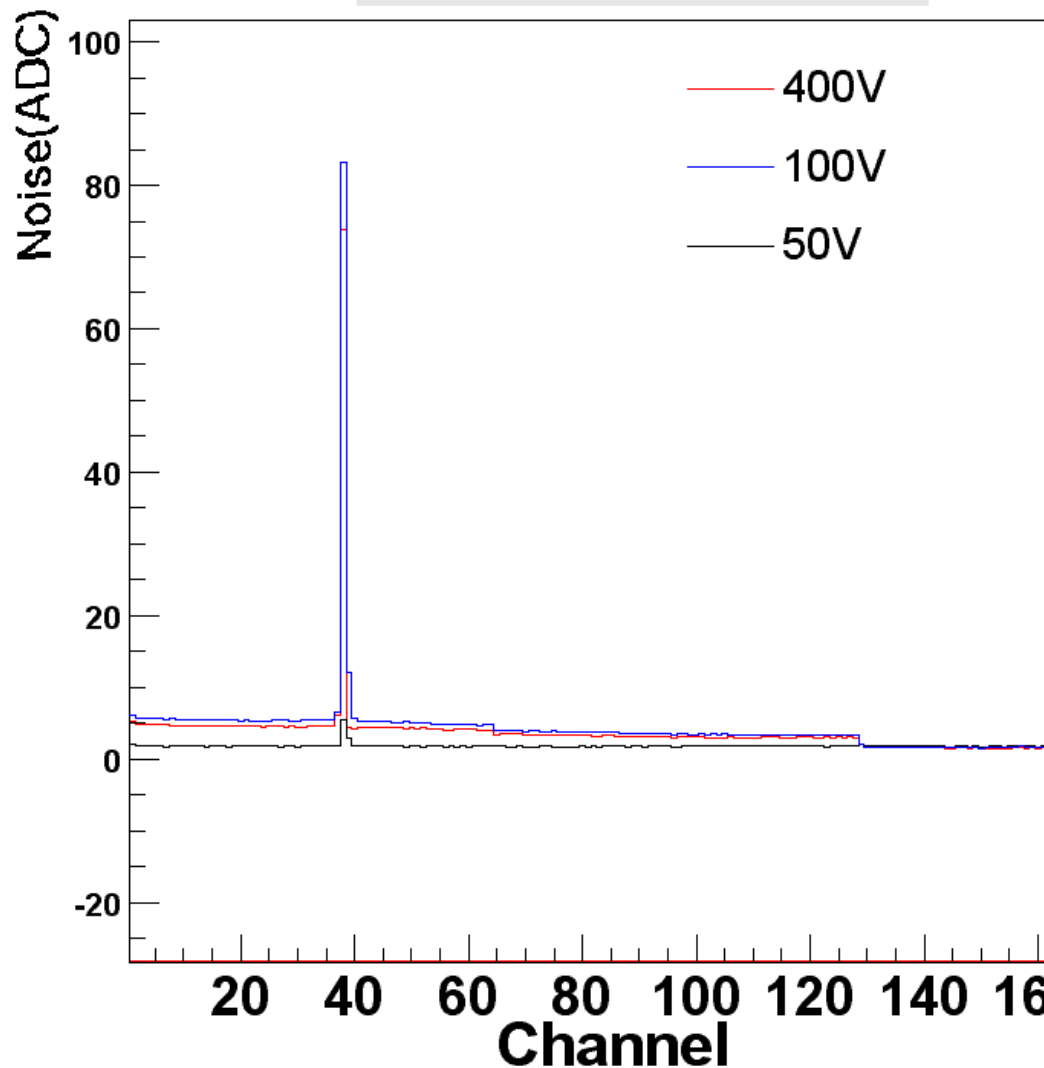
Module 1016

Noise starts increasing on channel 38 with 10 V bias

- Assume micro-discharge

Noise on channel 38 reaches a plateau at 100 V bias and is large enough to cause 5 ADC common mode noise on chip 1.

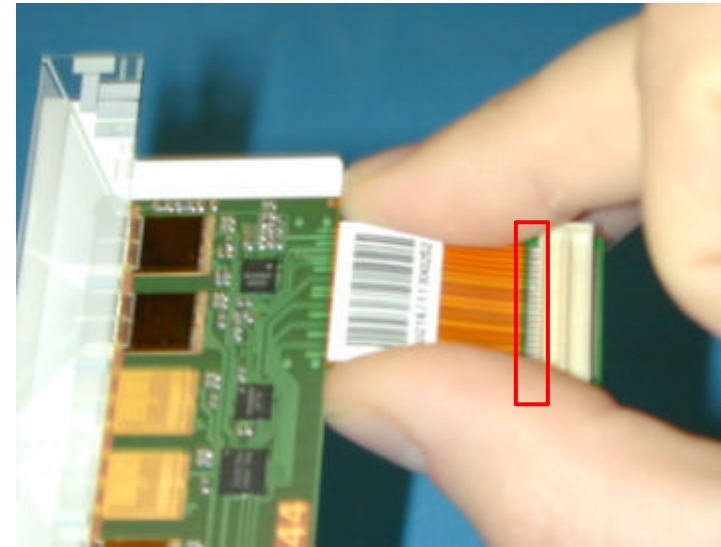
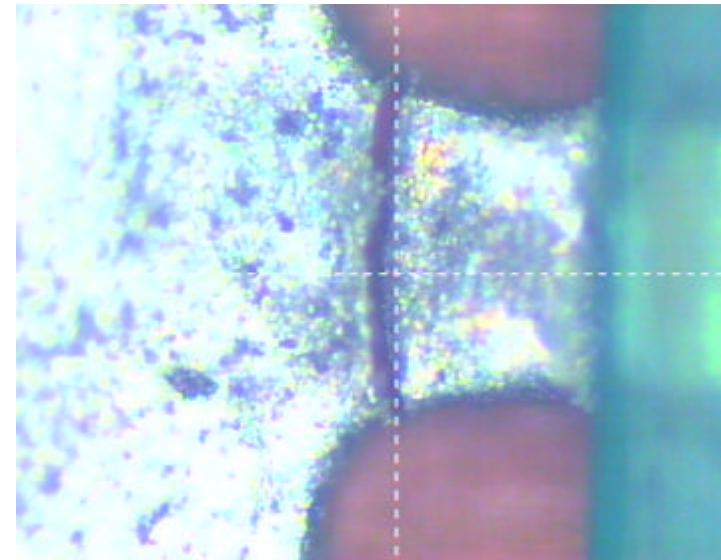
- Cable extremely brittle near solder pads of connector
- In TOB SS4 connector-up hybrids, first line to break is differential data output lines
 - Causes header (with chip/column info) to have smaller height than usual (0-70%)
 - If too small, first two chips not found
 - After data, level not near zero
 - Pedestal and noise different
- Can change results by bending cable (not suggested as causes problems to get worse)
 - Bending upwards made breaks close and results normal
 - Bending downwards made breaks open even more and results look even worse
