TIB Module Production

Introduction

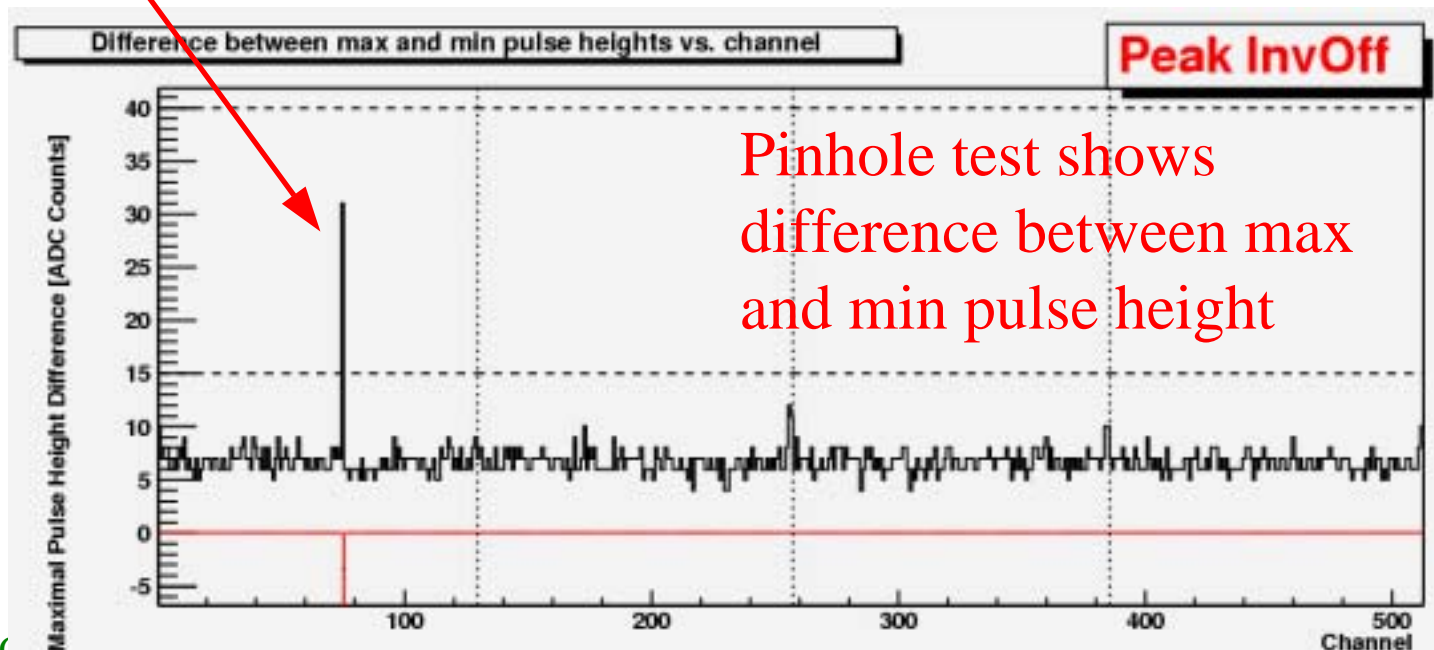
The One Strip

Only 1 module seems to have a “real” problem: 050 (bonded in Pisa) has a strip flagged as a **pinhole** by official macros

Chan#	Peak Off	Peak On	Dec Off	Dec On
75		PHL-		PHL-

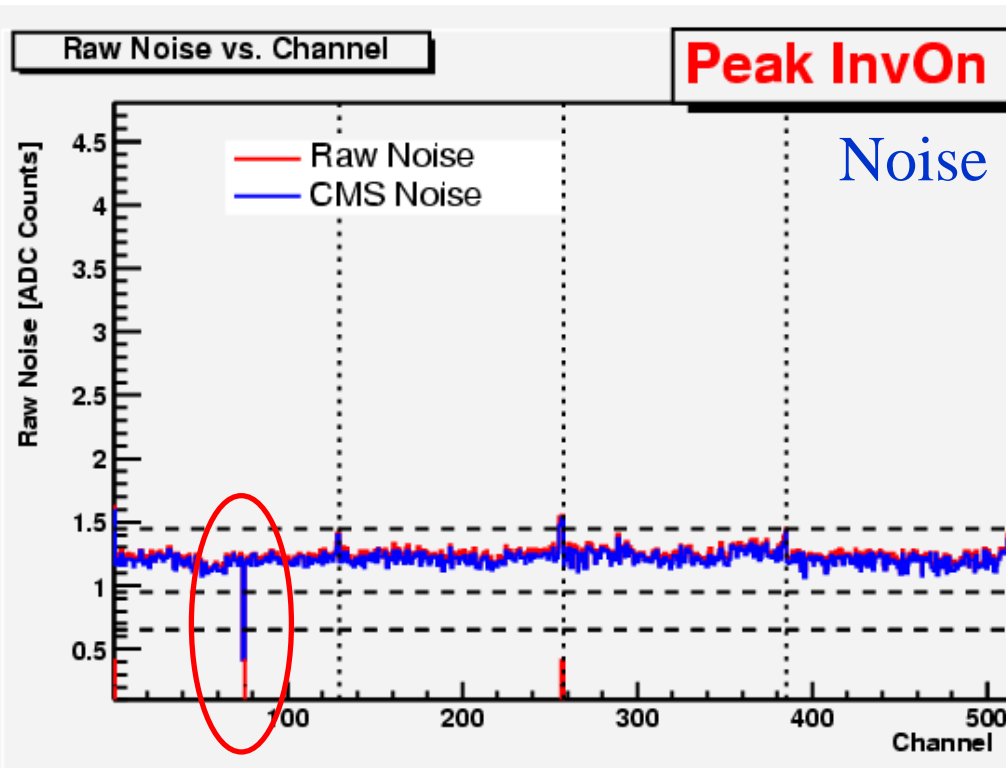
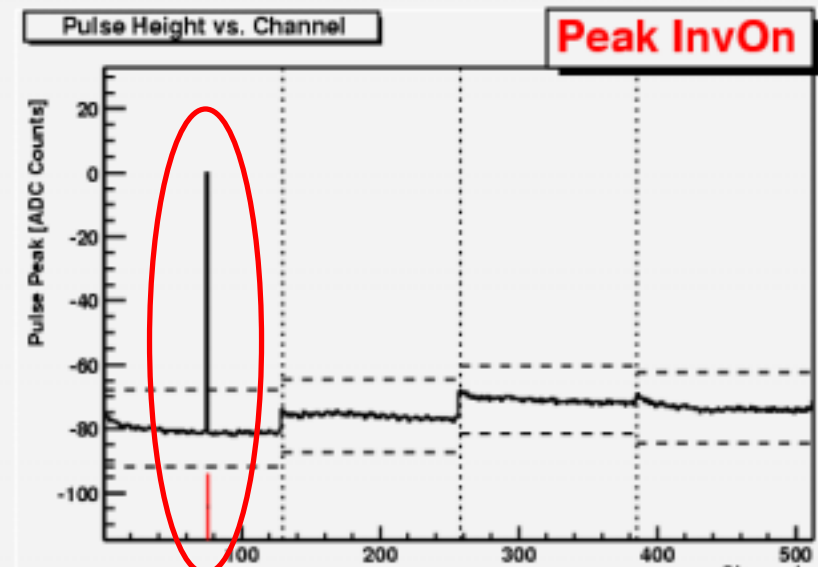
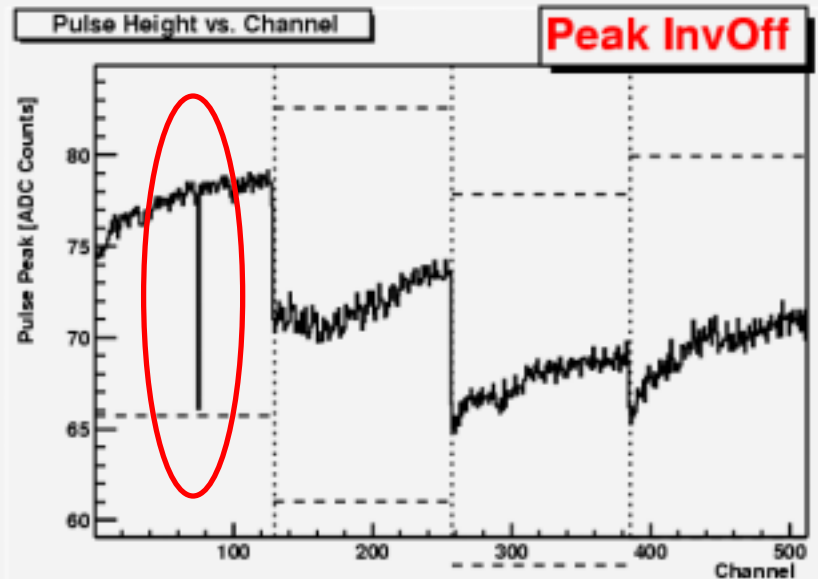
The One Strip

This is confirmed also
by **noise and pulse
shape** tests results

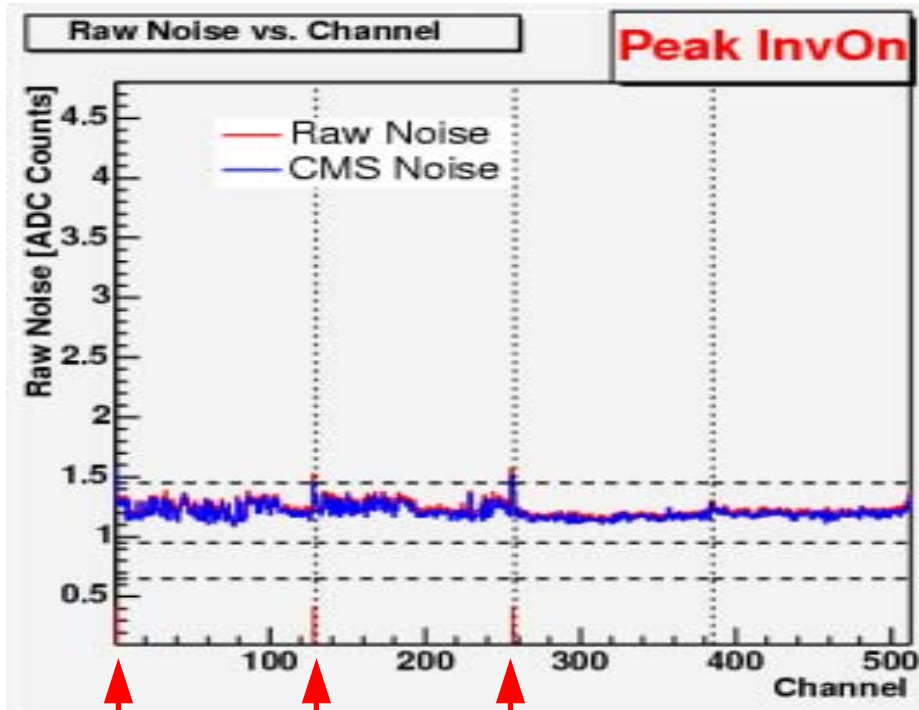
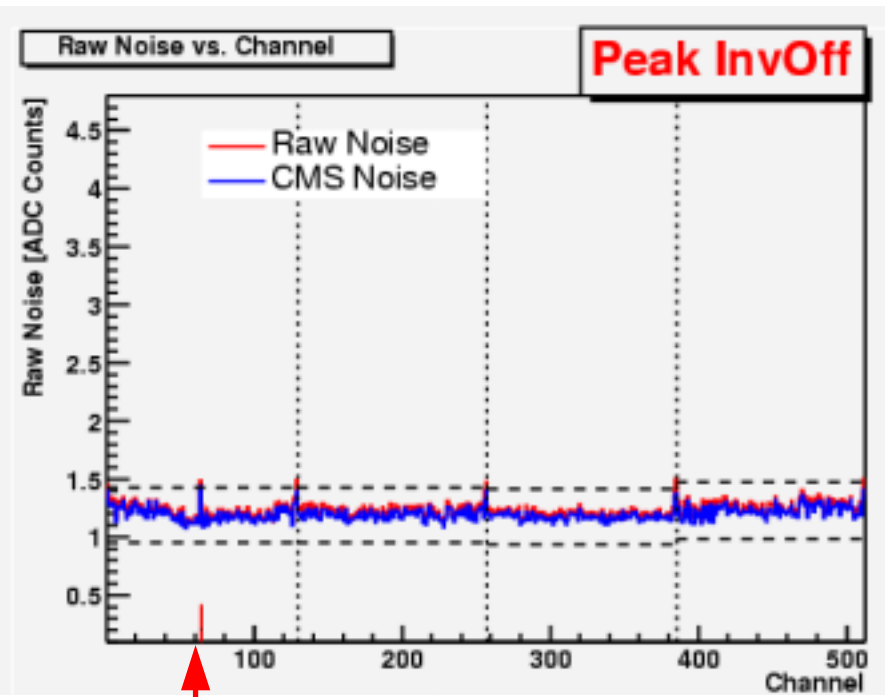
Edges and mid APV channels

- A lot of channels at the edges and in the middle of each chip (1 64 65 128) are marked as bad **only in the noise test**
- We do not like to consider these strips as really bad
- Moreover the noise is so small that they will have **MINIMAL or NO** impact in detector performance

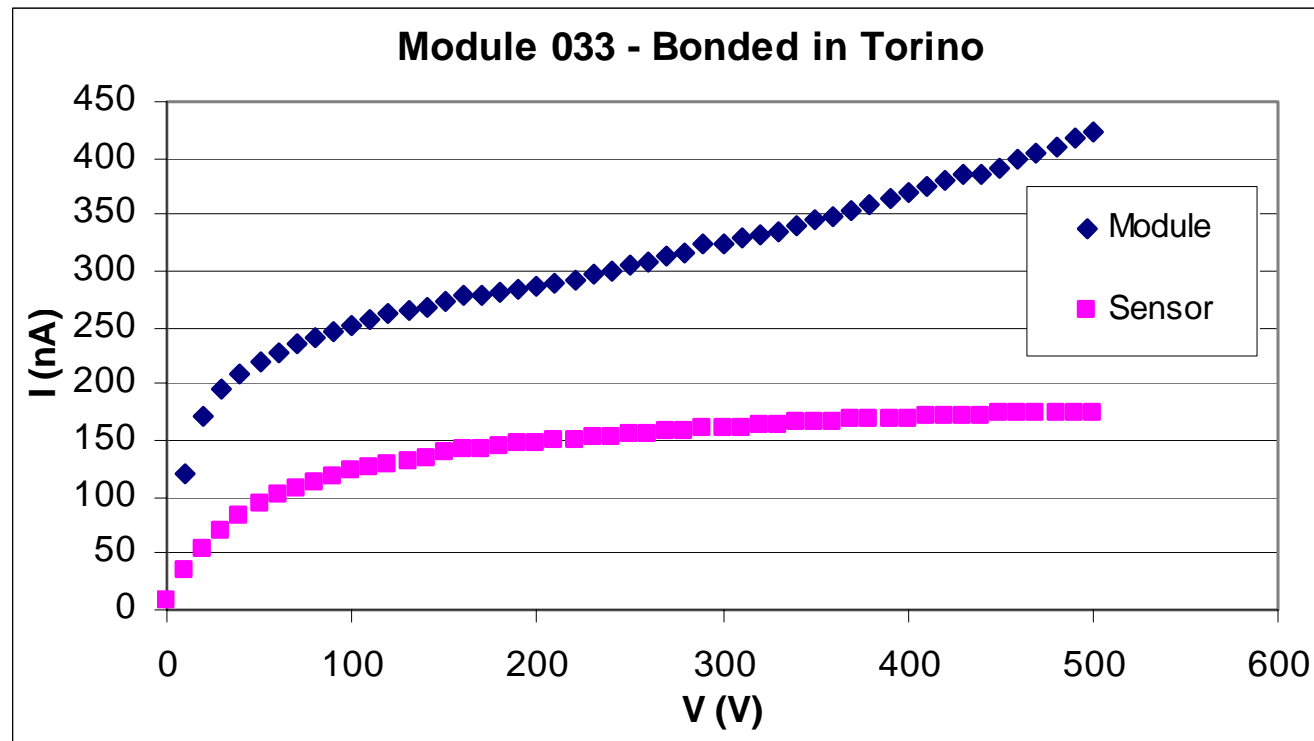
More on I -V

- One module has a current of 420 nA @ 450 V
 - From the sensor db should be 182 nA
- Continue on investigating, but do not discard

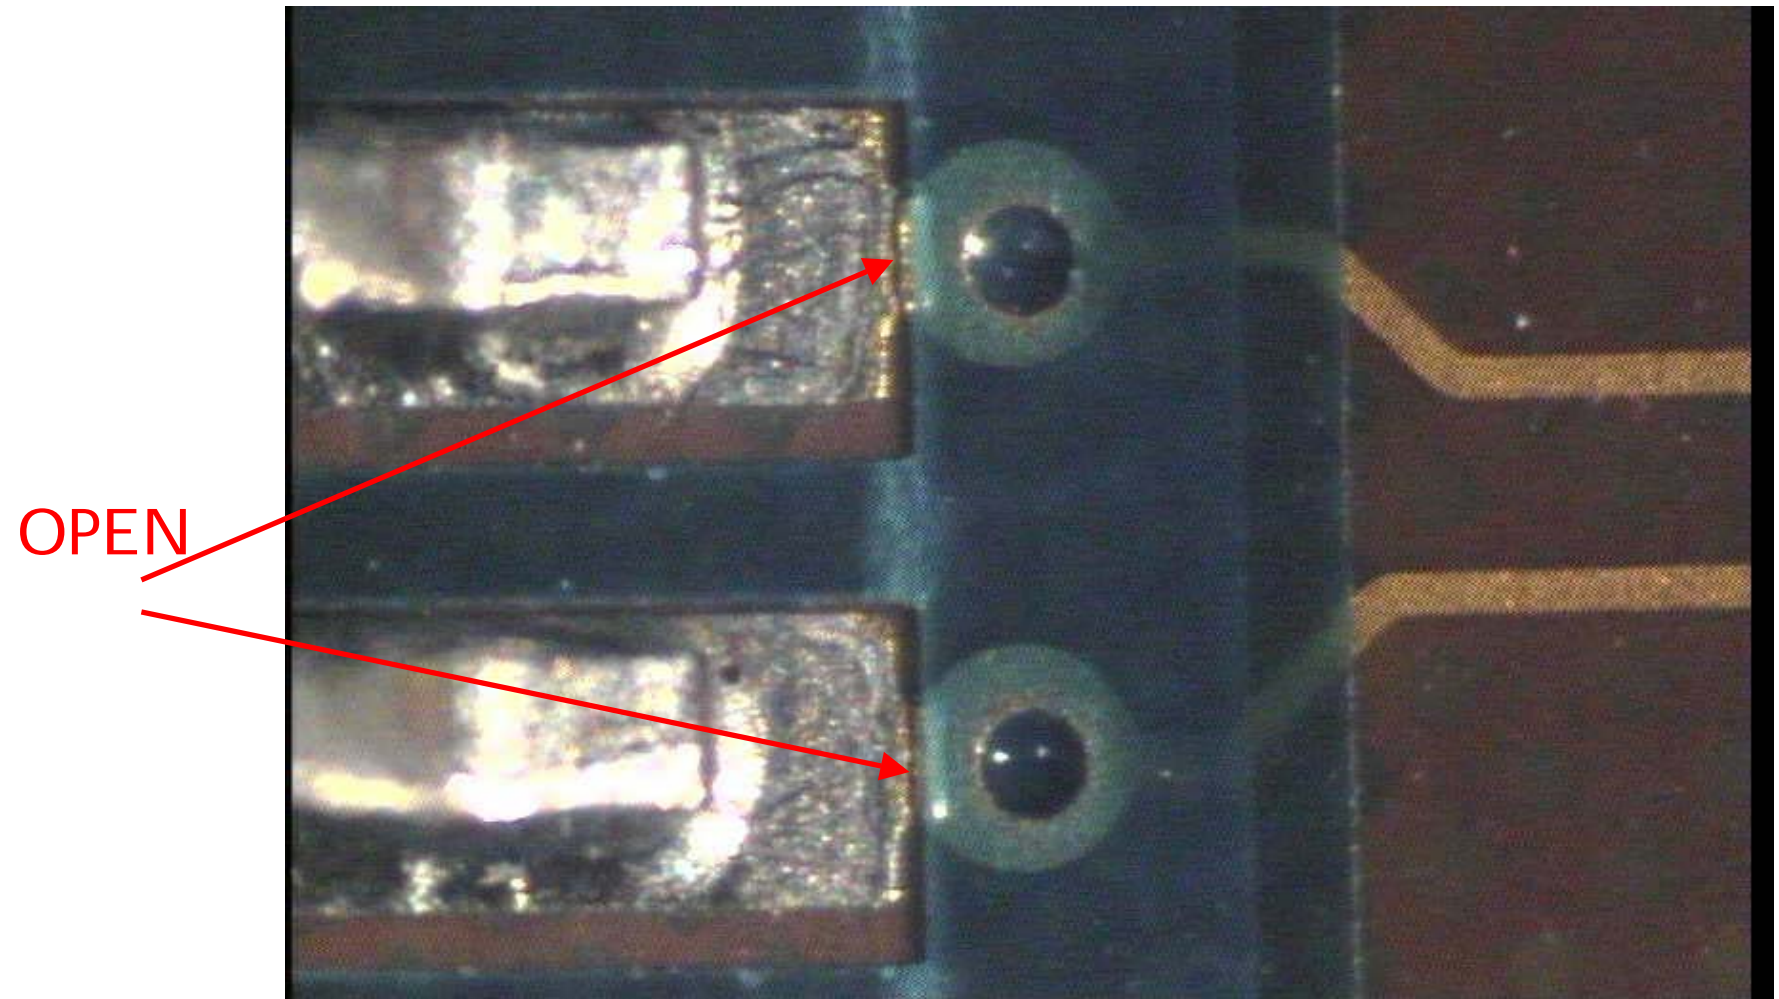
Hybrid Investigations in Bari

- In Bari 1 module lost I²C control: failure found on kapton/samtec connector traces. REPAIRED

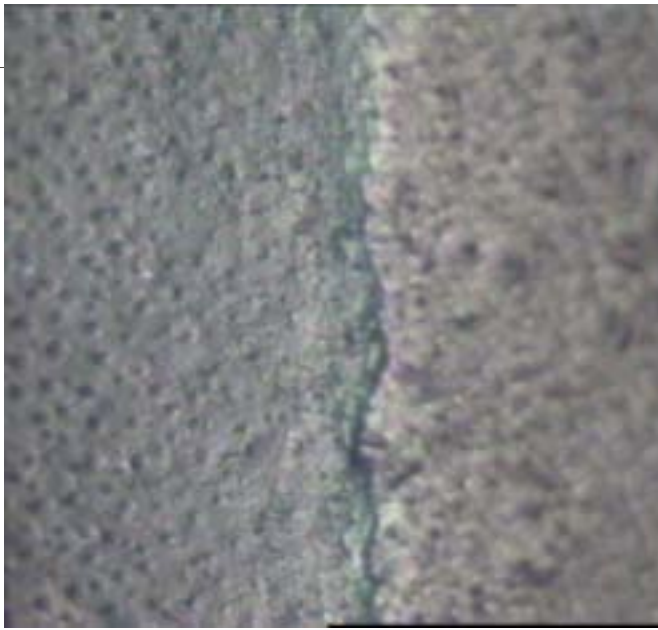
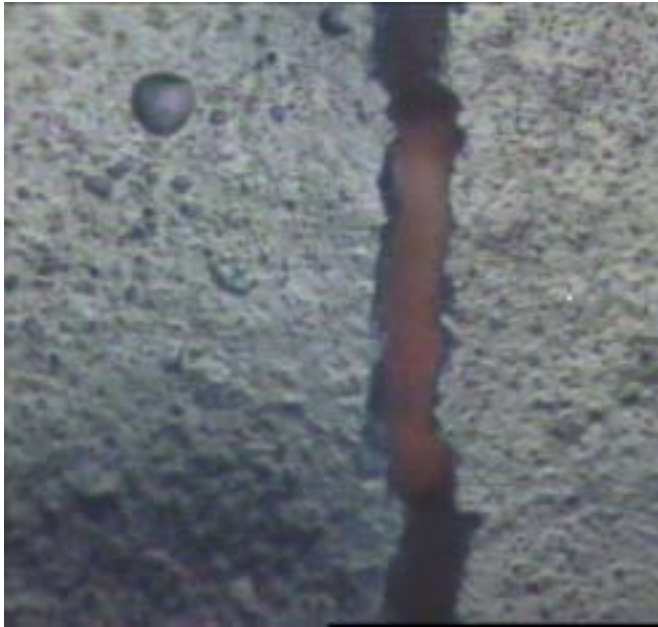
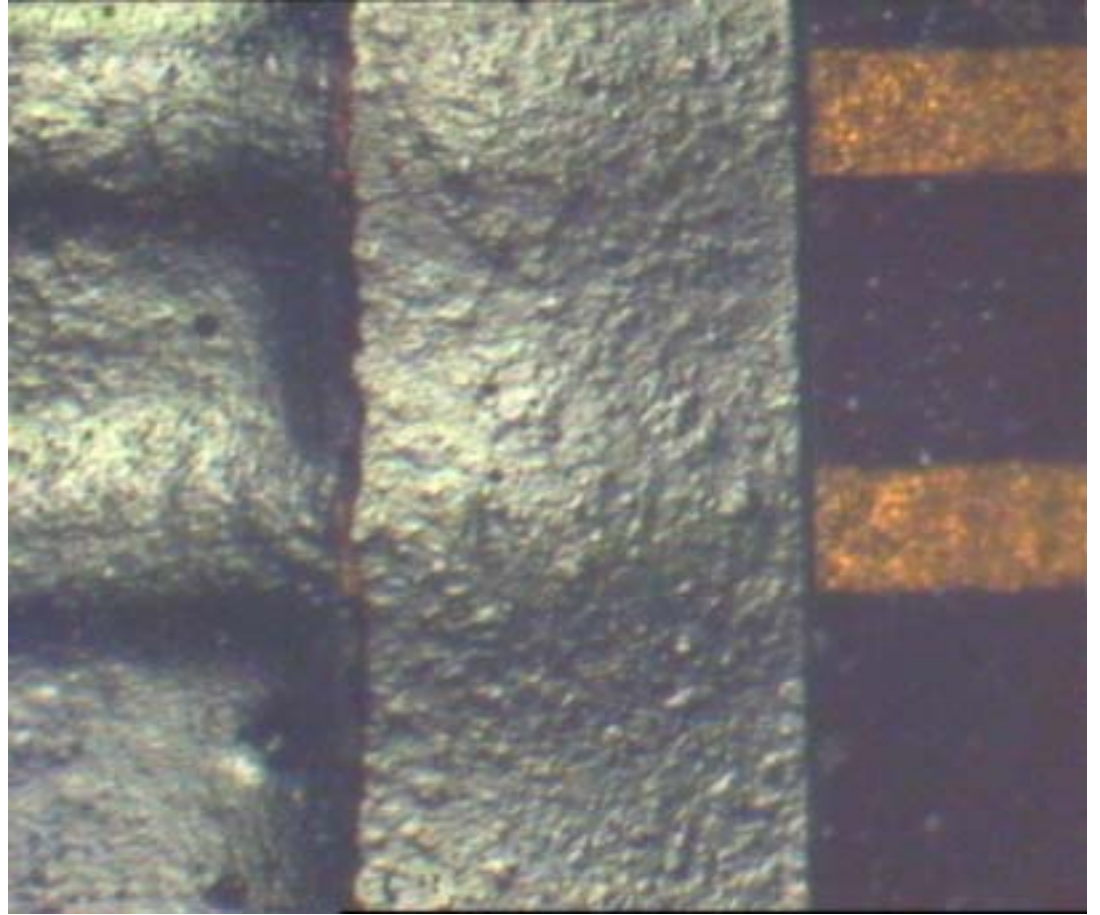
Hybrid Investigations in Firenze

- In Firenze a module which had already passed tests before and after HV bonding, failed last test after sensor bonding.
- The kapton cable had never been disconnected before failure
- No evident reason: carefully studied for electrical contact, broken traces or so.
- A high magnification microscope showed tiny cracks (5 to 20 micron wide) on 6 kapton cables out of 8. They could not be directly correlated with failures, but they appear as weak points.

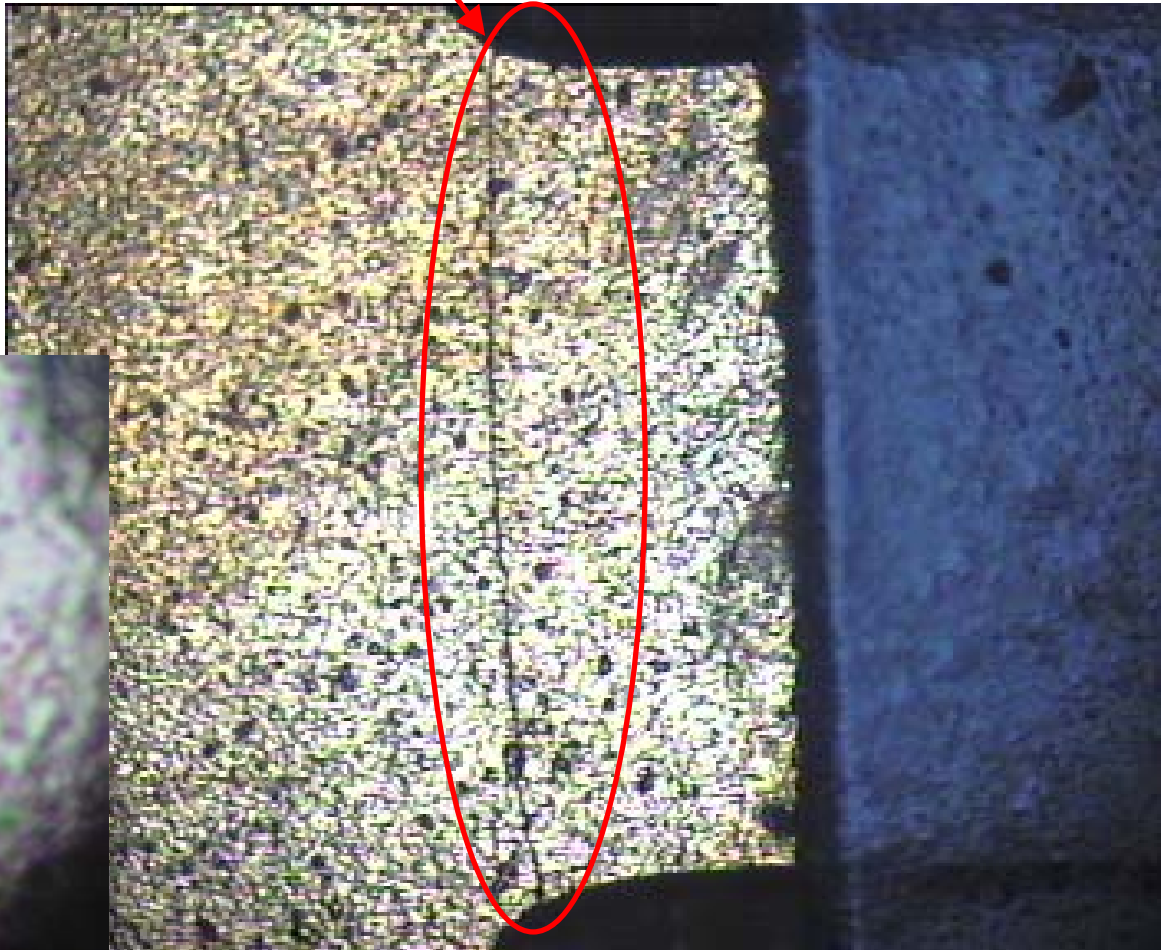
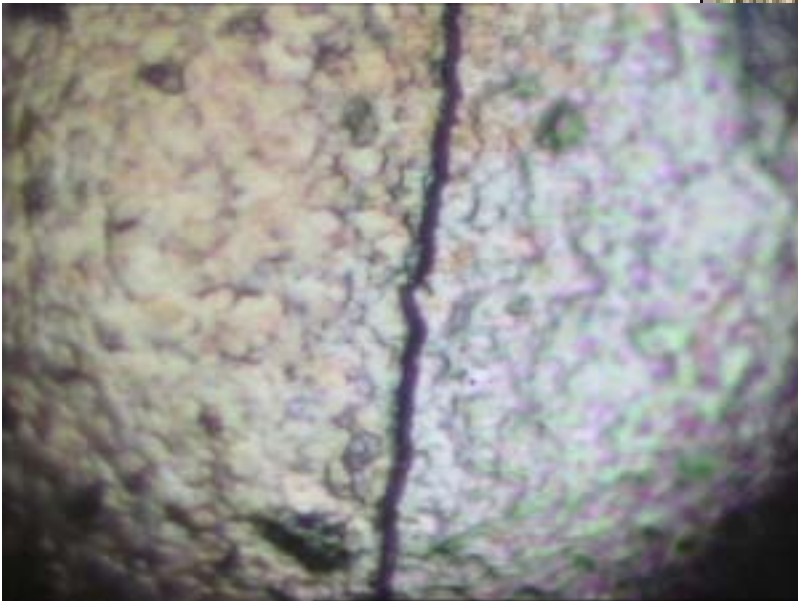
A tiny crack near NAI S soldering pad (different position on kapton cable w.r.t. previous pictures)

Cracks like this one could give intermittent problems as seen in TIB (and TOB) cables
