I²C Problems in LT: The Solution

Marco Meschini
INFN Firenze

Introduction: The Problem

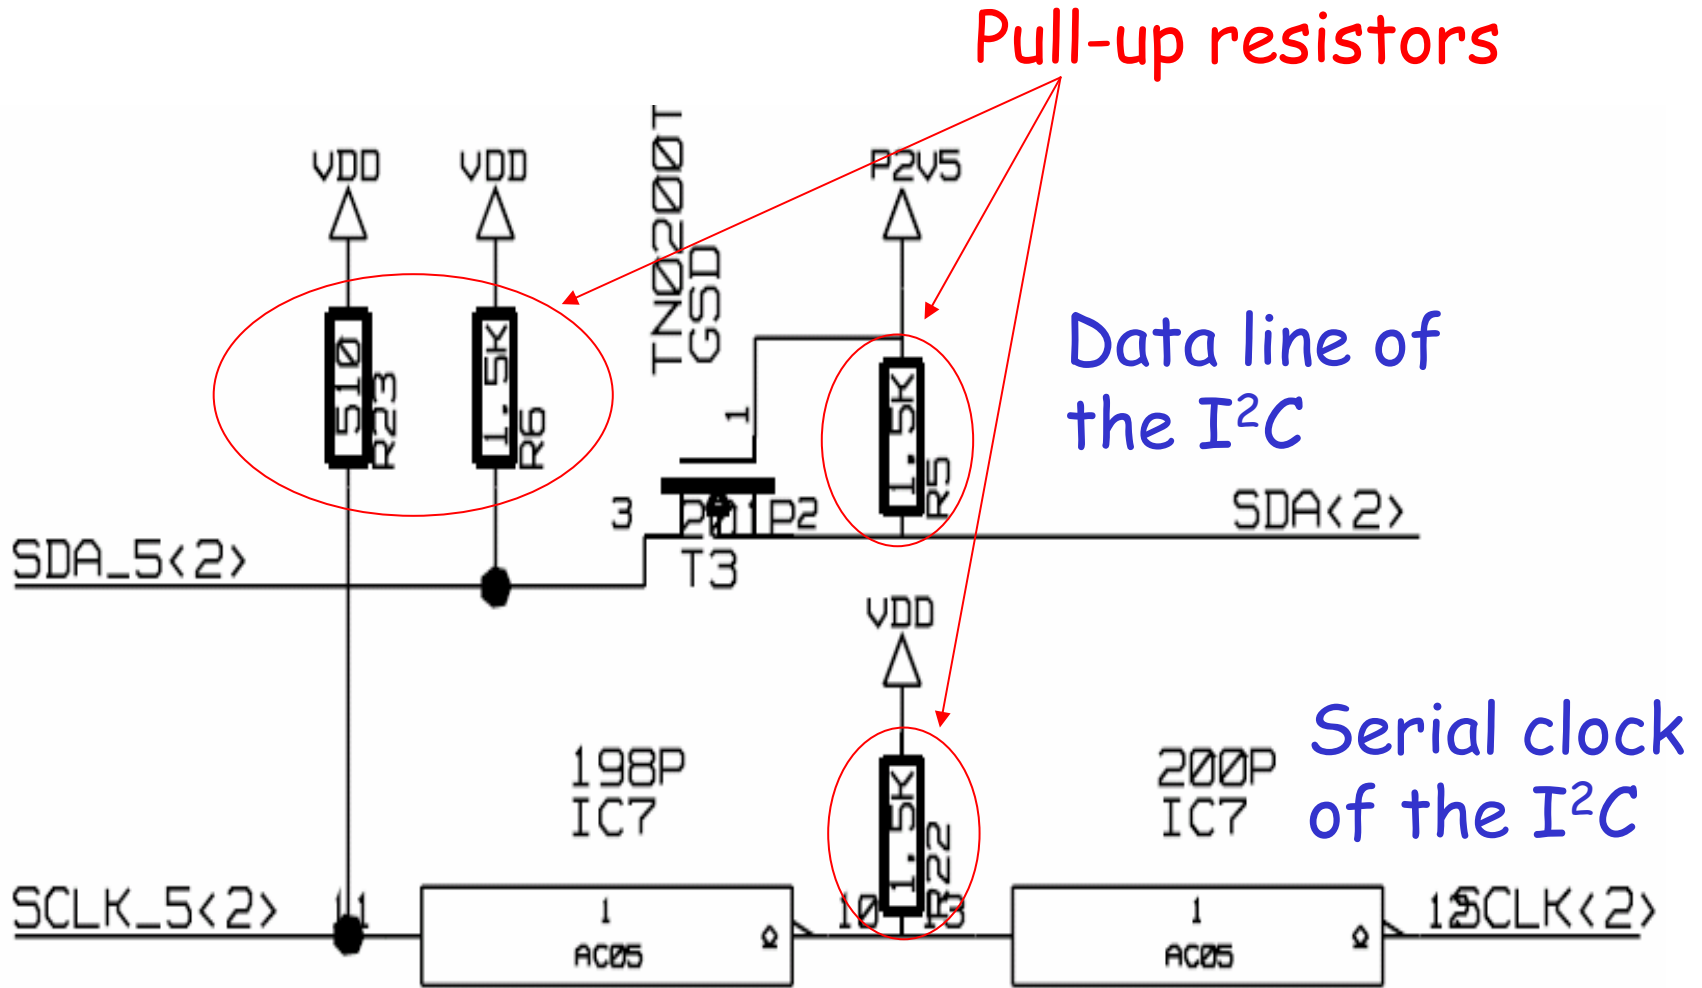
CCU6 Schematics

Depending on the pull-up R_p it can happen that the CCU6 does not pull down enough the I²C line

- Not all APVs behave in the same way: different sensitivity to LOW thresholds leads to loss of communication → **WE WERE RIGHT!**
- To avoid this problem we chose to increase the pull-up resistors on the data line of the CCU6 from 1500 Ω to 2200 Ω . **All R1 through R12 on the CCU6 boards have to be replaced**
- **With this modification no I²C errors appear, both on new tested modules and on previously failing modules which are then recovered**
- The line speed of the I²C bus in our case is 100 kHz. Is it safe going to higher speed?

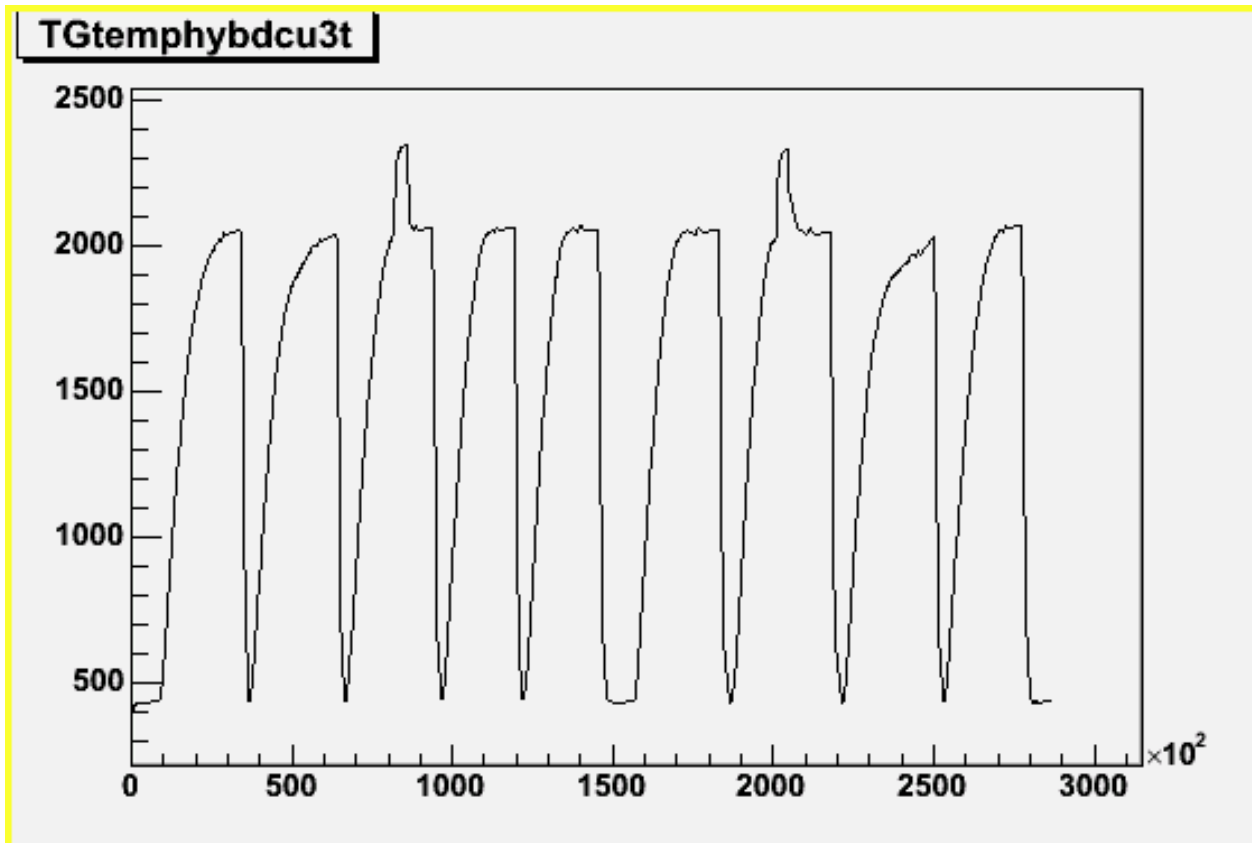
The DCU readout via I²C shows no problem both at +20 °C and -20 °C during a full 3 days scenario in the cold box

Readout of the NTC thermistor on the silicon

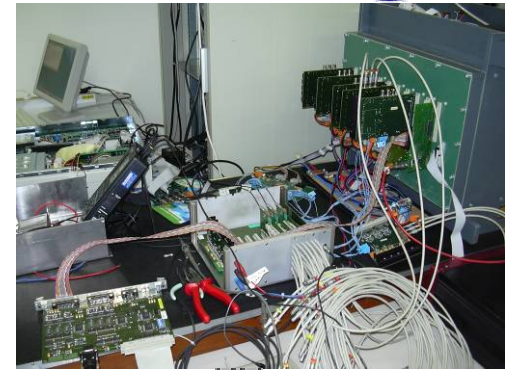
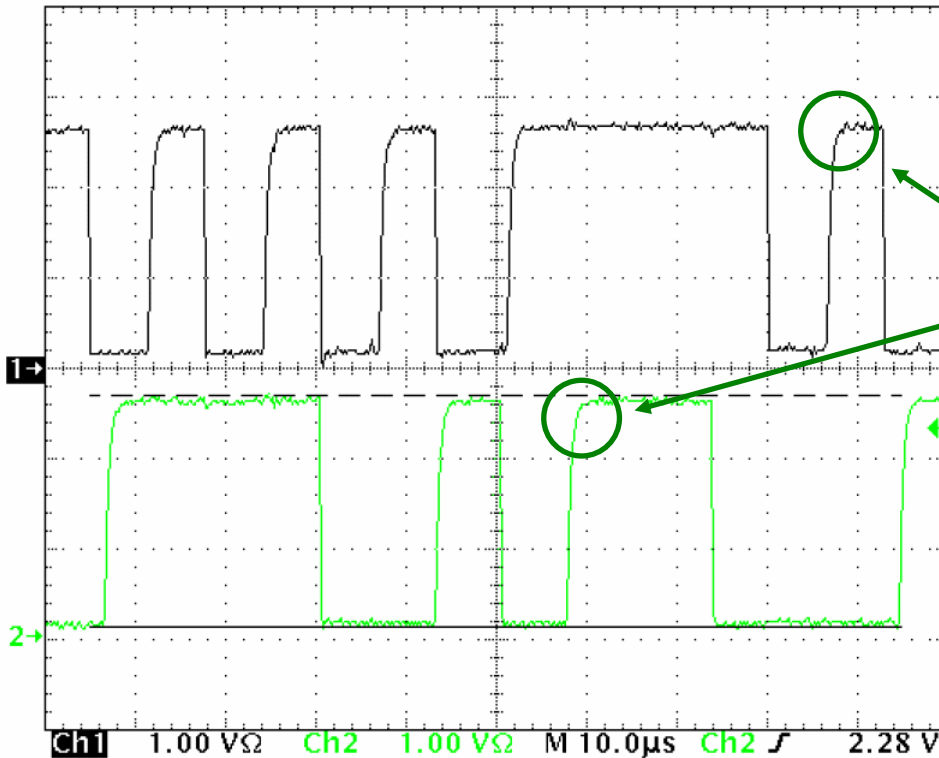
- ARC connected to the cold box
- Modules at $-20\text{ }^{\circ}\text{C}$
- Different I²C driving
- I²C signals are recognized correctly

Even a slower rise time wrt the CCU6 setup has no bad influence
