TOB Testing Status and CMN Issues

Claudio Campagnari - UCSB

On behalf of the US module testing groups

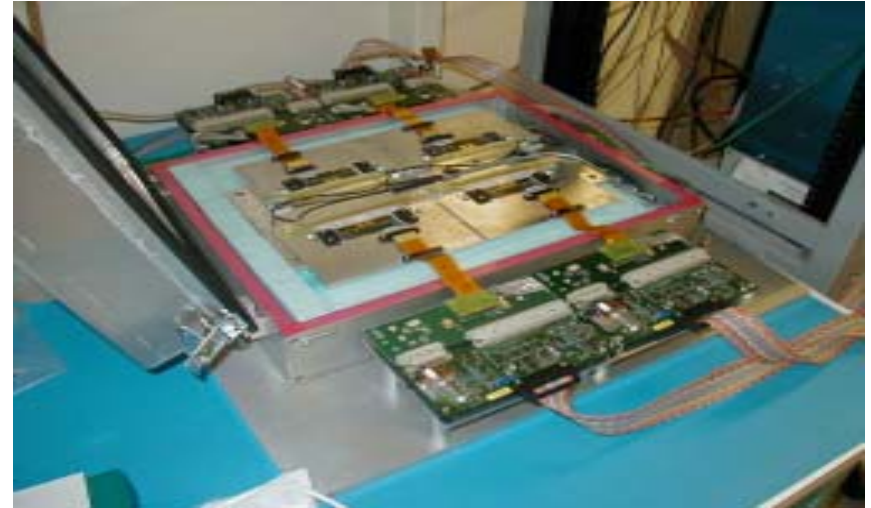
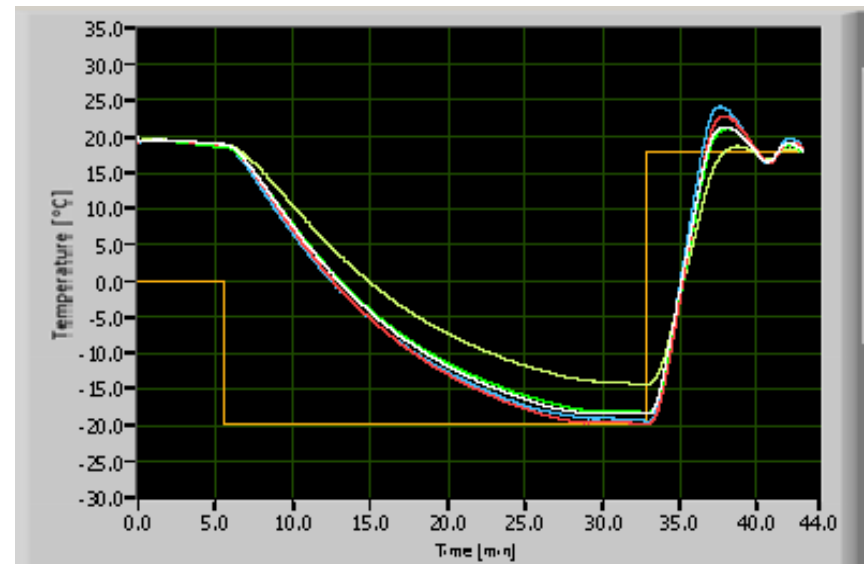
Hybrid Thermal Cycler-Pulser

- Now fully commissioned
 - Many thanks to CERN group for their constant aid
 - ~40 minutes to thermal cycle 4 hybrids
- 6 hybrids had APV-PA bonded at UCSB
 - 4 6-chip hybrids
 - 1 4-chip R- Φ hybrid
 - 1 4-chip stereo hybrid
- No opens or shorts caused by bonding
- **Ready for Production**

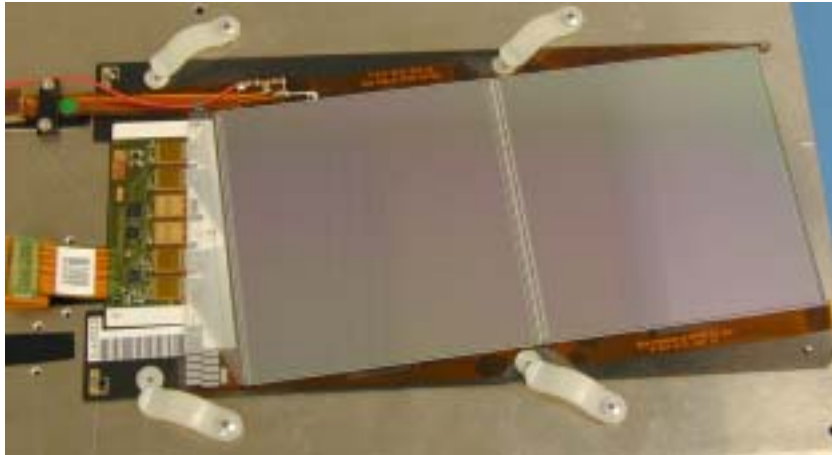
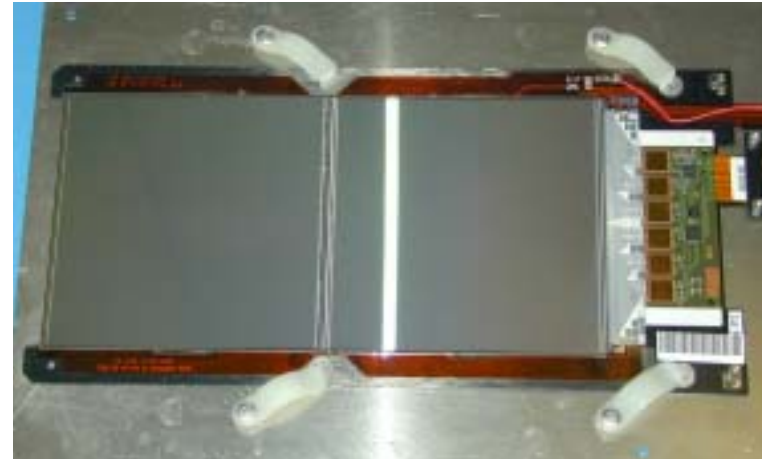
Modules Produced with Final Hybrids

- First Stereo TOB module made!!!
 - 3 TOB stereo module produced in total
 - All well within specs mechanically and all Grade A
 - Kapton circuit was missing a trace for bias. We made it by hand with Ag Epoxy.
 - One chip has dead pipeline column
 - Found to be dead prior to module production
- 2 TOB 6-chip R- Φ module produced (first module of this kind produced!!!)
 - Both Grade A
- 1 TOB 4-chip R- Φ module with final hybrid built
 - Grade B due to known sensor faults

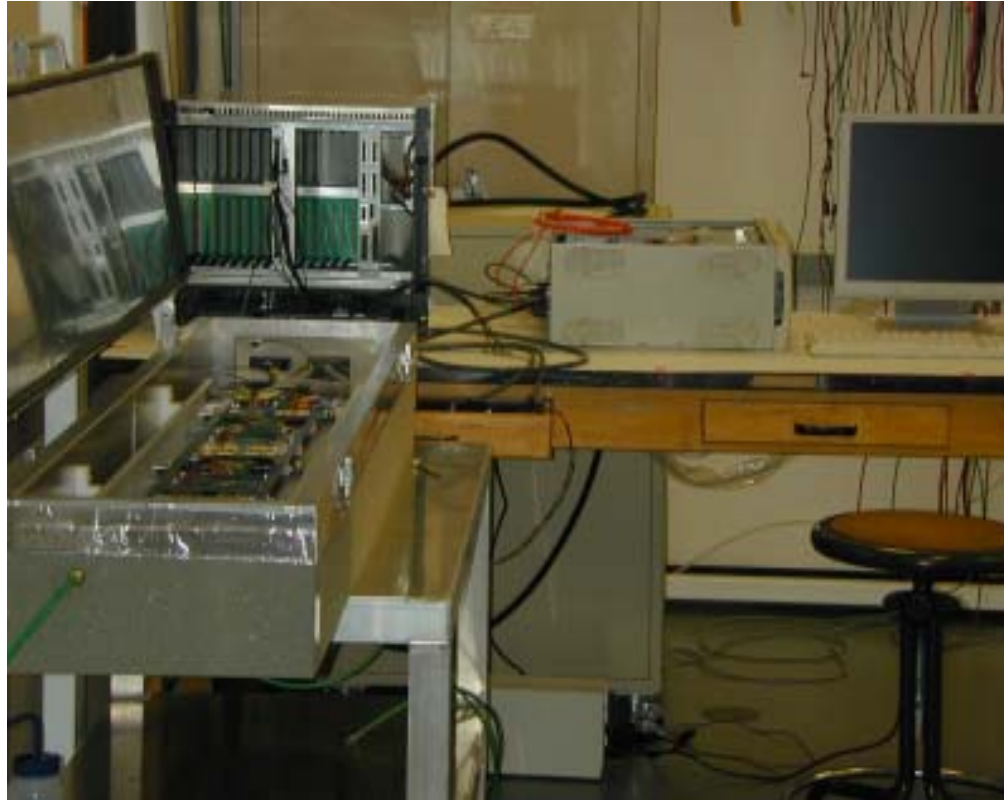
Single Rod Test Stand at UCSB

- Complete set of electronic ready to test single rods
 - Test box provides dry, dark, and electrical isolated environment
 - Connects to Rod burn-in chiller for cooling
- Prototype rod with 3 biased modules tested on stand

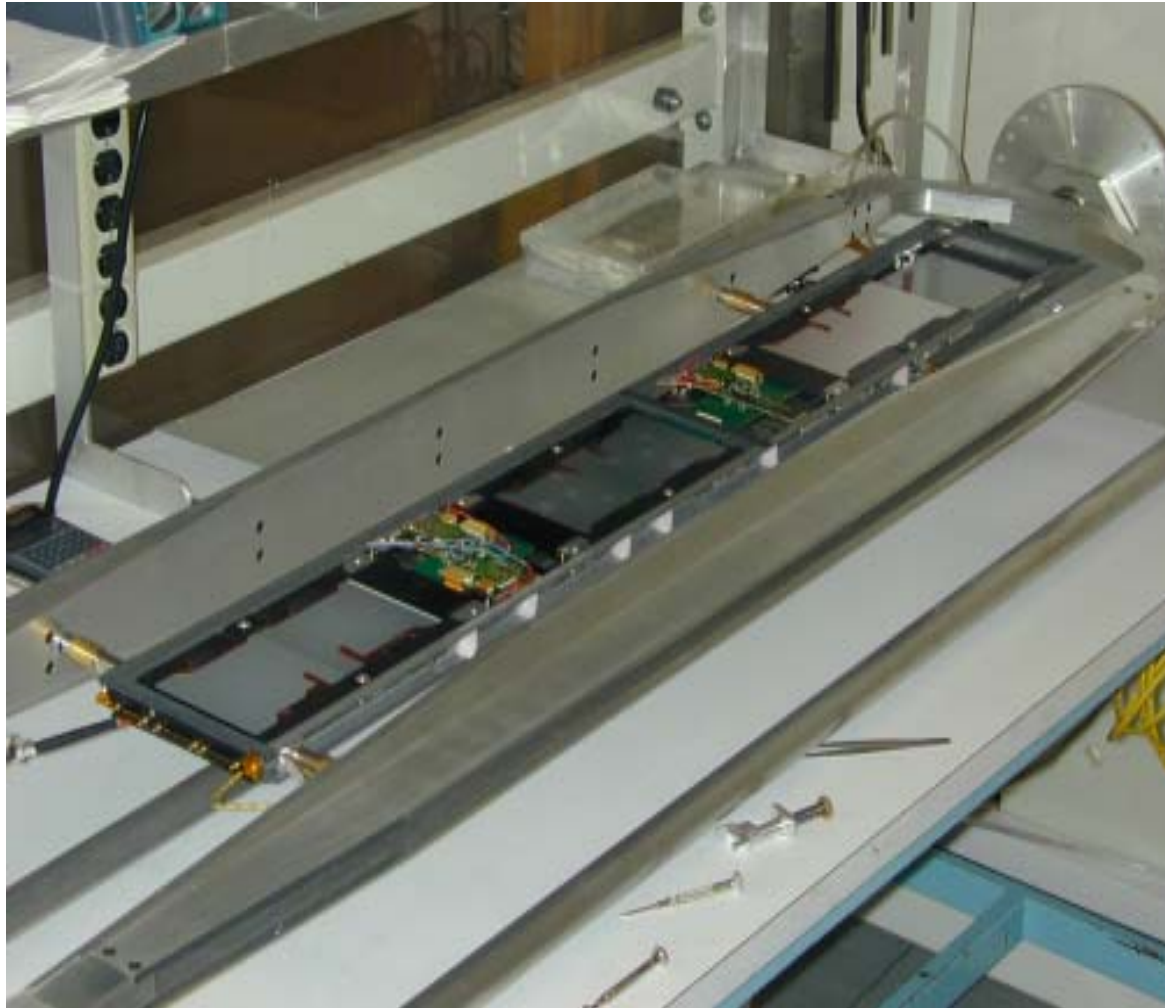
First Assembled Rod in US

- First rod in US fully assembled
 - Took approximately 2 hours for assembly
- Initial electric tests OK, noise under control
