TOB Testing Summary

E. Chabalina

(University of Illinois Chicago)

for US-CMS Tracker group

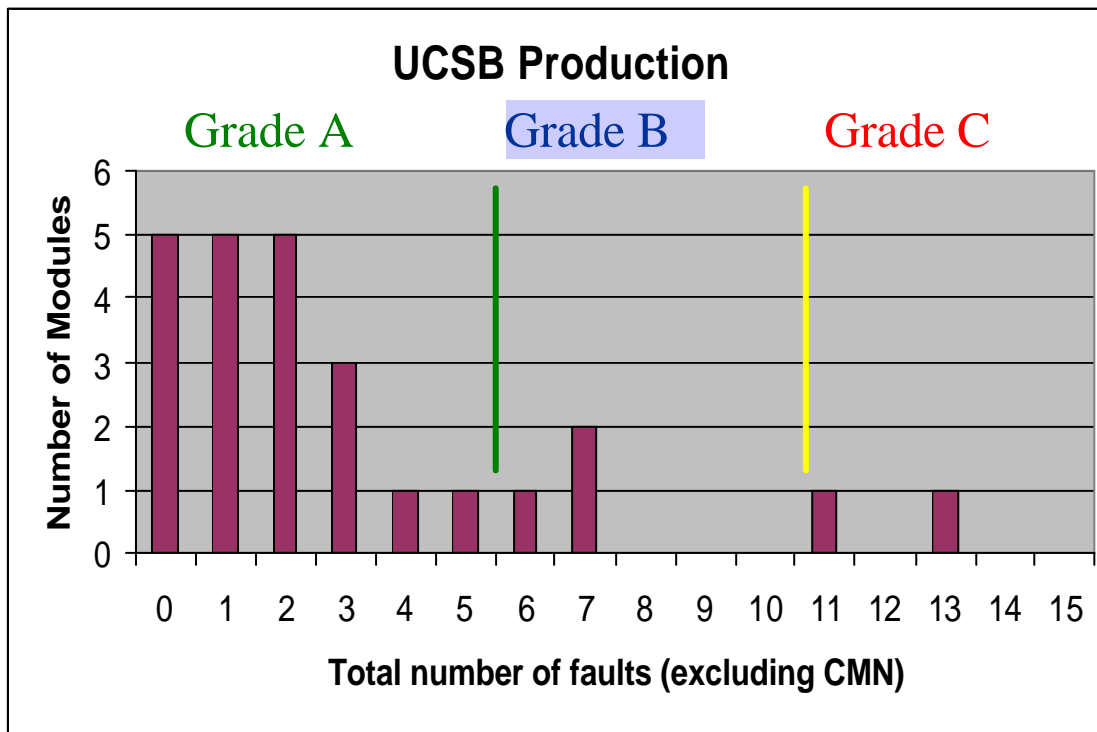
- 17 Grade A
 - 1 has CMN/increased I_{BIAS} occasionally (not understood)
- 3 Grade A/F
 - 2 Broken Cables
 - 1 Broken Cable/CMN
- 2 Grade B
- 1 Grade B/F
 - CMN
- 2 Grade C/F
 - 2 CMN

CMN = Common Mode Noise)

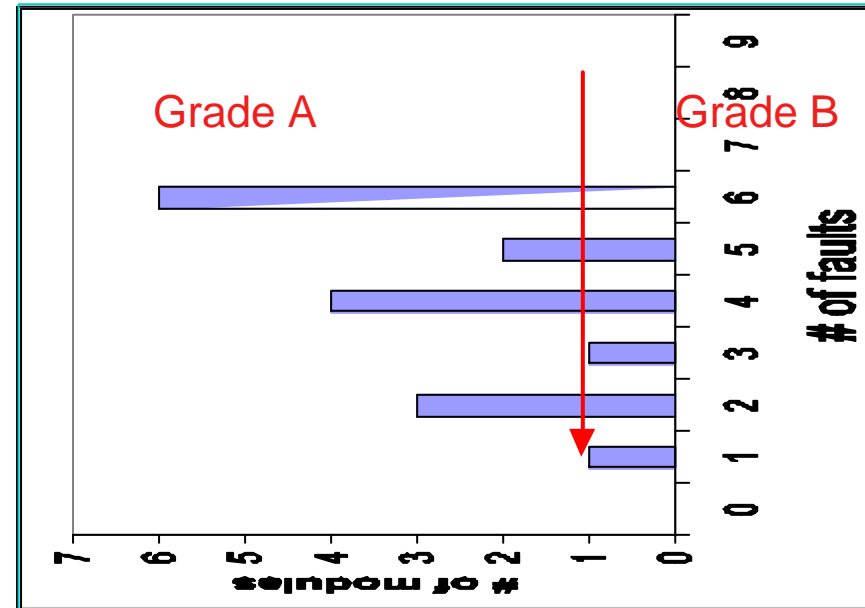
IV curve
module
690

- 9 Grade A
 - 1 has blown the fuse twice when tested with crow bar; shows normal behavior without current limiting
- 2 Grade A/F
 - CMN
- 5 Grade B
- 1 Grade B/F
 - CMN

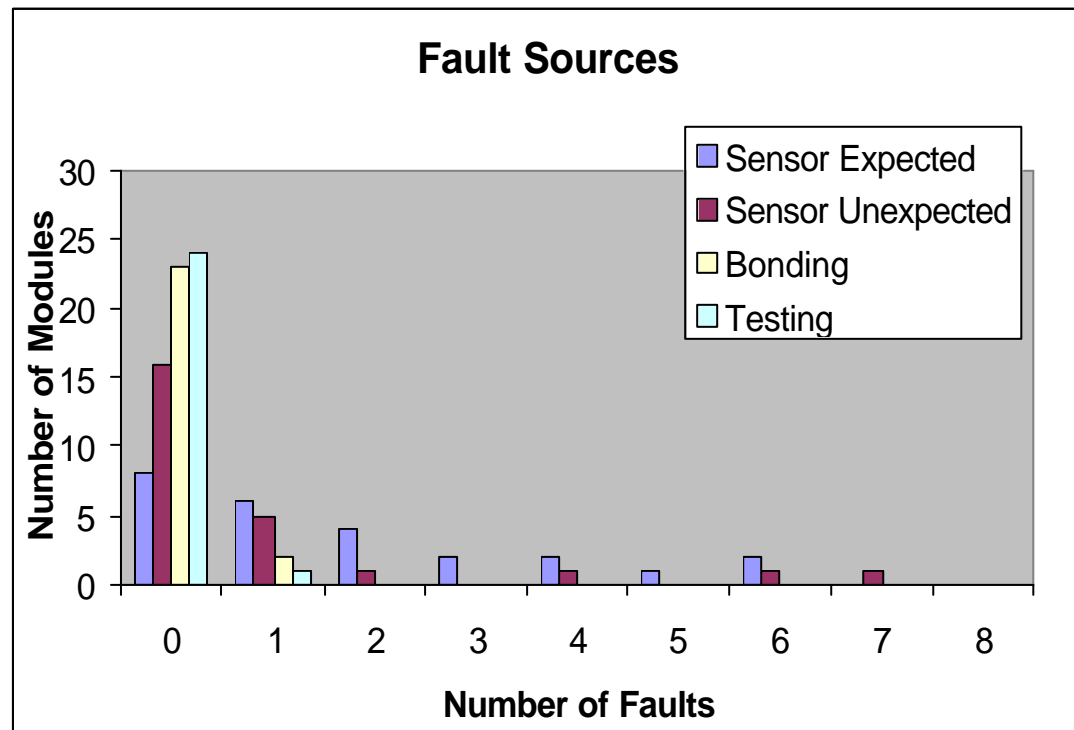
- Hybrid – 0.02%
- Sensor (in DB) – 0.38%
- Sensor (not in DB) – 0.17%
- Bonding- – 0.016%
- Testing – 0.012%

Total faults: 0.598%
cable breaks and
CMN are not
included in statistics

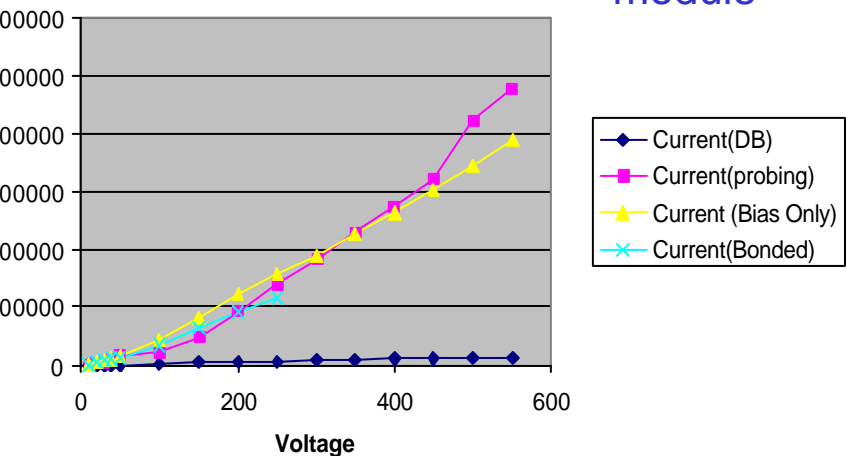
30200020001016

Mid-sensor open “burn” seen in sensor 30210422067903, channel 285.

Strip defect is observed in channel 38 of sensor 30210422066202.

The channels referenced above were found to be the noisy channels in module testing

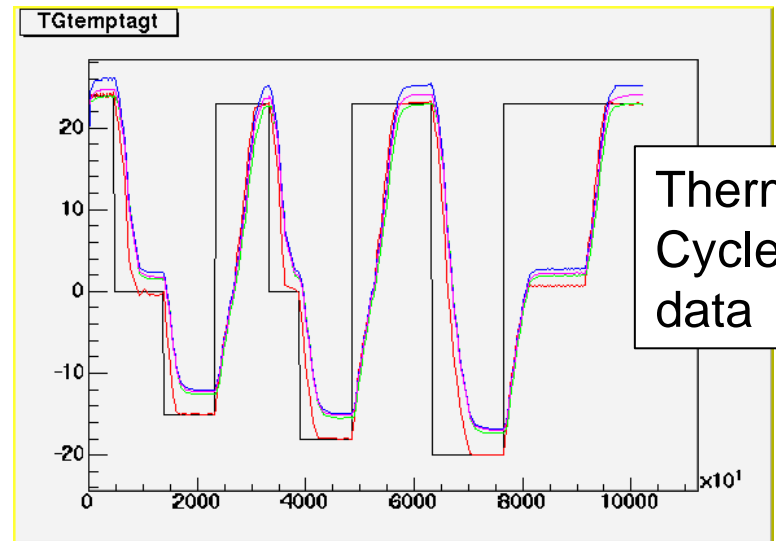
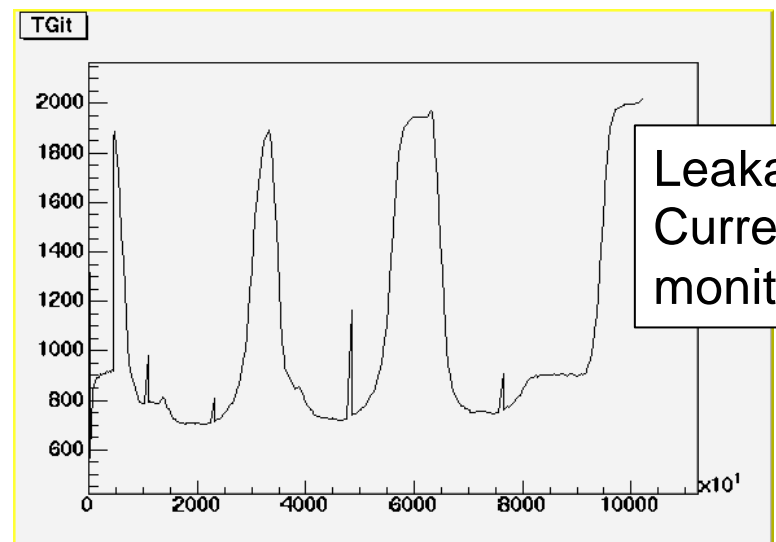
After rechecking on ARC/LED no new bad channels found

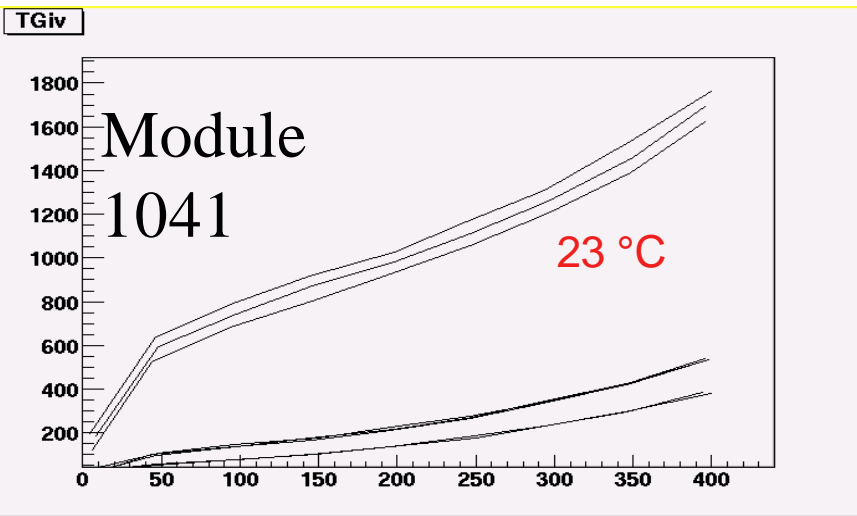
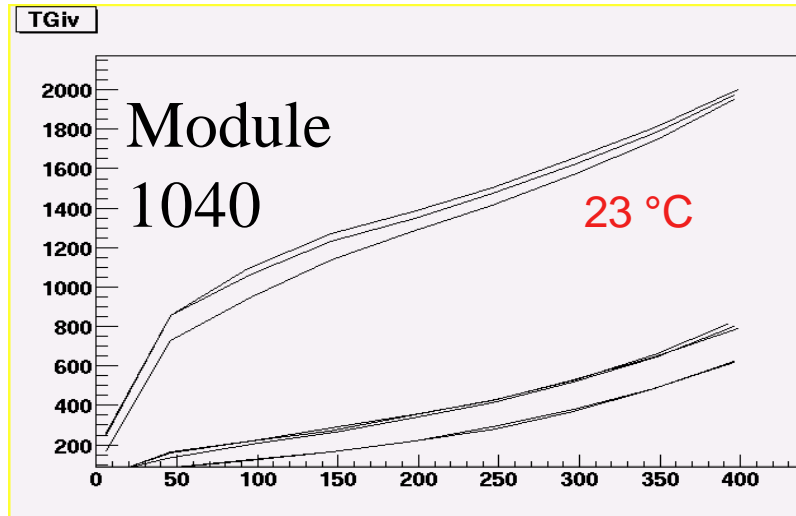
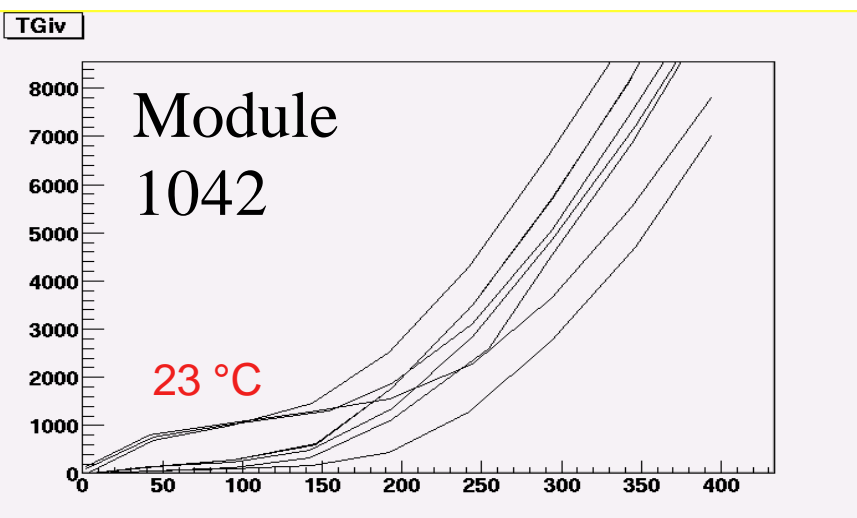
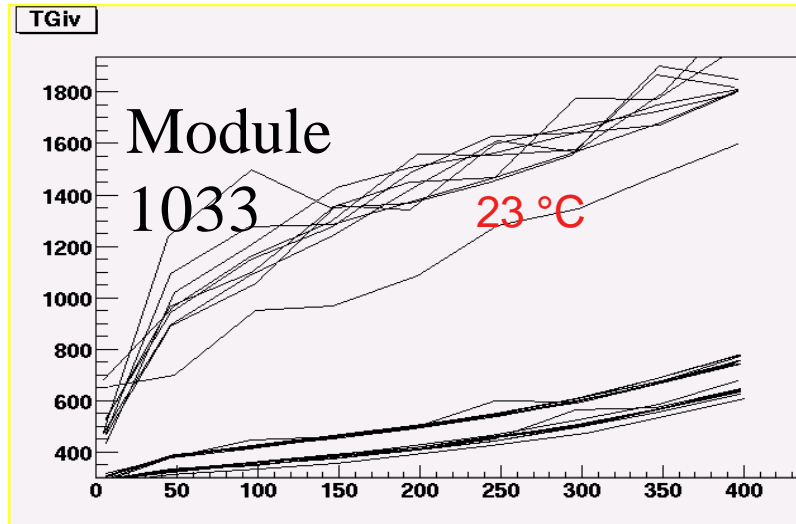
LT Test Results – IV curves

Lower IV curves at taken at $T = -15^{\circ}\text{C}, -18^{\circ}\text{C}, -20^{\circ}\text{C}$

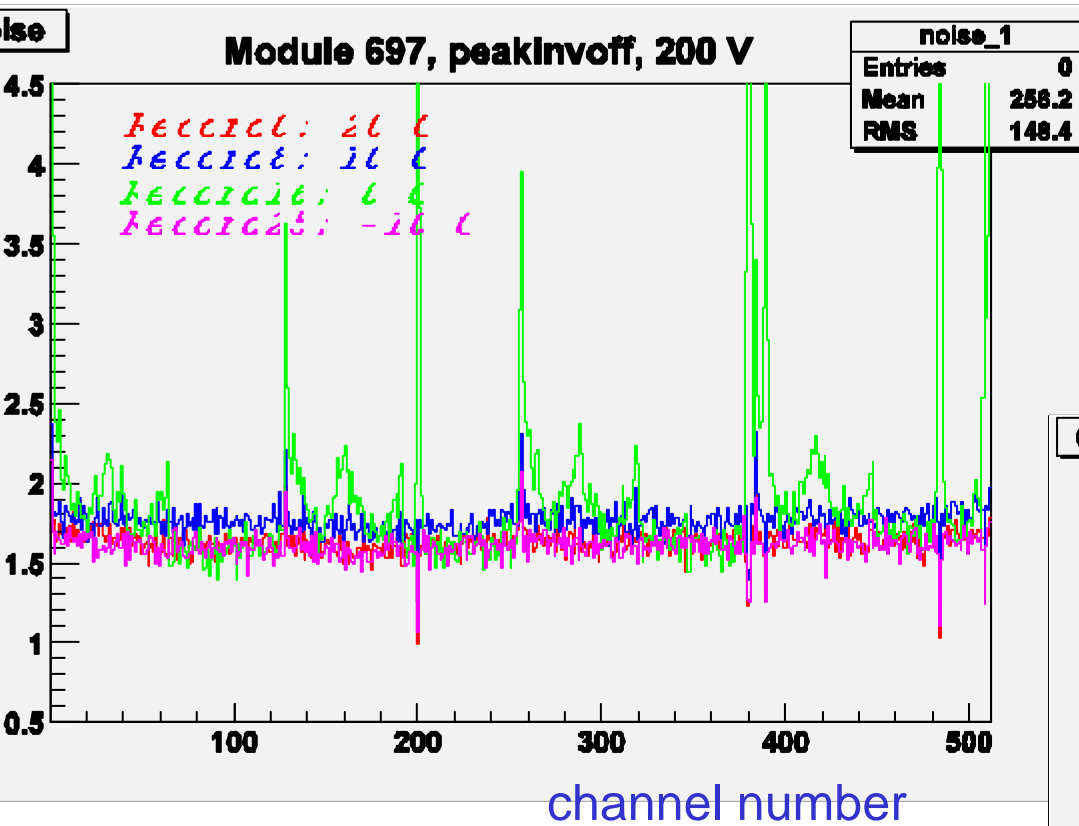
No obvious temperature dependence of noise is observed

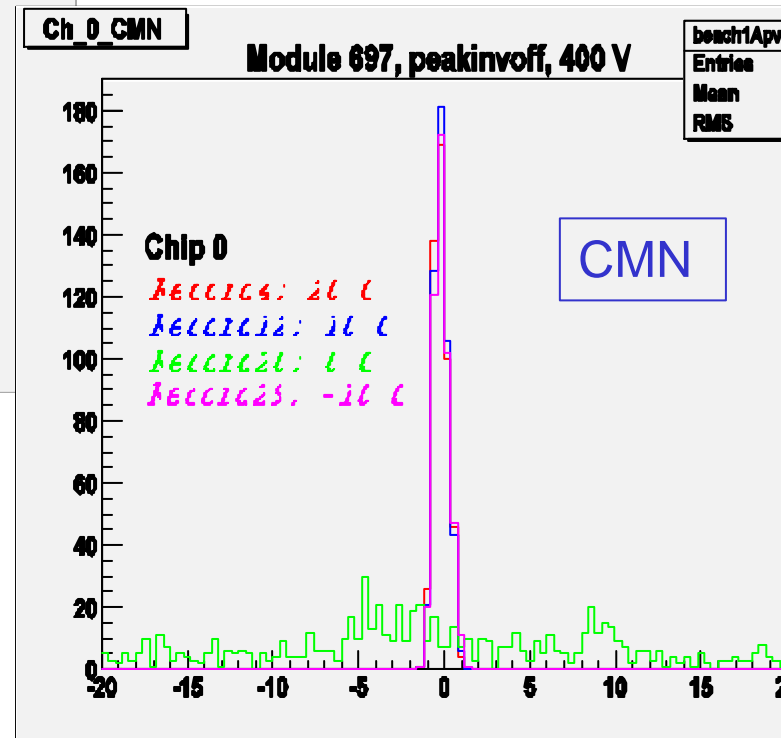
Large amount of noise is occasionally seen in LT systems at both UCSB and FNAL. The problem is under investigation

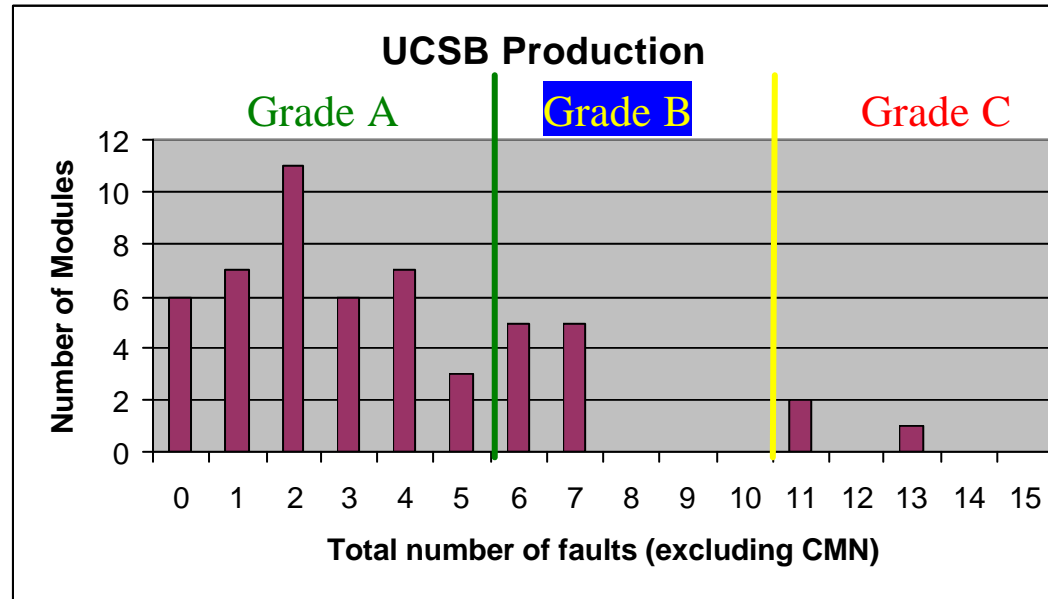
- 28 Grade A
 - 1 has CMN/increased I_{BIAS} occasionally
- 10 Grade A/F
 - 2 Broken Cables
 - 1 Broken Cable/CMN
 - 7 CMN
- 6 Grade B
- 6 Grade B/F
 - 4 CMN
 - 2 Missing Bias Bond
- 3 Grade C/F
 - 2 CMN
 - 1 Missing Bias Bond

- **Catastrophic Failures**
 - 3 Missing Bias Bonds
 - Early in production missing PA-sensor wire bonds caused damage and high bias current
 - 3 Broken Cables
 - 13 micro-discharge/CMN

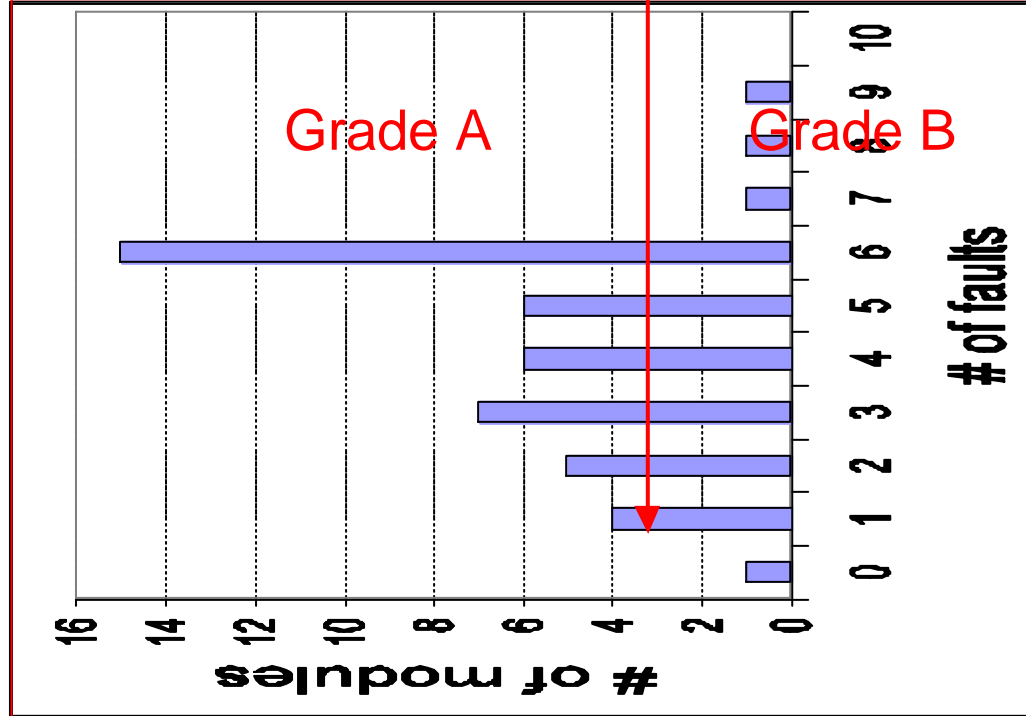
- 22 Grade A
 - 7 CMN
- 7 Grade A/F
 - 7 CMN
- 17 Grade B
- 1 Grade B/F
 - 1 CMN

- **Catastrophic Failures - 8 micro-discharge/CMN**

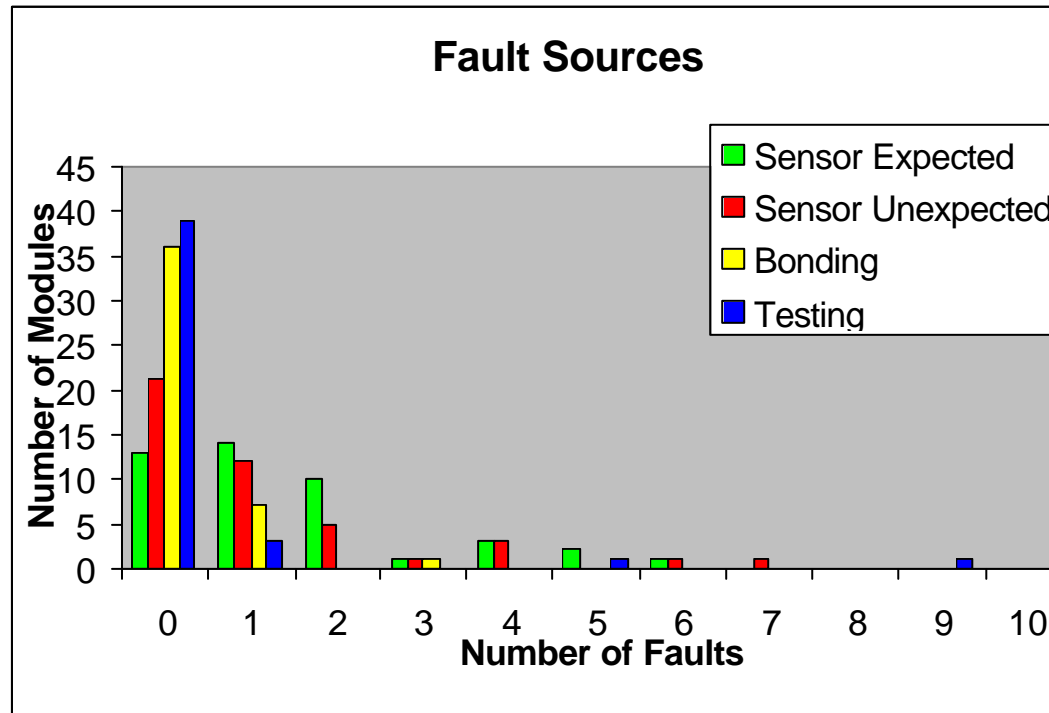
- Hybrid – 0.011%
- Sensor (in DB) – 0.33%
- Sensor (not in DB – 0.26%
 - Either high noise and/or visible sensor damage
- Bonding – 0.037%
 - Mostly due to hard to bond PA
- Testing – 0.074%
 - Mostly due to missing bias bond

Total faults – 0.712%
(0.598% for mini-production batch)
