TIB Module Production

Introduction

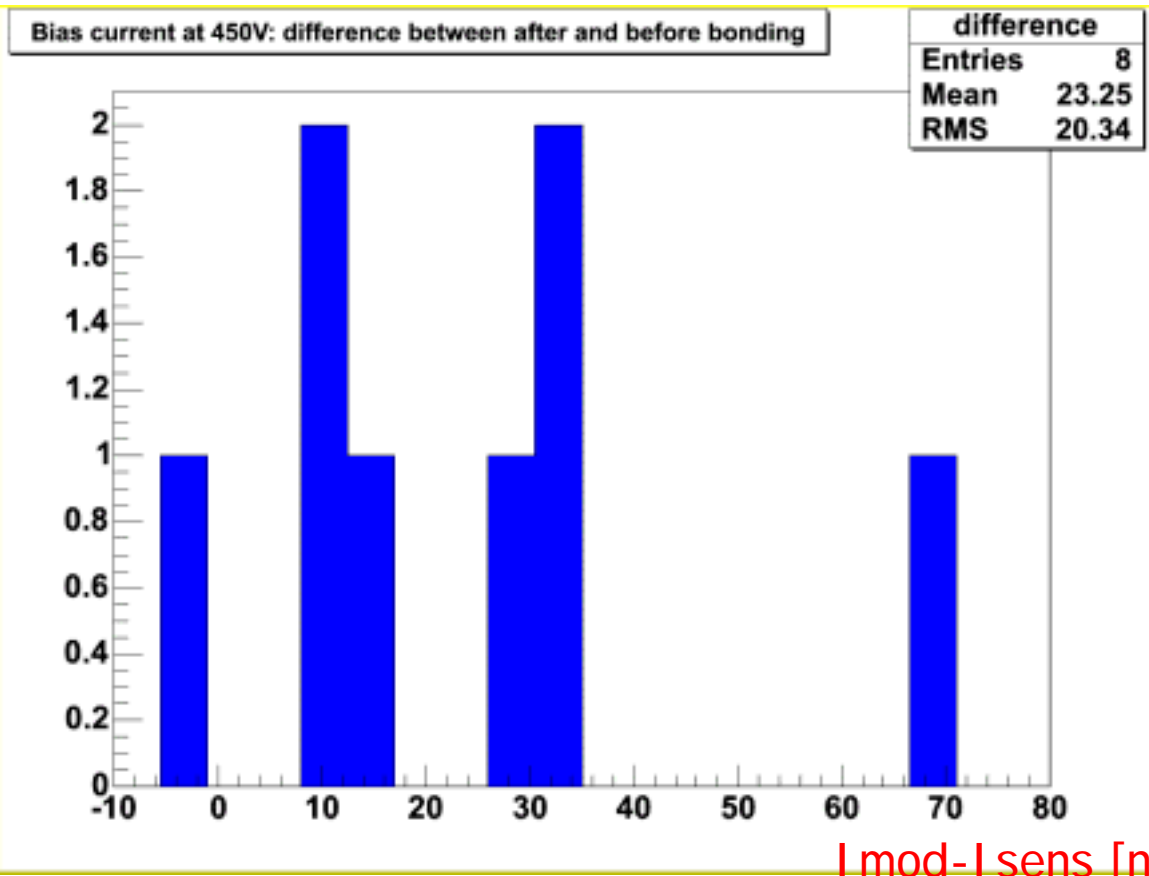
The Plot shows Current Differences Distributions on a sub-sample. Scale is nanoAmpere !

Mod #	I_{mod} nA	I_{sens} nA
24	237	209
25	243	211
26	226	216
27	241	233
28	196	200
30	281	214
31	248	217
32	219	205

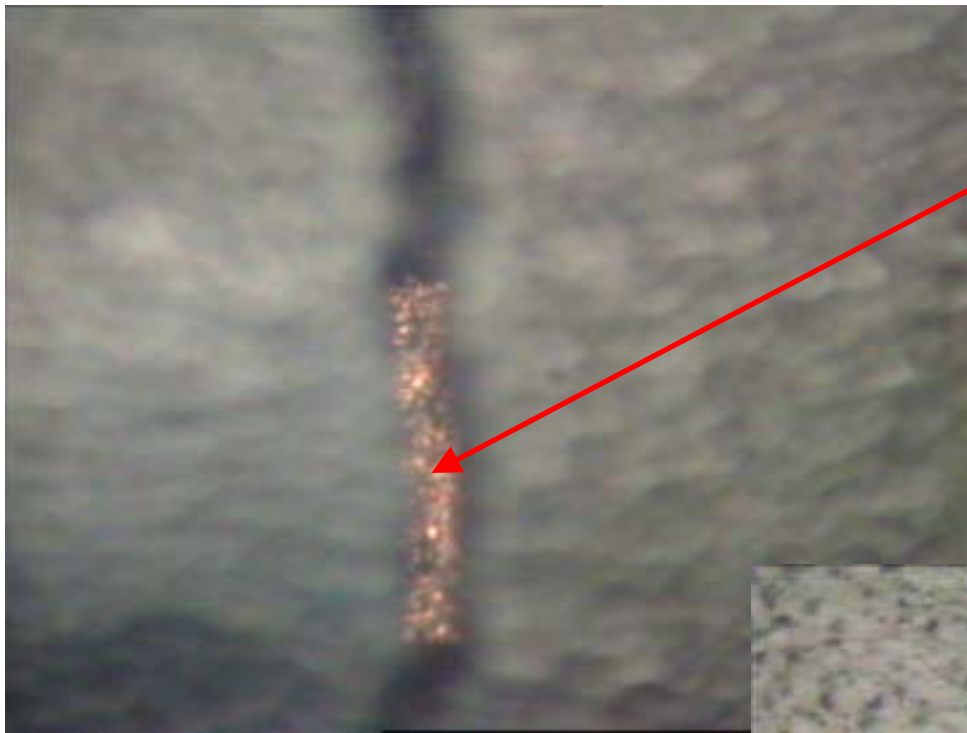
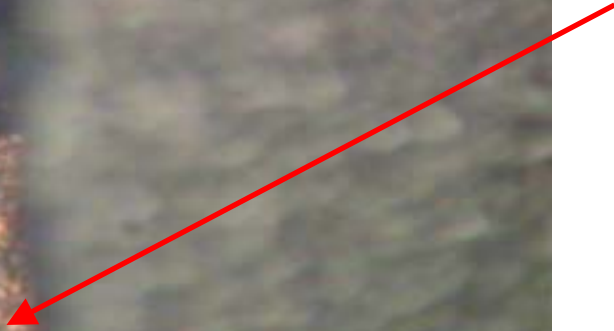
Focus on gold trace

- In Firenze a module which had already passed tests before and after HV bonding, failed last test after sensor bonding.
- The kapton cable had never been disconnected before failure
- No evident reason: carefully studied for electrical contact, broken traces or so.
- A high magnification microscope showed tiny cracks (5 to 20 micron wide) on 6 kapton cables out of 8. They could not be directly correlated with failures, but they appear as weak points.

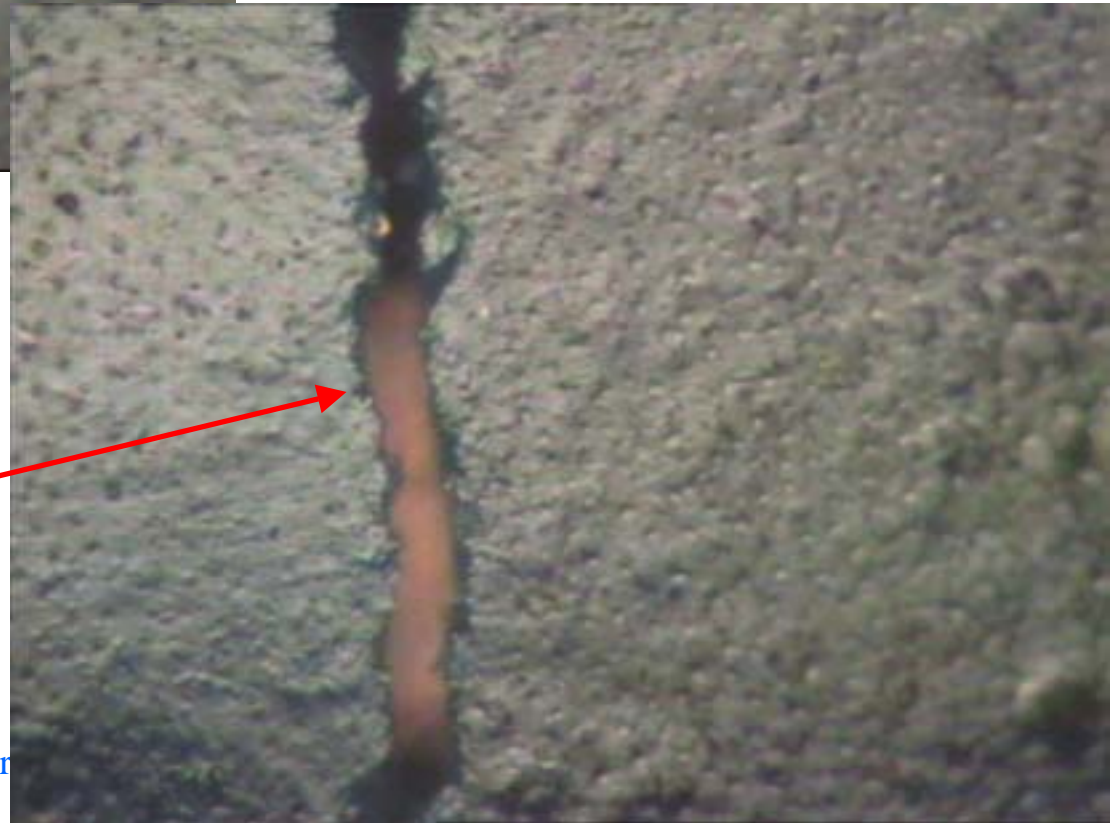
Focus on top layer

A tiny crack near NAI S soldering pad (different position on kapton cable w.r.t. previous pictures)

Cracks like this one could give intermittent problems as seen in TIB (and TOB) cables
