Module Production and Testing in the U.S.

Last month we had a two day workshop on production and testing at the two U.S. sites.

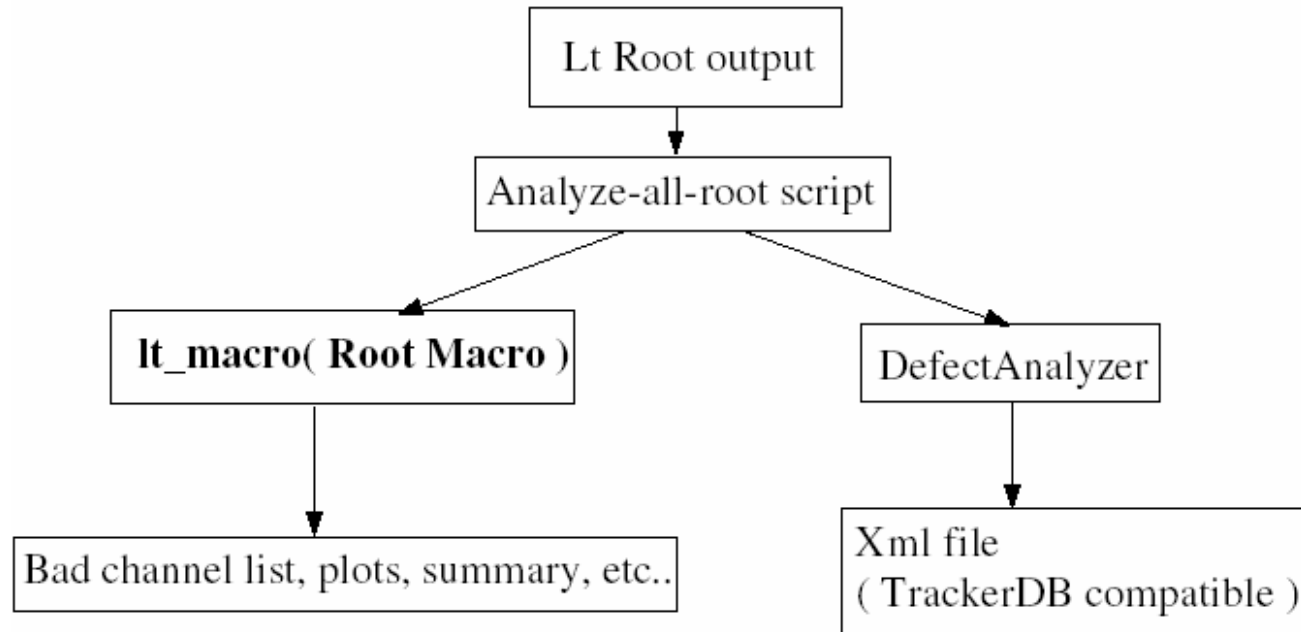
LT data analysis flow

Following modules records had "string literal too long" and caused **ERROR:ORA-01704:**

Some work is necessary to consistently generate legal XML files.

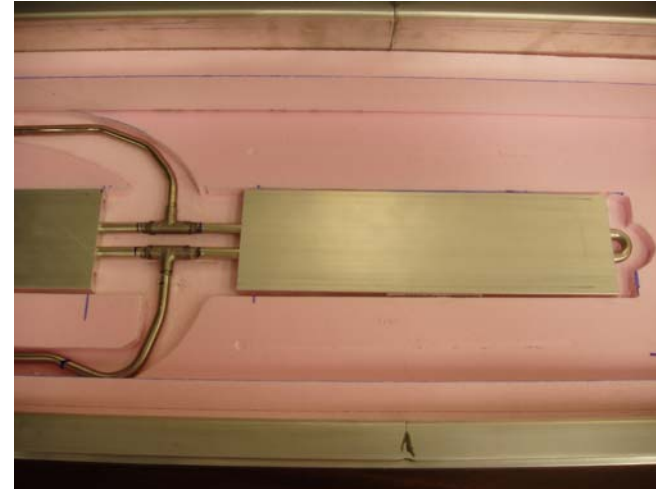
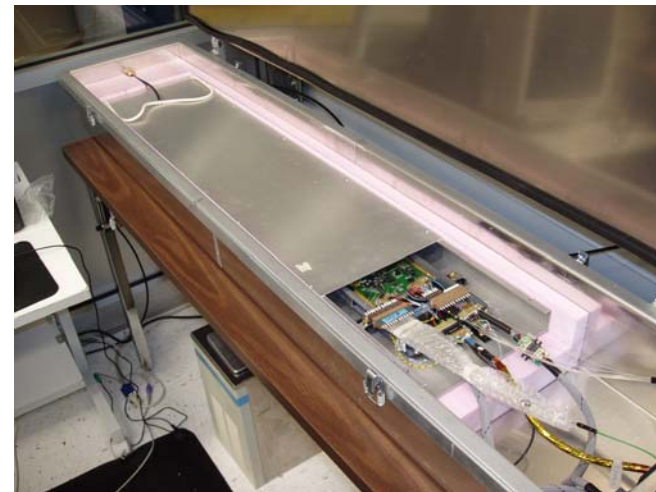
Single-Rod Systems

The single-rod system at FNAL was recently modified to allow chilled water cooling of the test box.

Single rod testing is intended as a quick screening for the multi-rod systems.
